**IN-STREAM HABITAT COMPLEXING,
1996**

- Pilot Testing -

*NECHAKO FISHERIES CONSERVATION PROGRAM
Technical Report No. RM96-2*

Prepared by:
Triton Environmental Consultants Ltd.
January 2003

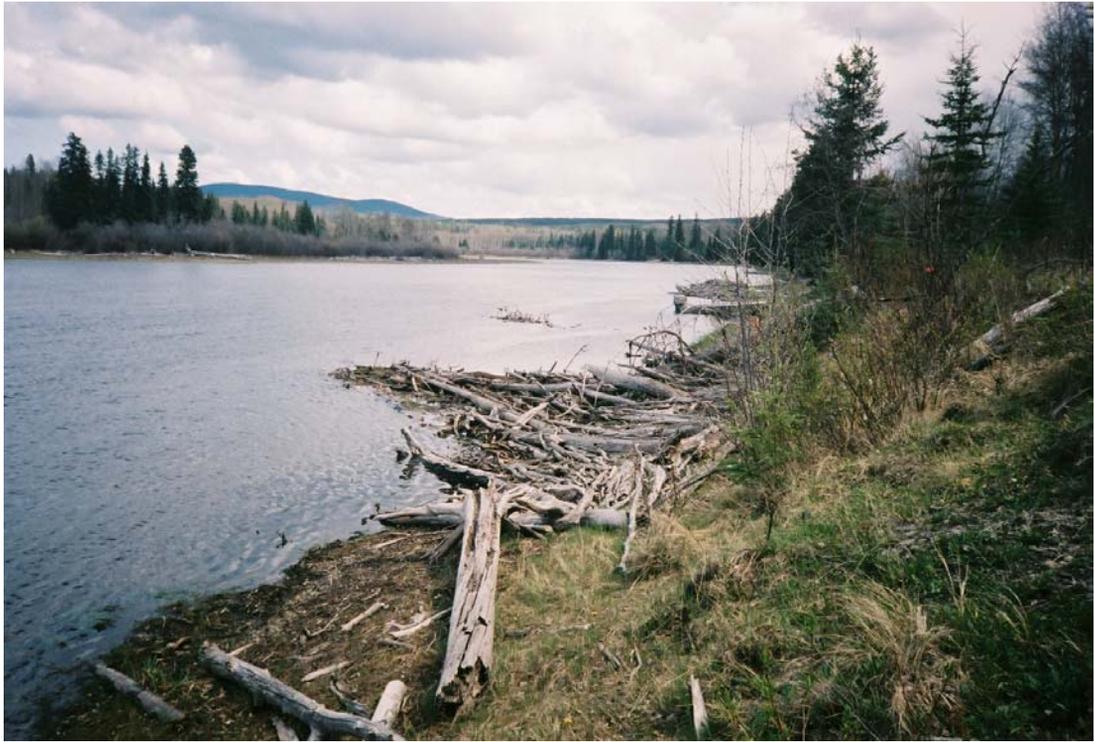
Photograph 1: Stable rootwad sweeper (RM24.35RS) providing 72 m² of cover area (May 1996).

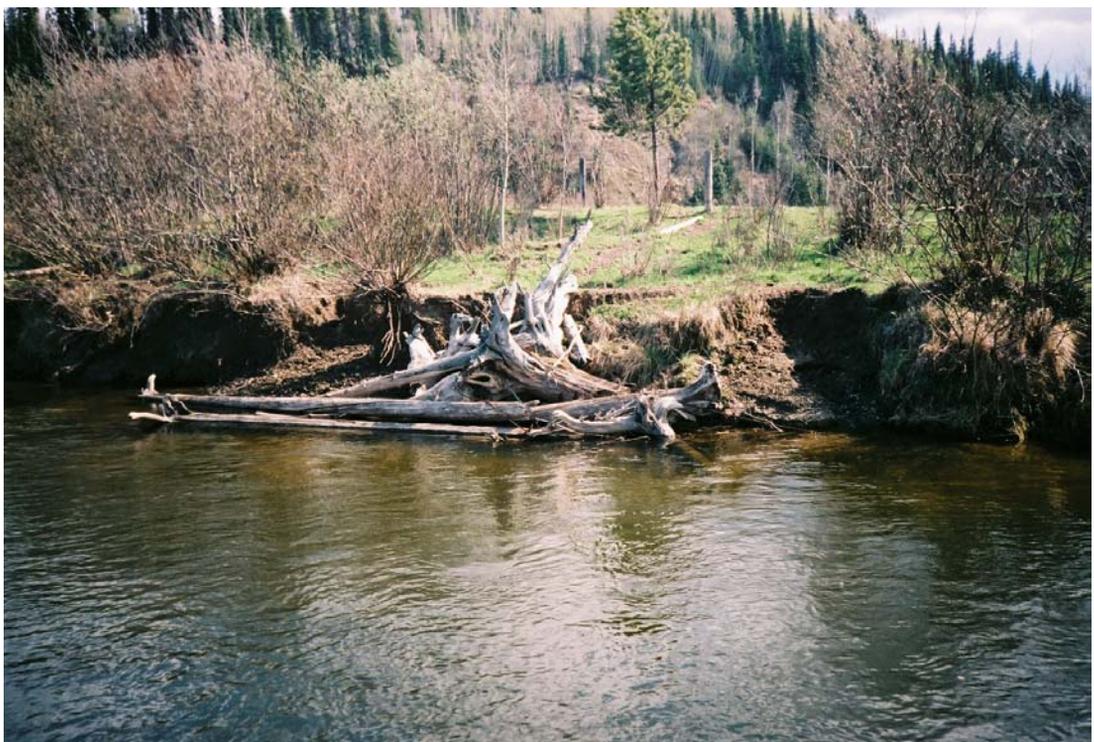
Photograph 2: Brushpile (RM31.4BP) with little cover area due to mobile river bank (May 1996).

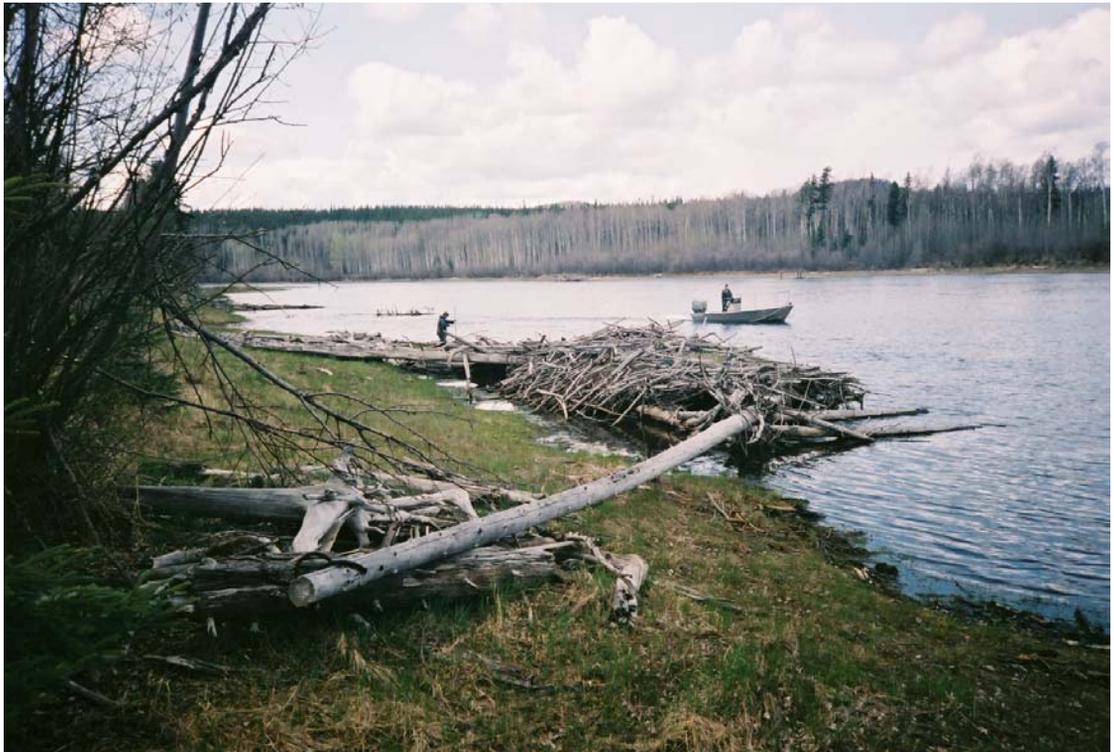
Photograph 3: Stable floating crib (RM24.4FC) showing large cover area of 78 m² (May 1995).

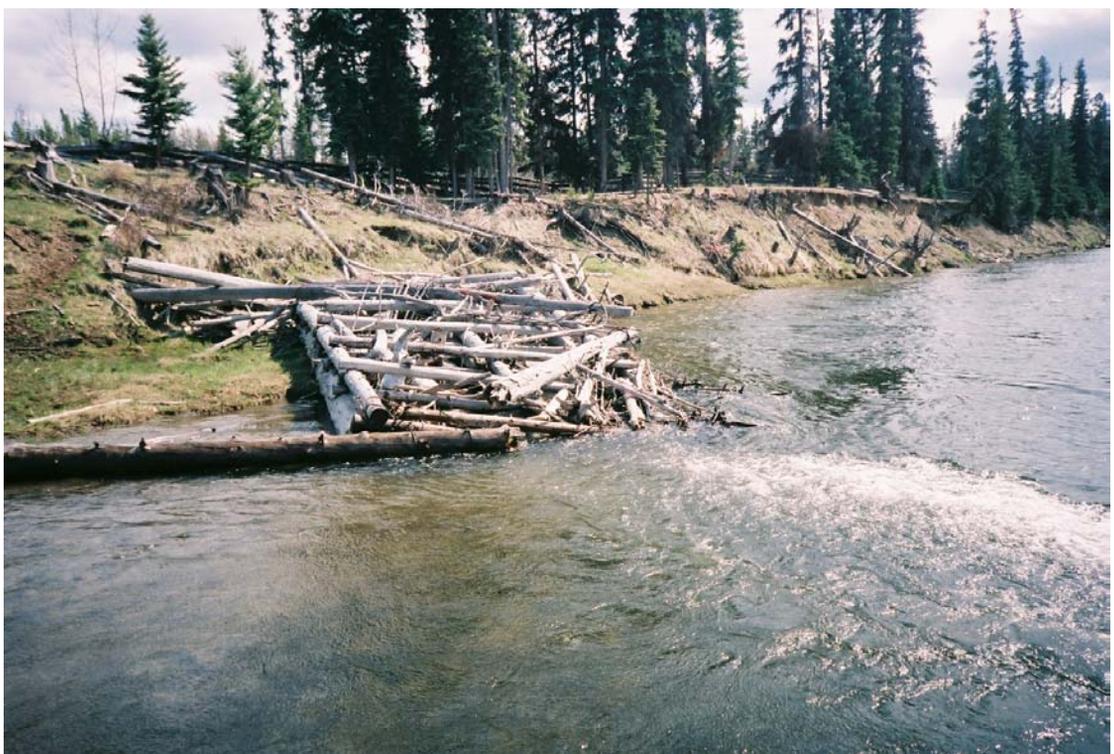
Photograph 4: Floating crib (RM27.4FC) not providing much cover as its upstream end pushed onto the shore (May 1996).

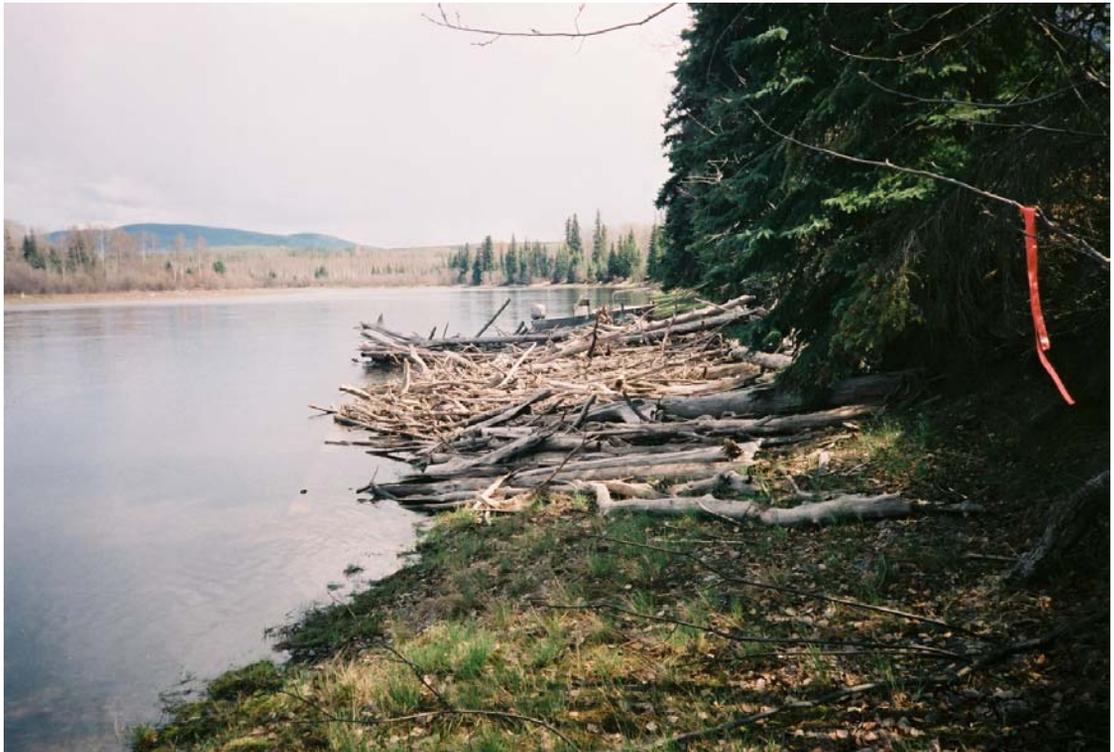
Photograph 5: Pseudo beaver lodge (RM24.6PBL) still retaining debris, providing 38 m² of cover area (May 1996).

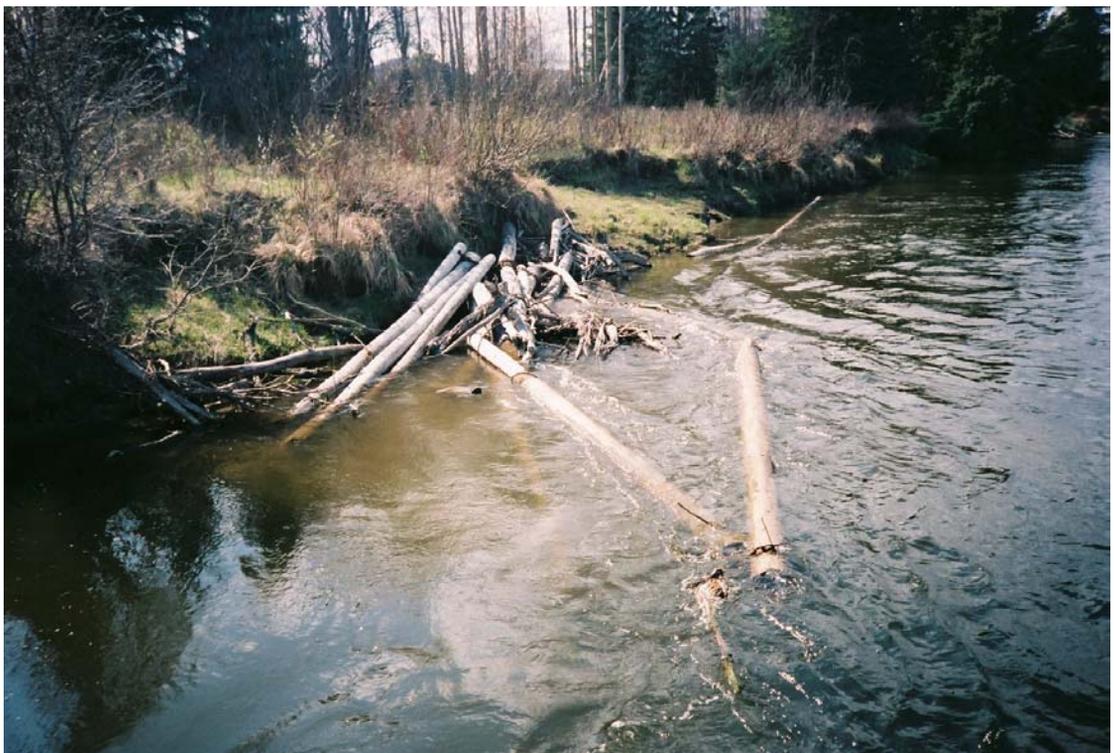
In 1996, one of the two remaining complexes had its structure collapse and both complexes lost debris. No recommendations for modifications have been made but it is not recommended that further units be constructed as these designs have experienced problems during fluctuating flows.

Photograph 6: Pseudo beaver lodge (RM31.0PBL) only providing a cover area of 15 m² due to collapsed frame (May 1996).

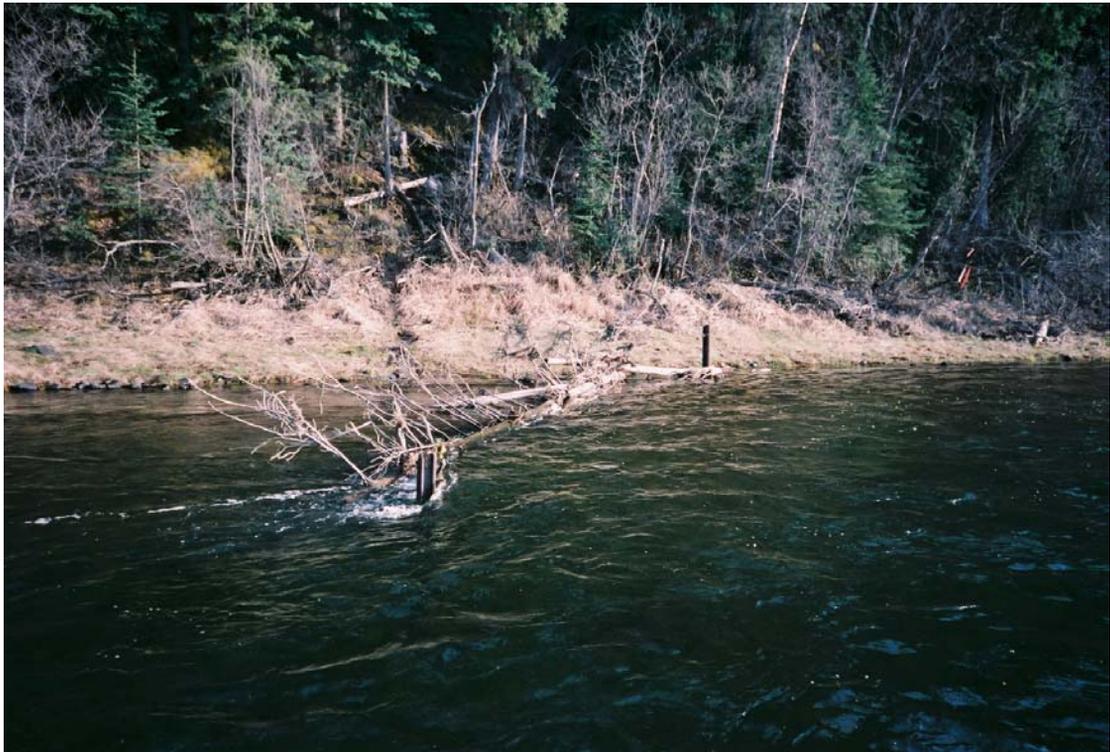
Photograph 7: Rail-anchored sweeper (RM16.2RAS) stripped of majority of branches and not providing much cover area (May 1996).

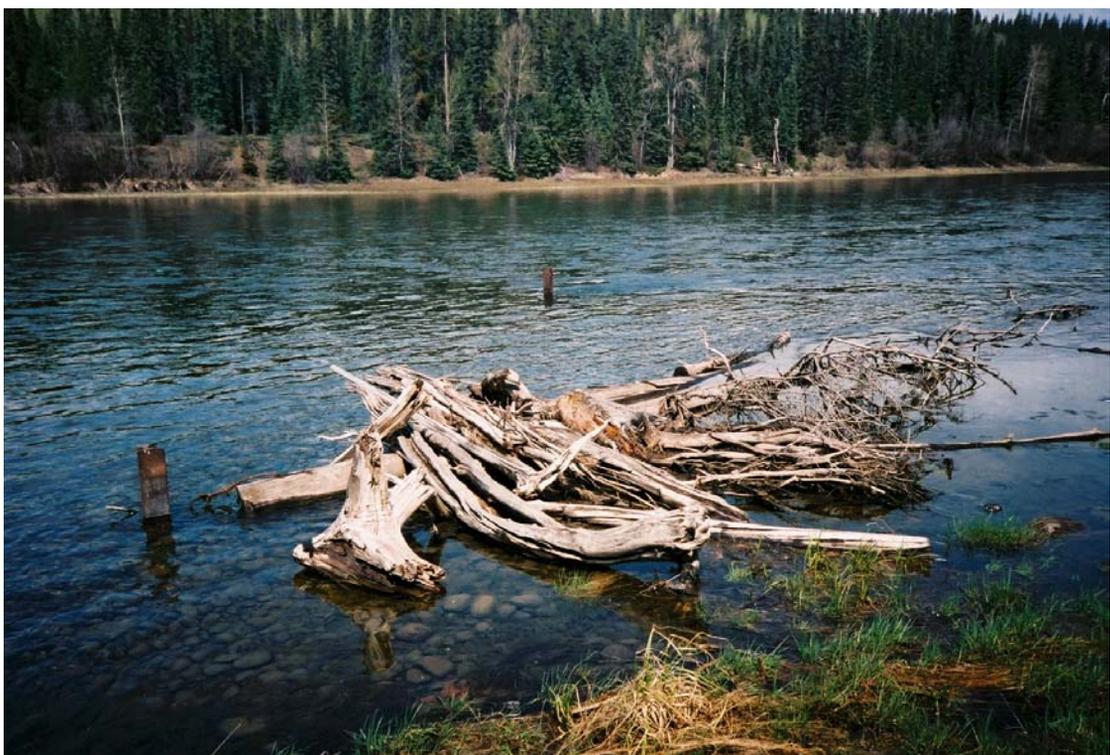
- Rail debris catcher RM22.1RAS was displaced as its boom log had become detached from the outside rail.
- Emergent fry structures RM19.7EFS and LM20.1EFS had lost branches, possibly by beavers. Several trees were missing branches, and one tree had been completely stripped of all foliage. The structures had only experienced moderate flows to this time.

Photograph 8: Rail-anchored sweeper (RM22.1RAS) with boom detached from the outside rail (May 1996).

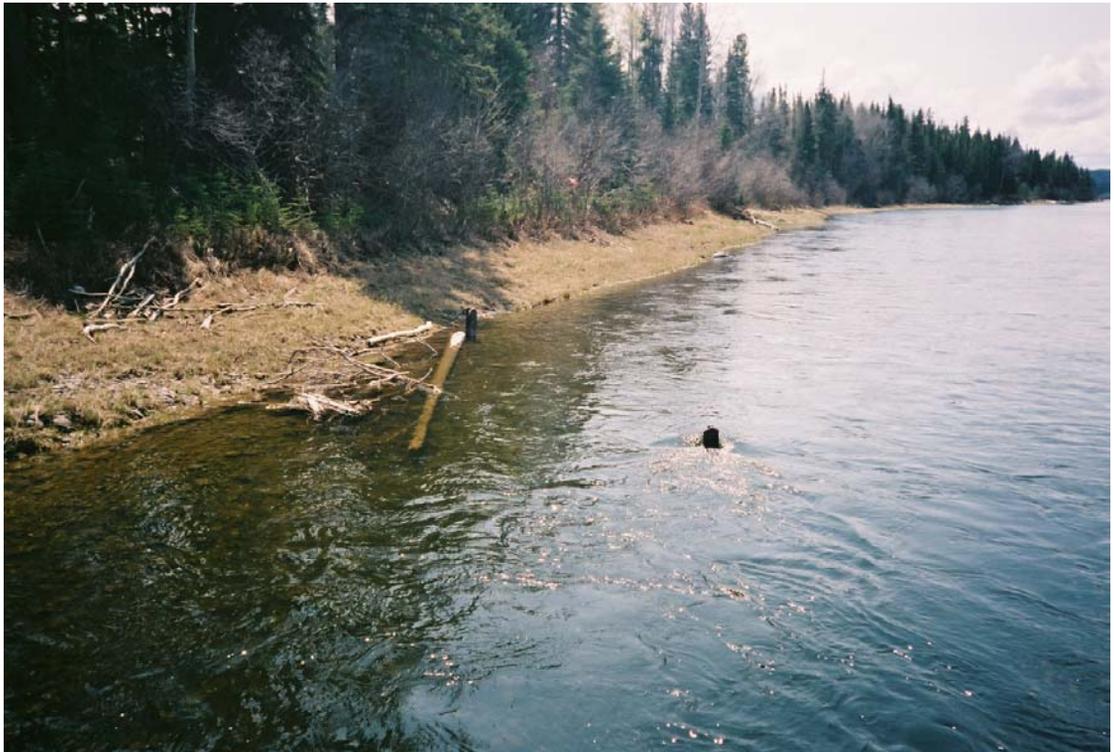
Photograph 9: Rail-anchored sweeper (RM22.95RAS) with boom detached from the outside rail (May 1996).

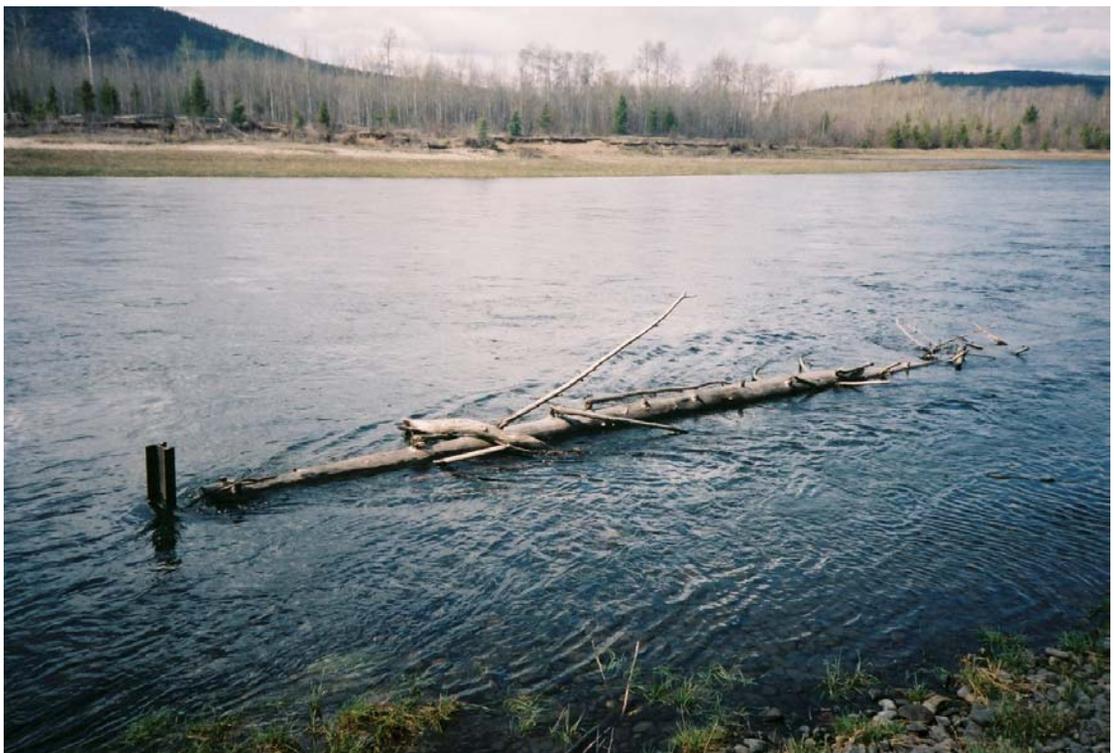
Photograph 10: Rail-anchored sweeper (RM26.9RAS) stripped of majority of branches and not providing much cover area (May 1996).

Rail-anchored sweeper RM26.9RAS was recommended for removal as it had been reduced to a bare log.

Finally, rail-anchored sweeper RM26.9RAS, which had previously been reduced to a bare log, failed to trap any new debris and it was recommended that it be either replaced or removed.

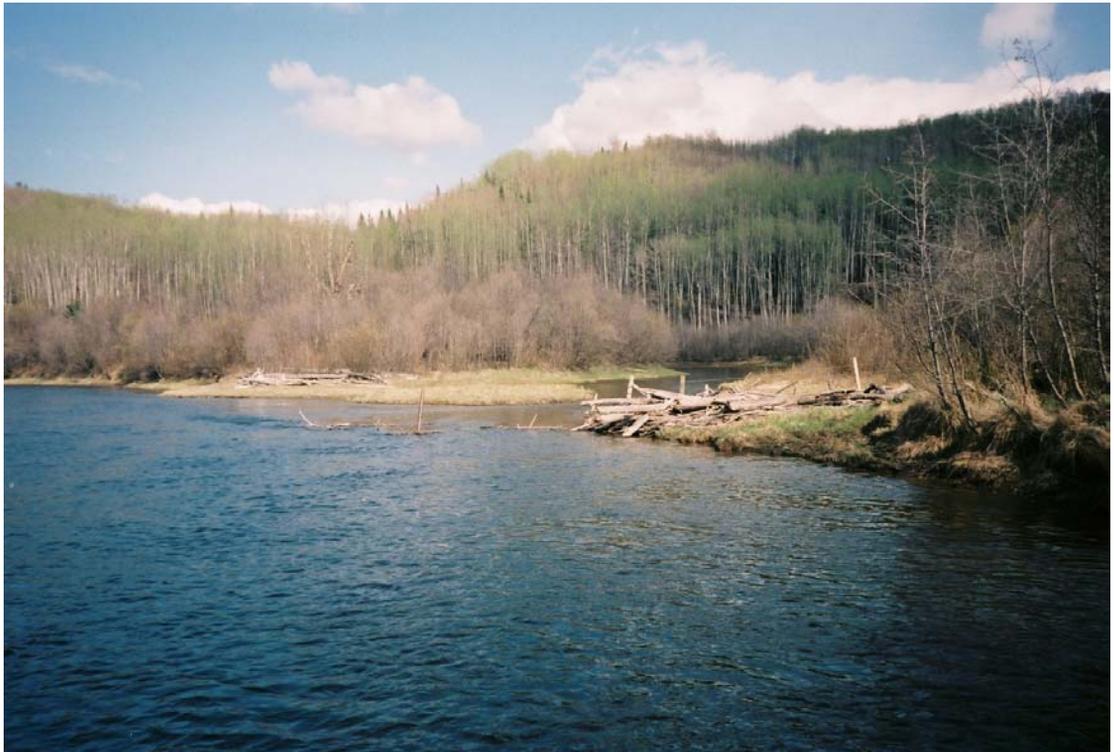
Photograph 11: Smaller pipe-pile debris catcher (RM34.7PDC) providing 20 m² of cover area despite loss of one pile in the previous year (May 1996).

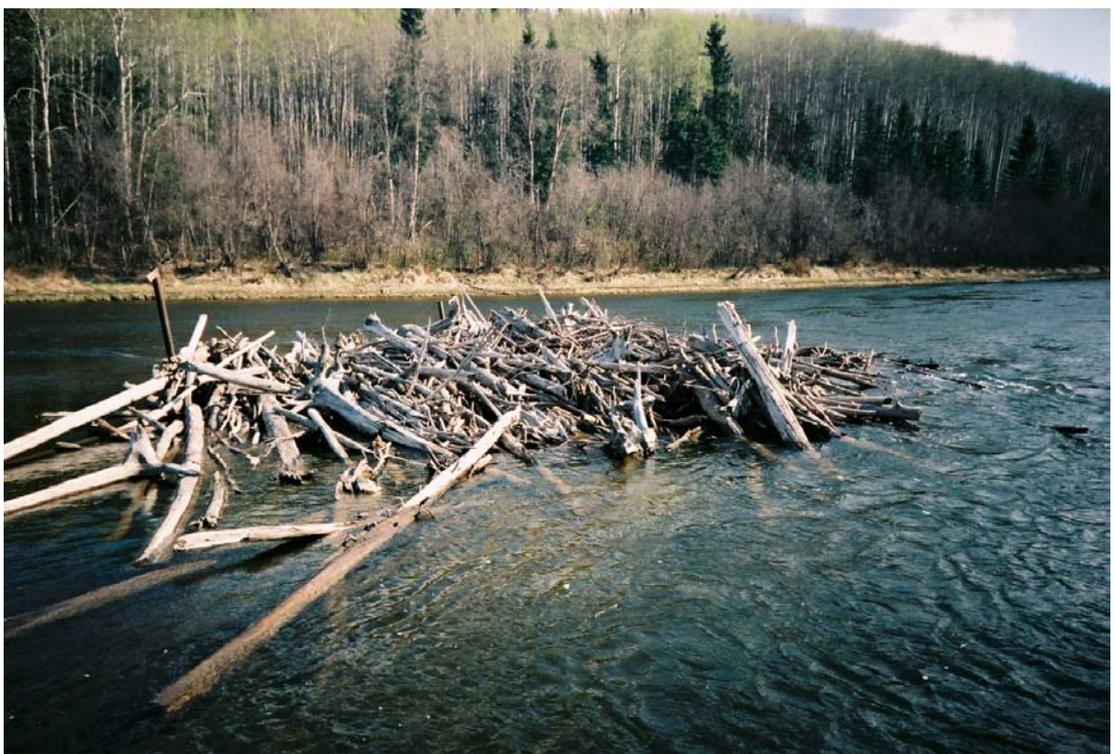
Photograph 12: Large accumulation (180 m²) at pipe-pile debris catcher (MC35.4 PDC, May 1996).

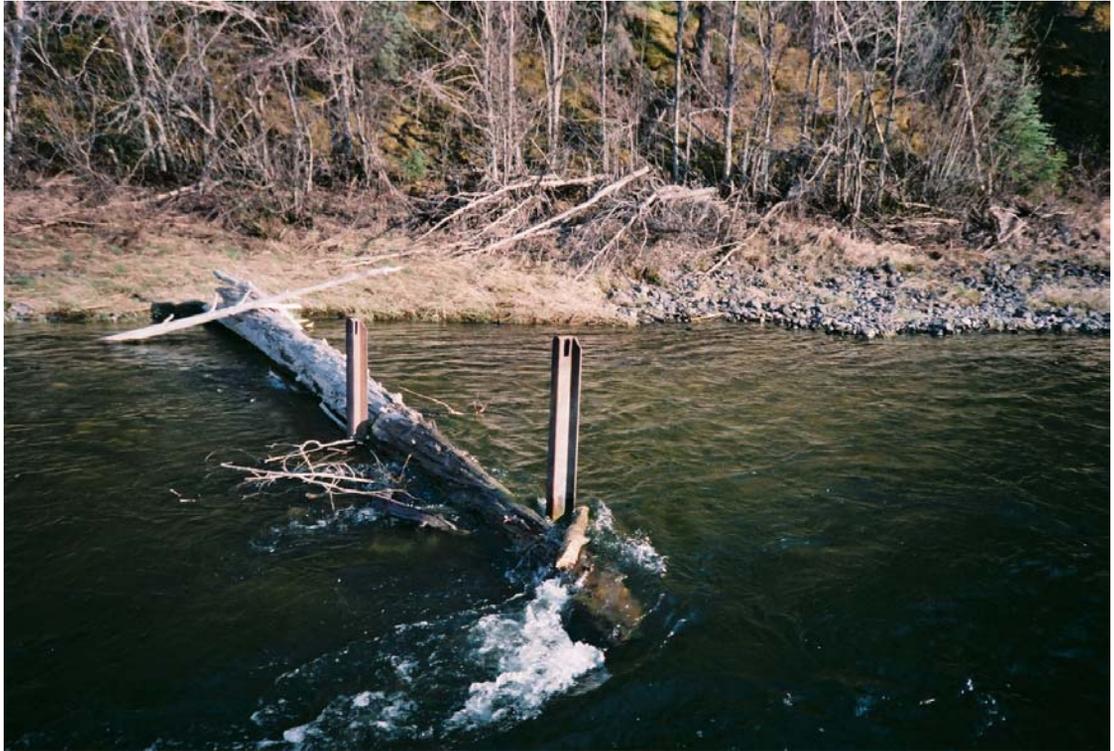
Photograph 13: Rail debris catcher (RM16.5RDC) showing very little debris capture (May 1996).

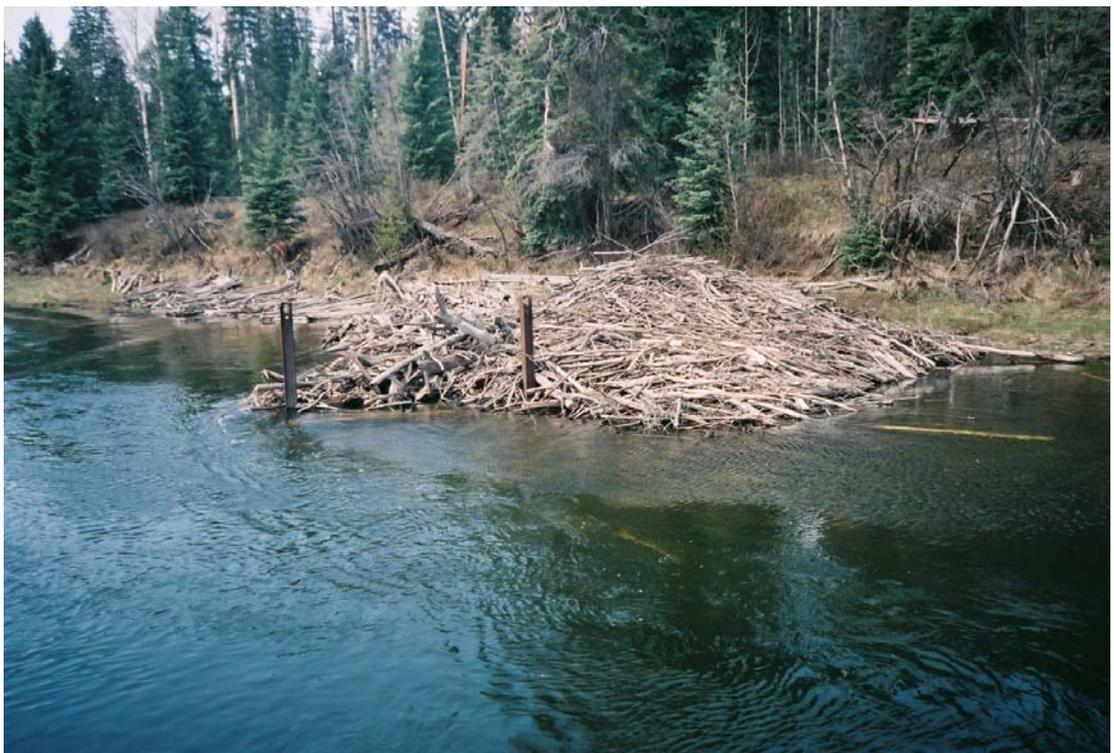
Photograph 14: Beaver lodge built at rail debris catcher (LM22.6RDC, May 1996).

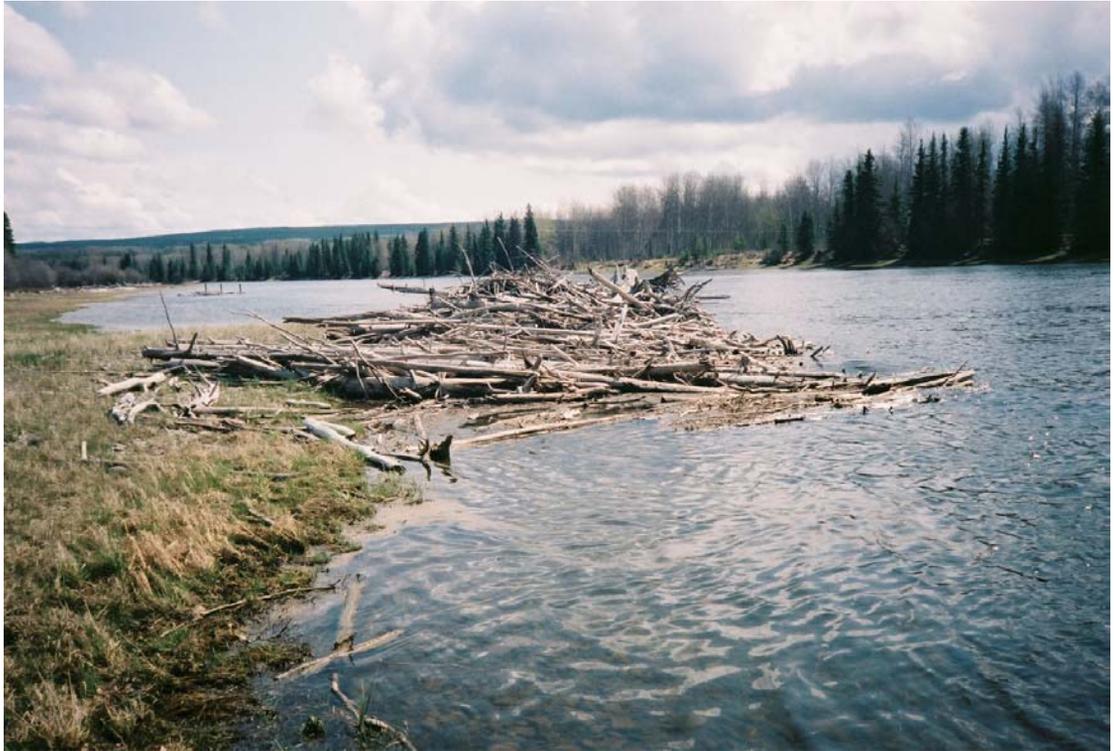
Photograph 15: Rail debris catcher (LM24.2RDC) showing significant debris capture (May 1996).

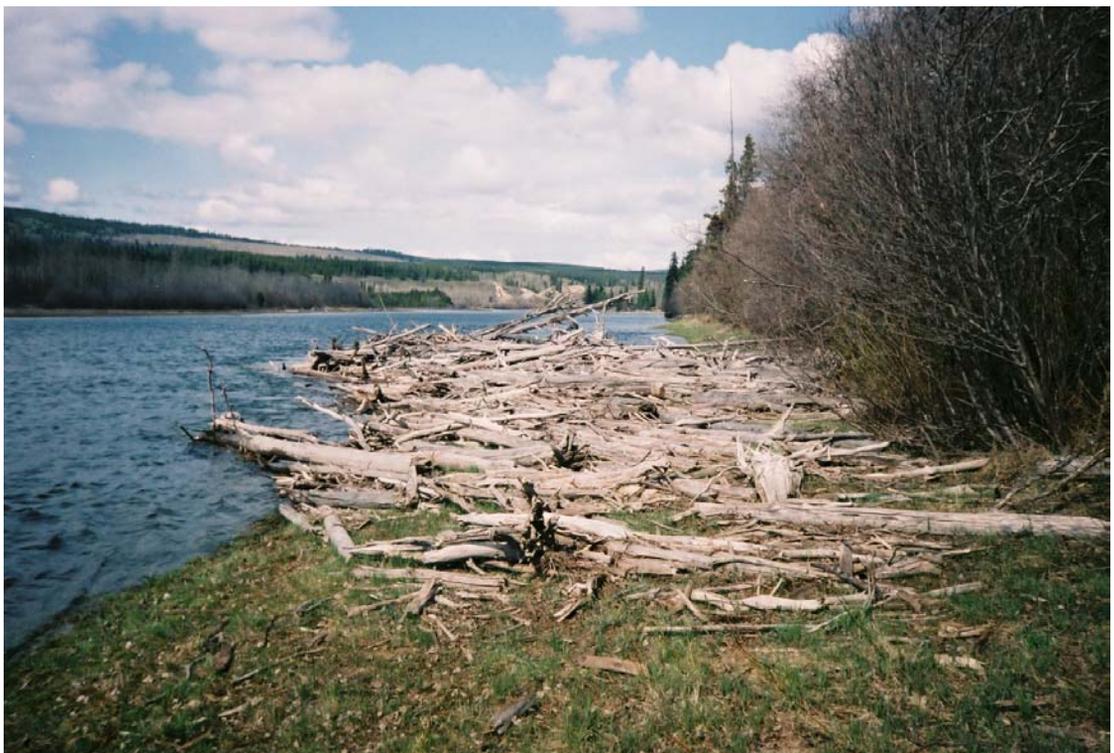
Photograph 16: Beaver lodge built at rail debris catcher (RM28.4RDC, May 1996).

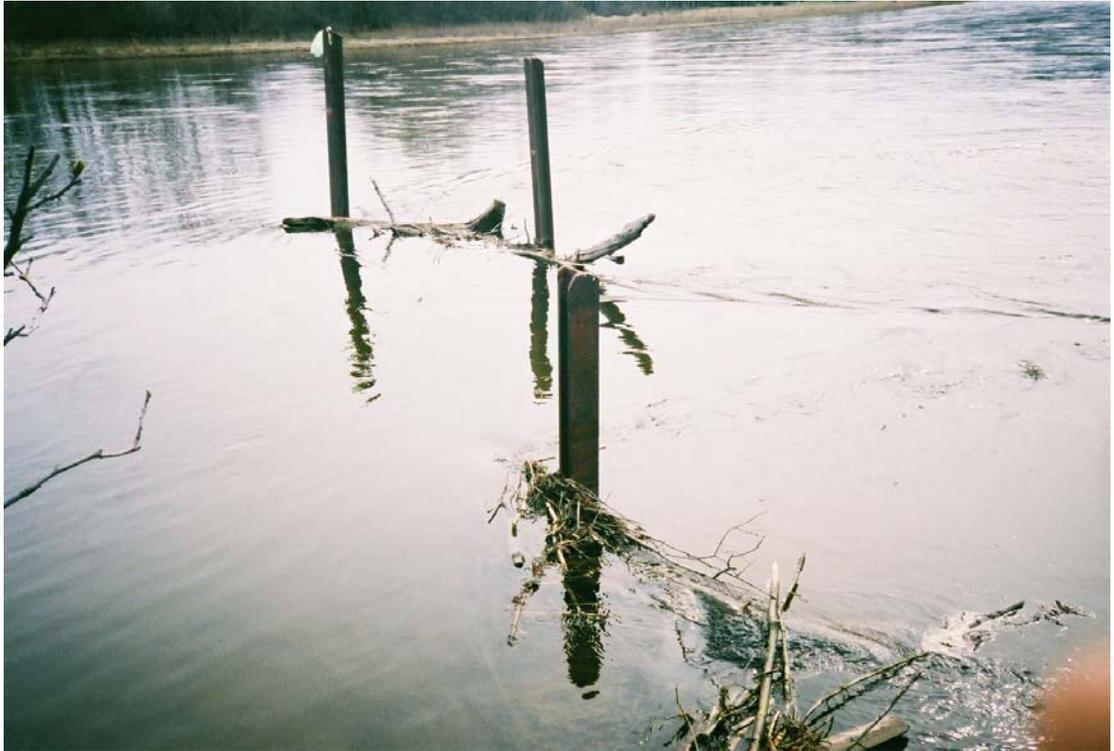
RM86.35RDC had broken a boom and RM86.375 had lost a rail, yet both still maintained adequate cover areas.

Photograph 17: Break through in the center of the rail debris catcher (RM86.35RDC, May 1996).

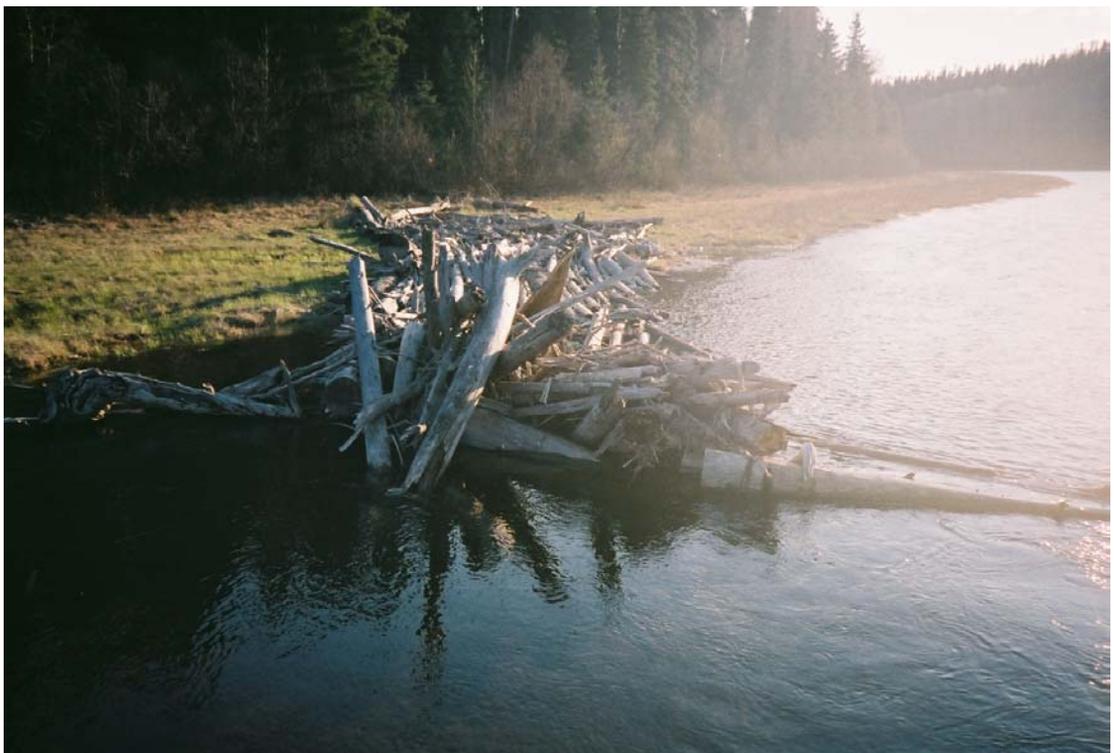
Photograph 18: Stable debris boom (RM17.9DB) providing 62m² of cover area (May 1996).

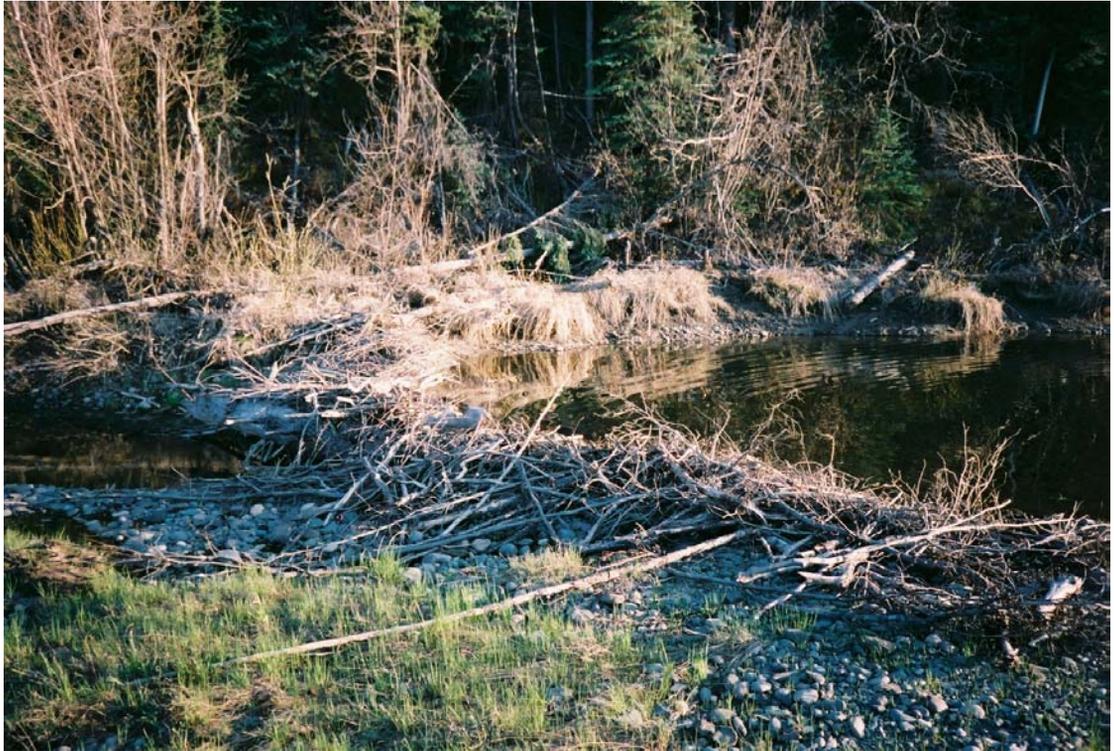
No damage or displacement was noted at the in-stream modifications in 1996. Cover area in the side channel had been reduced, but flow continued to be blocked by beaver dams. The side channel debris boom was stable despite the shore deadman anchor having been unearthed in 1992. No further displacement had occurred.

Photograph 19: Side channel (RM17.9SC) showing low water level and no velocity due to beaver dam blockage (May 1996).

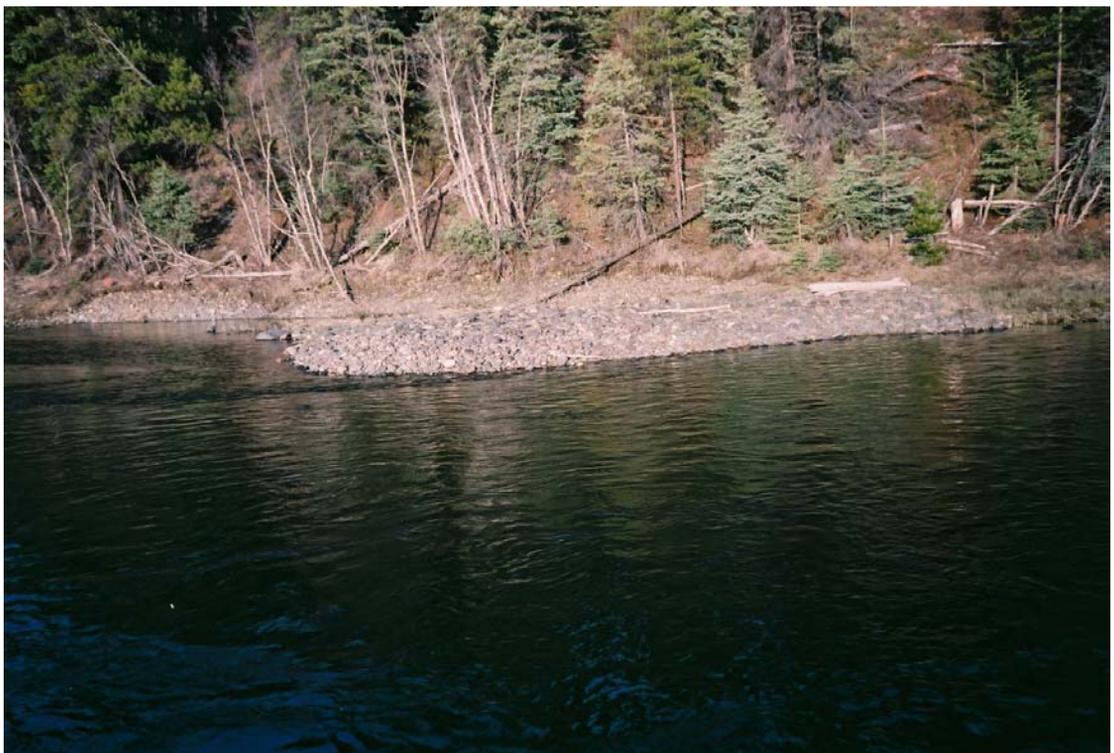
Photograph 20: Stable point bar (RM17.15PB) showing shear zone (May 1996).
