Nechako River Habitat Complex Removal (RM 86.375 RDC)

Post Construction Monitoring Report

January 8th, 2007

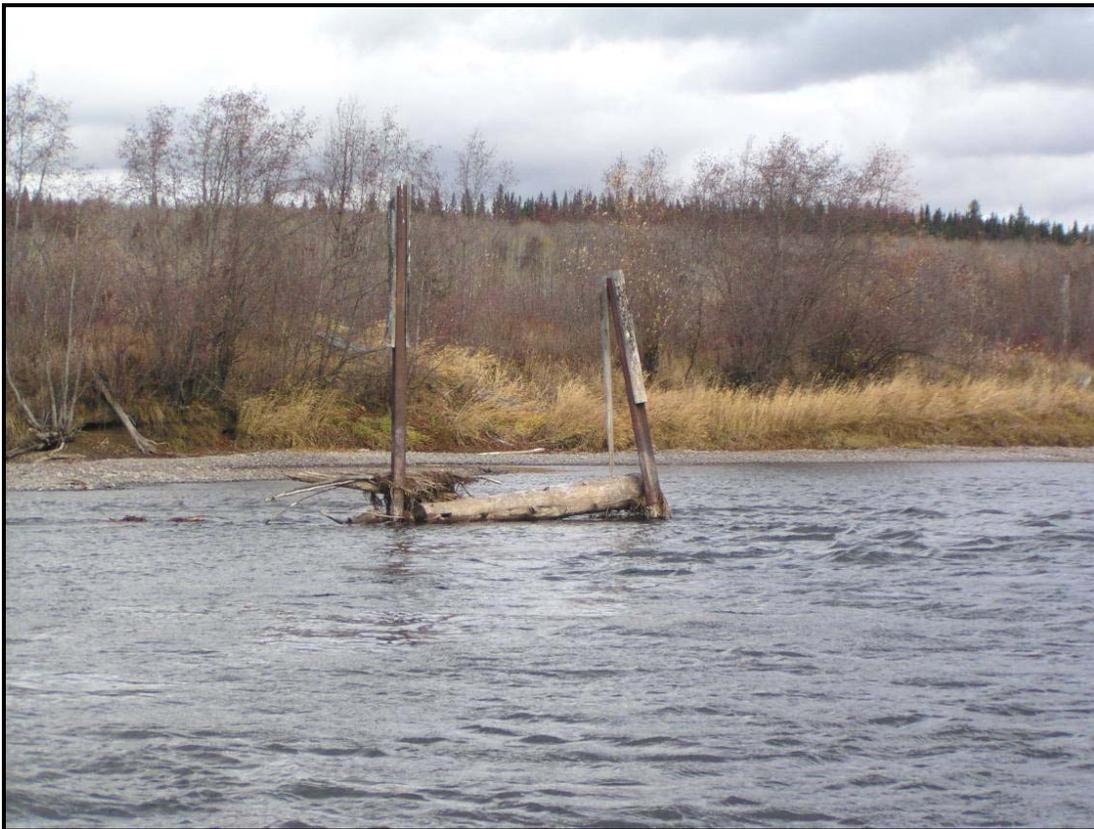
In the fall of 2006, it was determined that the debris catcher at Km 86.375 was no longer functioning as intended (Plate #1). Continued destabilization of the structure may create a potential navigation hazard. As such, the Technical Committee of the NFCP agreed that the rails associated with the habitat structure should be removed from the river.

Plate # 1. Date: October 31, 2006. **Comments:** Showing the condition of the structure during the fall of 2006. Note the angle of the leading rail, and a lack of captured debris.

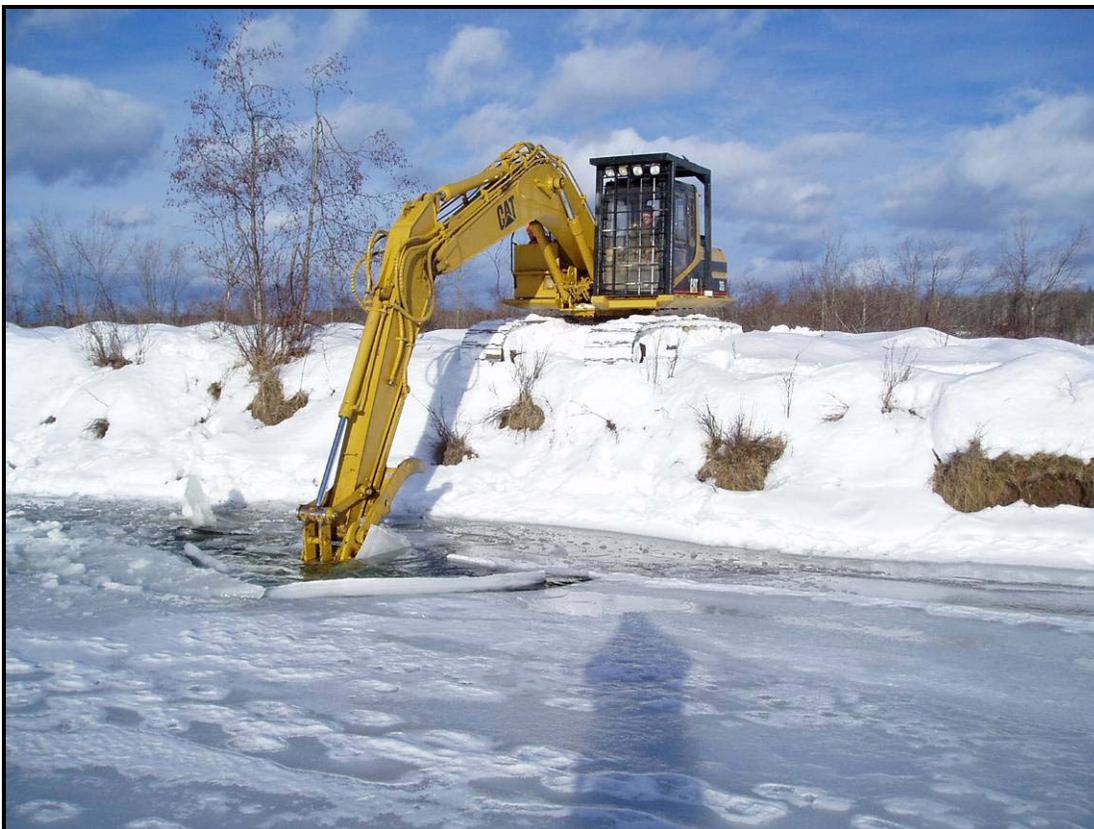
A natural clearing was present within the riparian zone at the edge of the side channel, which greatly reduced the disturbance on the plant community associated with the movement of the machine. The excavator approached the edge of the bank, and the operator disembarked to assess the situation. Following this assessment and subsequent testing of ice (15-20 cm) and water depth (>1 m), it was determined that the site could not be accessed via this location (Plate # 2). The bank height and slope were too great for the machine when combined with the depth of the water. The operator was concerned that the machine would not be able to return to the top of the bank without creating a significant disturbance to the bank and the river bed.

Plate # 2. Date: December 21, 2006. **Comments:** Showing the clear riparian area, steep bank and significant water depth below ice at the initial crossing point to access the RDC.

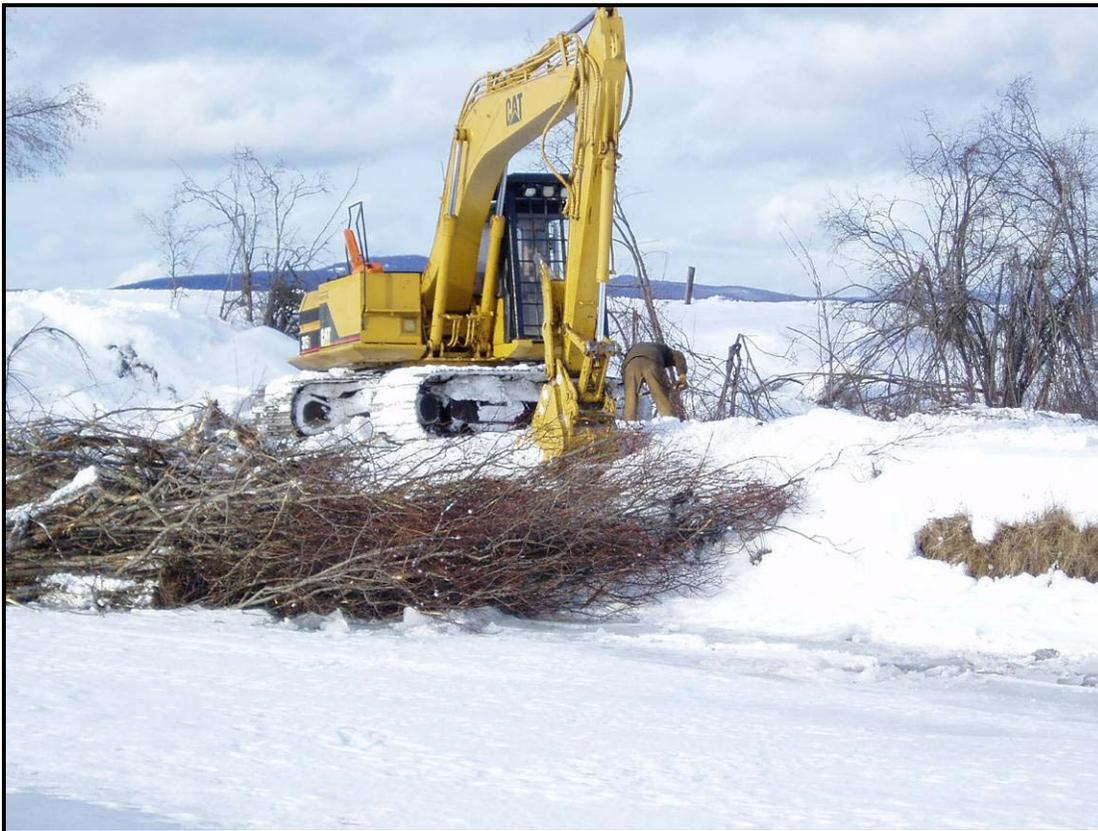
Plate # 3. **Date:** December 21, 2006. **Comments:** Showing the small woody debris installed along the bank edge, and the operator clearing the tracks prior to crossing.

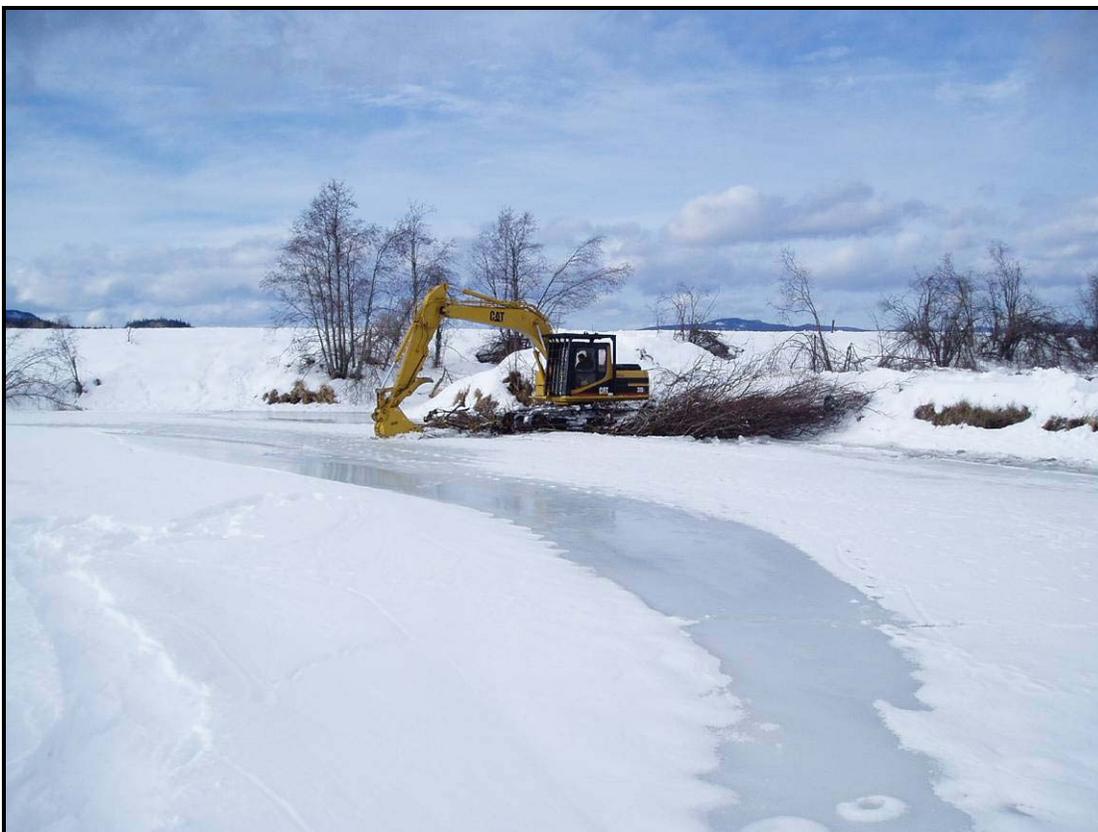
Plate # 4. **Date:** December 21, 2006. **Comments:** Showing the excavator perched on top of the woody debris, crossing out onto the ice.

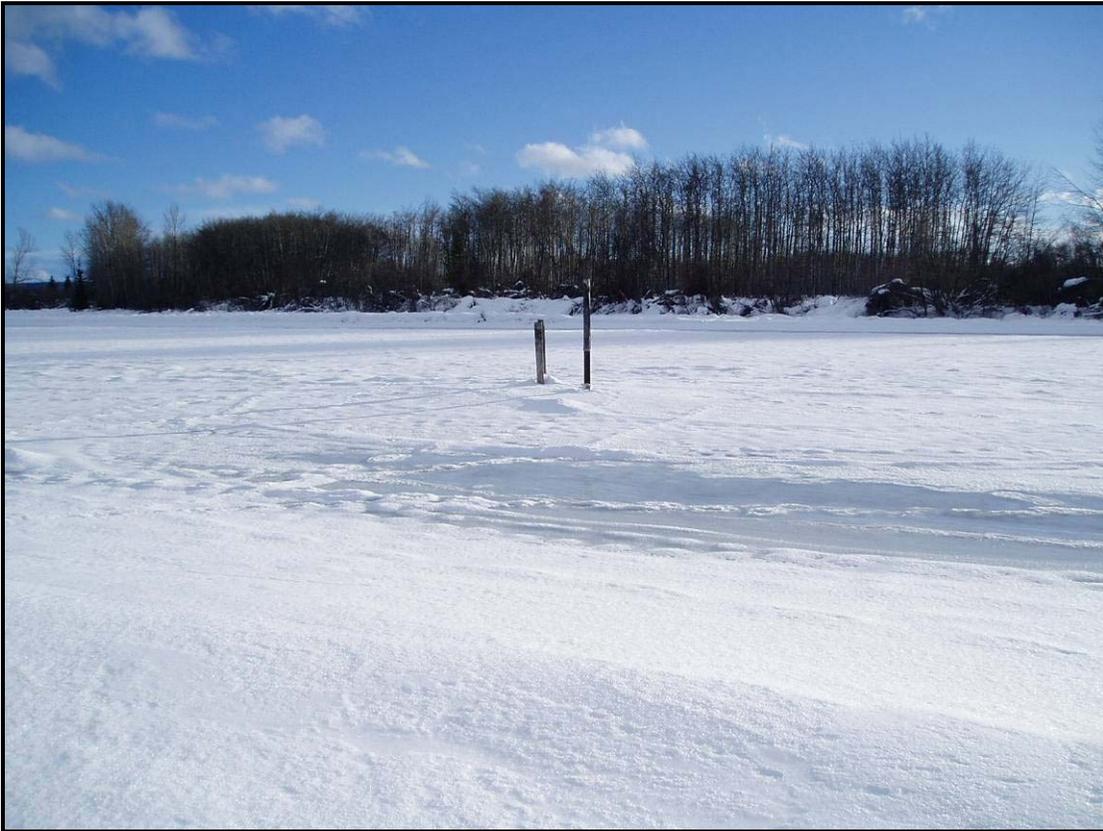
Both of the rails were encased in ice (Plate # 5), and the upstream rail still had a wooden housing attached. The presence of a significant amount of ice over the Nechako River significantly extended the wetted margins. Upon accessing the site of the RDC, it became apparent that the removal process could not be completed from the dry shoreline. The shore ice at the site was not able to support the excavator, so a path through the ice and instream works would be required.

Plate # 5. Date: December 21, 2006. **Comments:** Showing the condition of the site prior to the initiation of rail removal efforts.

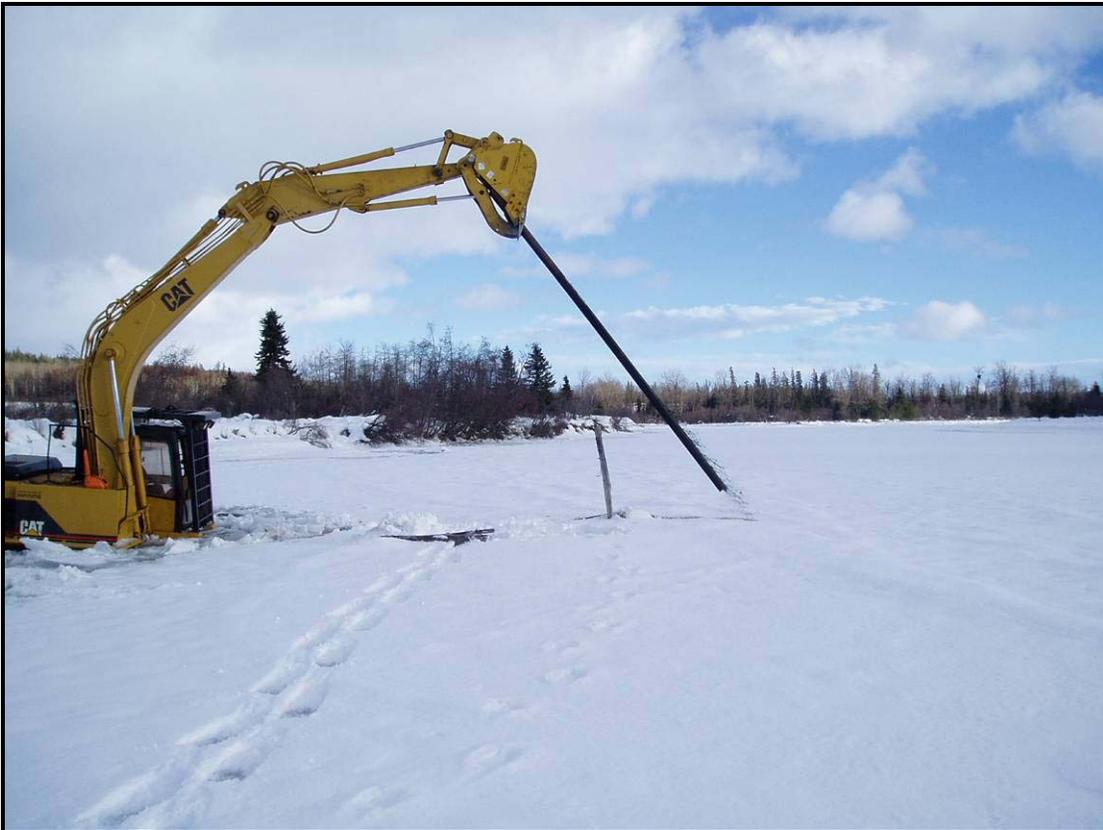
The shore side rail was approached first. This rail snapped at the water / ice horizon. The top part was placed on shore, and the operator proceeded to remove the second rail (Plate # 6). This rail was pulled clear without incident. A minimal amount of turbid water and mud was displaced to the surface of the ice as the rail was pulled free. When the second rail was pulled free, a piece of woody debris that was chained between the two rails was also removed. Following this, the excavator operator found the remaining portion of the shore side rail, and was able to pull it free of the river bed. Once this was completed, the excavator was removed from the wetted width of the Nechako River (Plate # 7)

Plate # 6. Date: December 21, 2006. **Comments:** Showing the removal of the second rail. Note the deep water, and the minimal amount of material coming off the rail.

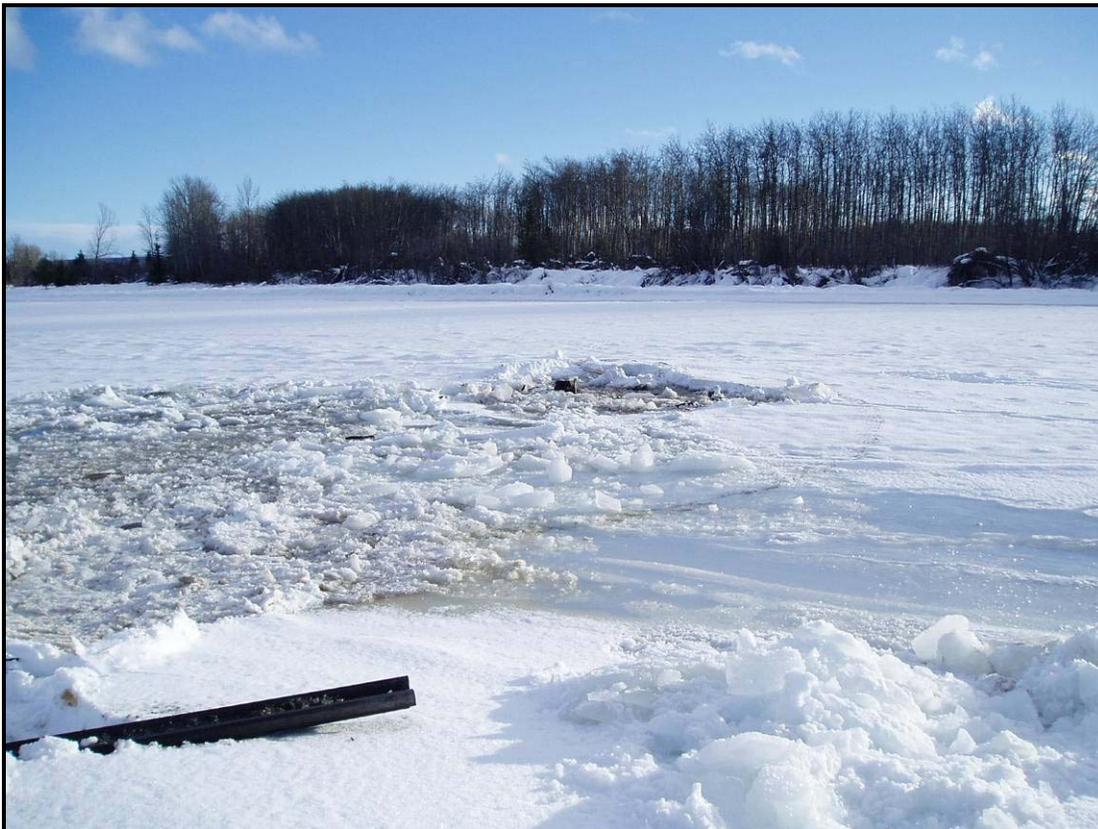
Plate # 7. Date: December 21, 2006. **Comments:** Showing the condition of the site following the completion of the rail removal effort.

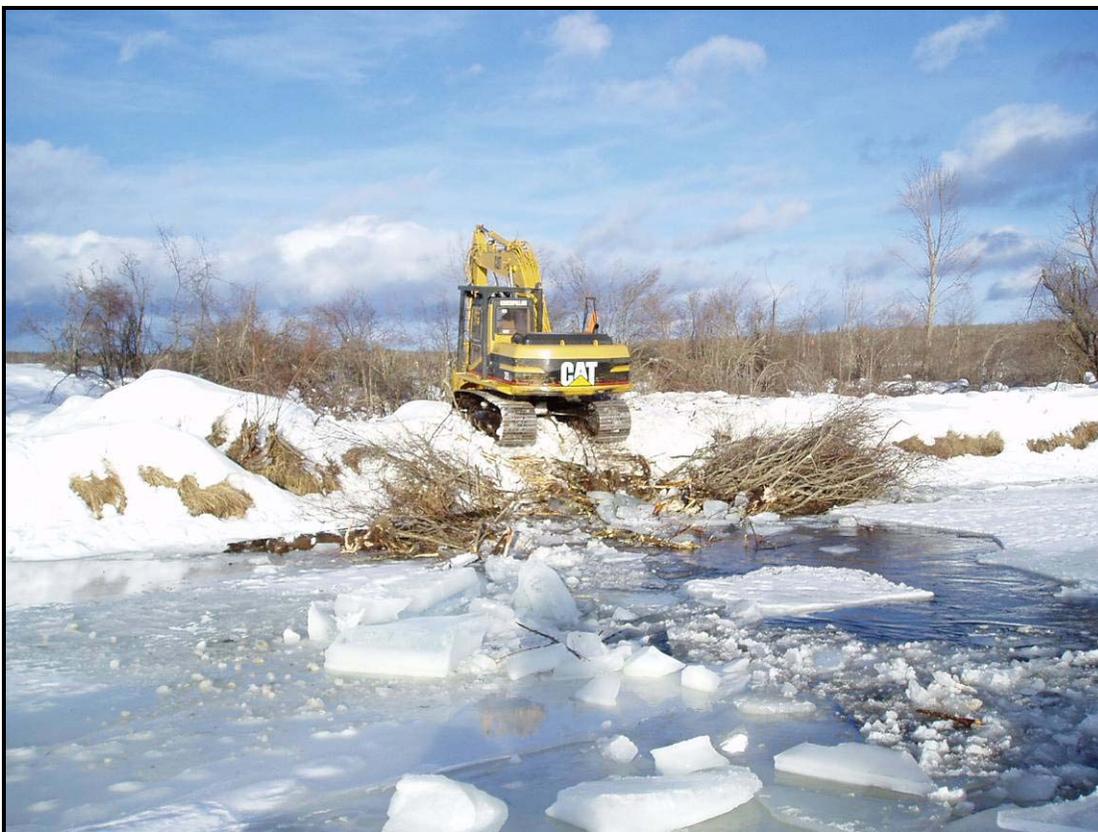
tracks created during the trip in. This provided a fresh layer of protective snow, and greatly reduced the potential for impacting the ground layer. The small woody debris provided an suitable ramp that enabled the machine to ascend the bank in one fluid motion (Plate # 8).

Plate # 8. Date: December 21, 2006. **Comments:** Showing the return of the excavator to the top of the river bank. Note the lack of disturbance to the bank under the machine tracks.
