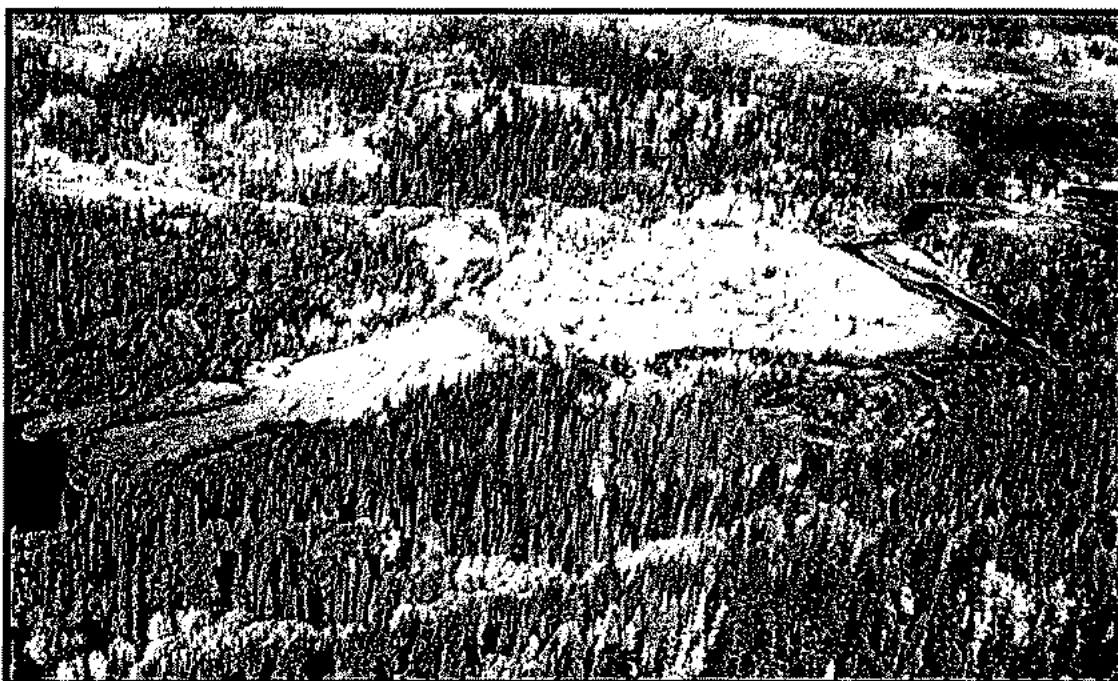
MM 02 - 91 - 7A

Plate 4.3.1-1 Looking downstream to Cheslatta Fan showing the sediment accumulations upstream of the constriction at Km 8.25

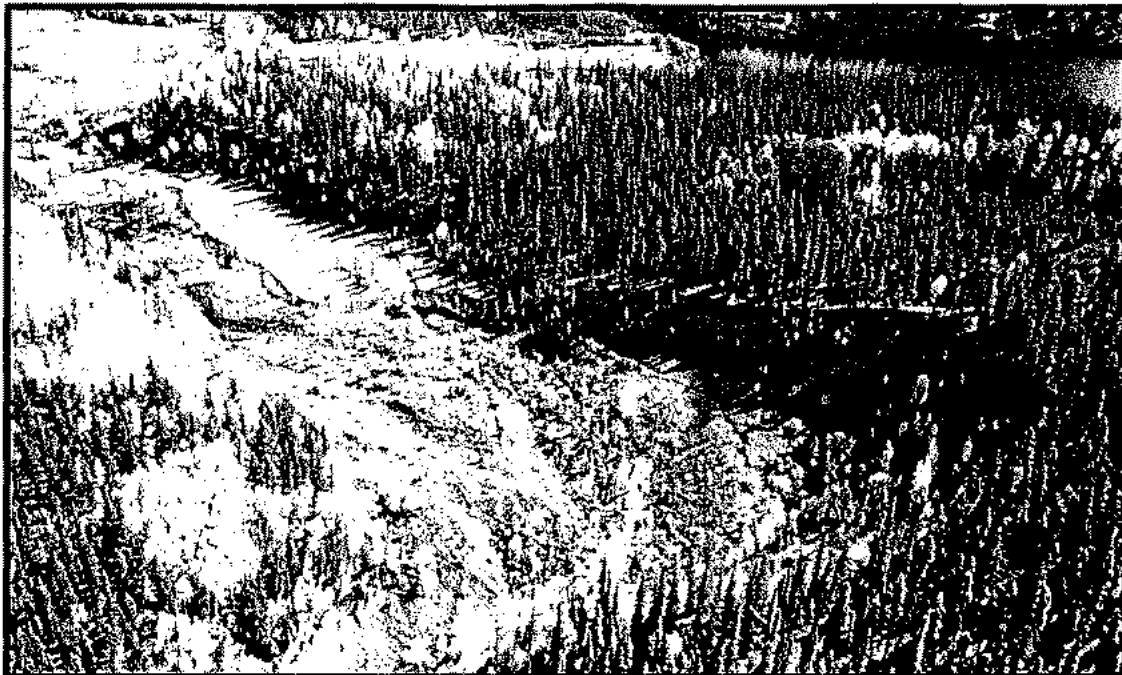
MM 02 - 91 - 35A

A) Looking downstream towards the upper end of the erosional gully.

Plate 4.3.1-3 Cheslatta Fan formed when Cheslatta River shifted course and downcut through a thick sequence of unconsolidated materials

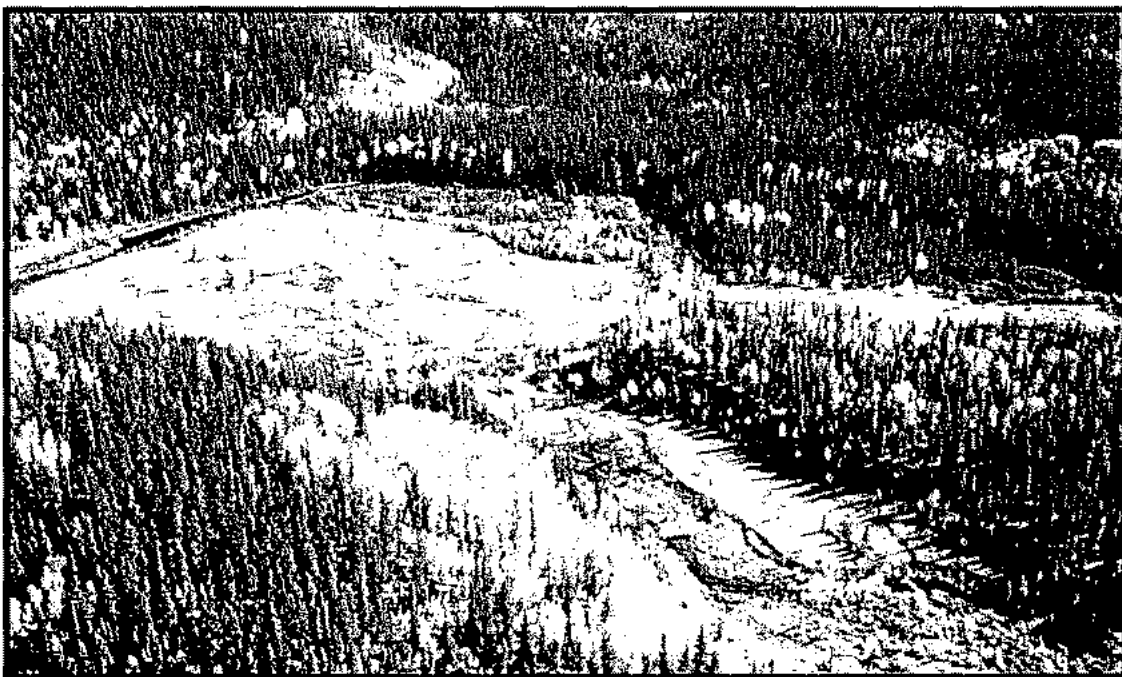
MM 02 - 91 - 33A

B) Looking downstream towards the lower end of the erosional gully.

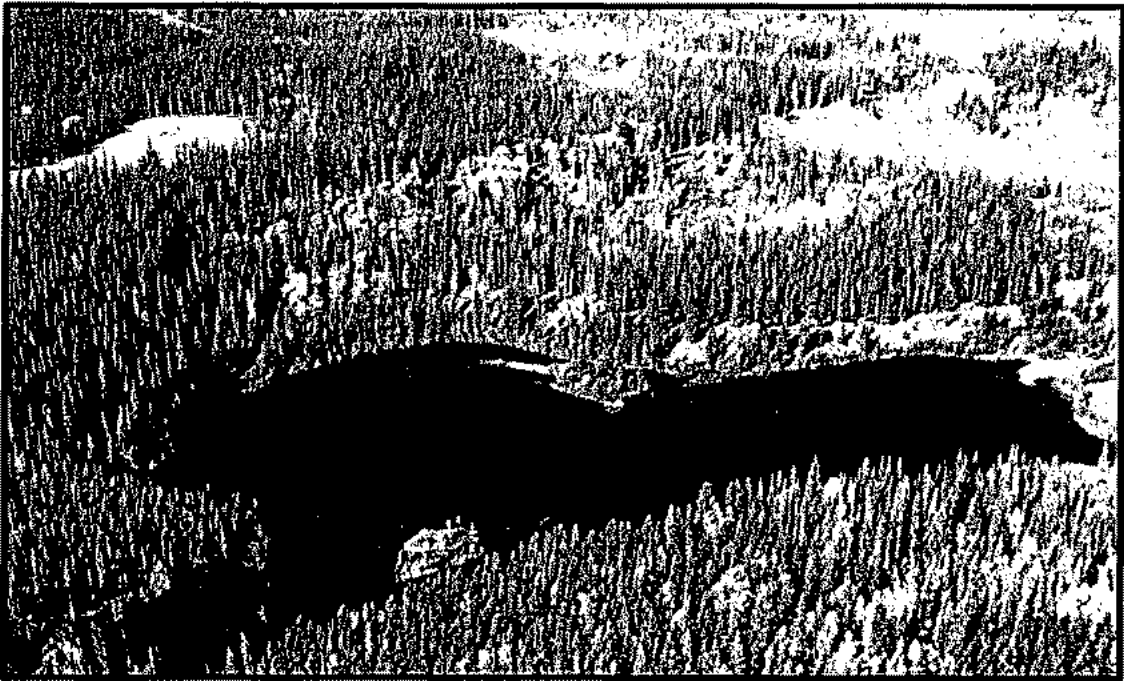
MM 02 - 91 - 6A

A) Looking downstream from the outlet of Nechako Canyon to Scour Hole Lake.

Plate 4.3.1-4 Scour Hole Lake is situated between the outlet of Nechako Canyon and the upstream end of Cheslatta Fan

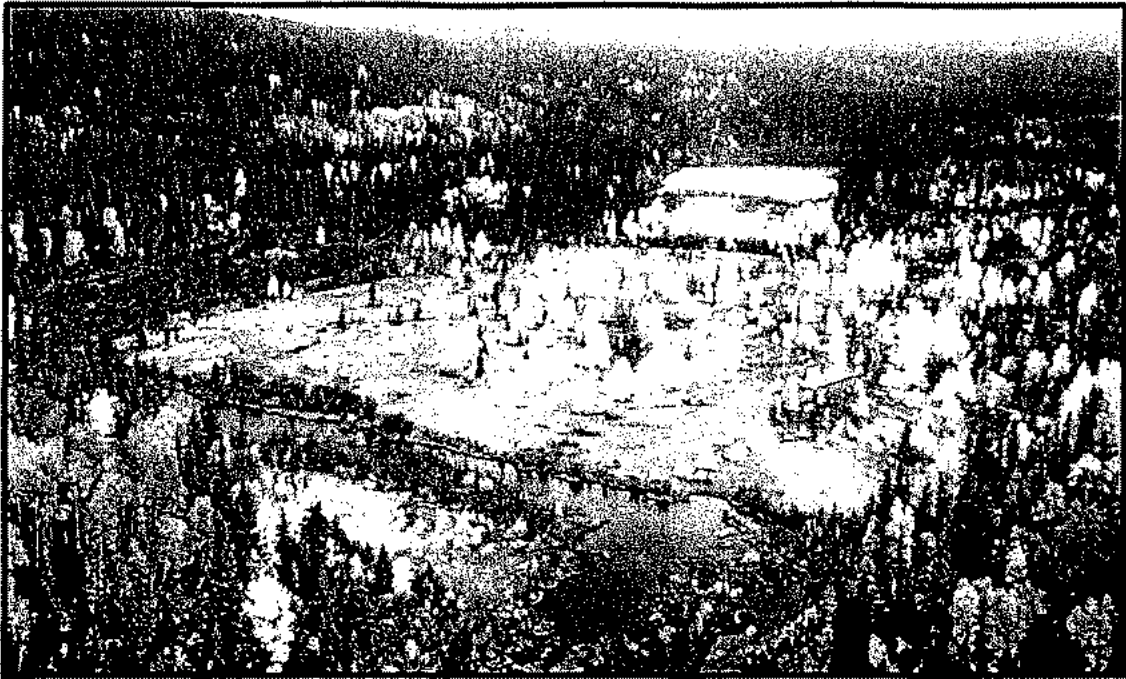
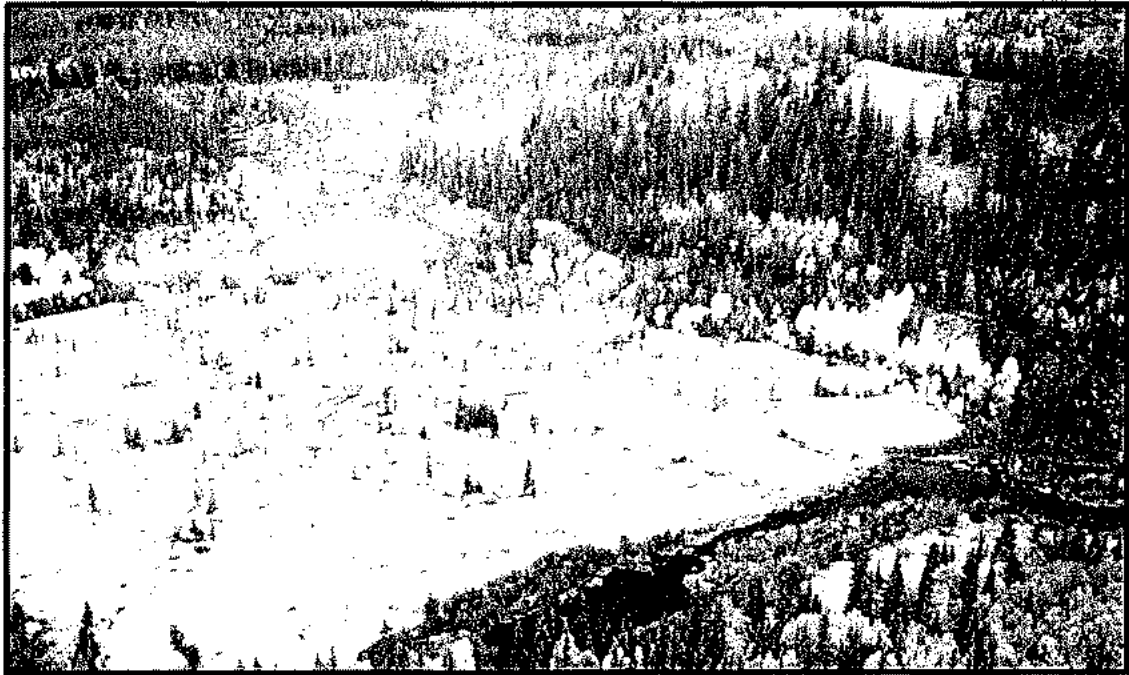
Plate 4.3.1-5 The Cheslatta Fan slopes towards the south. This has caused the residual Nechako River channel to be located against the right bank valley wall

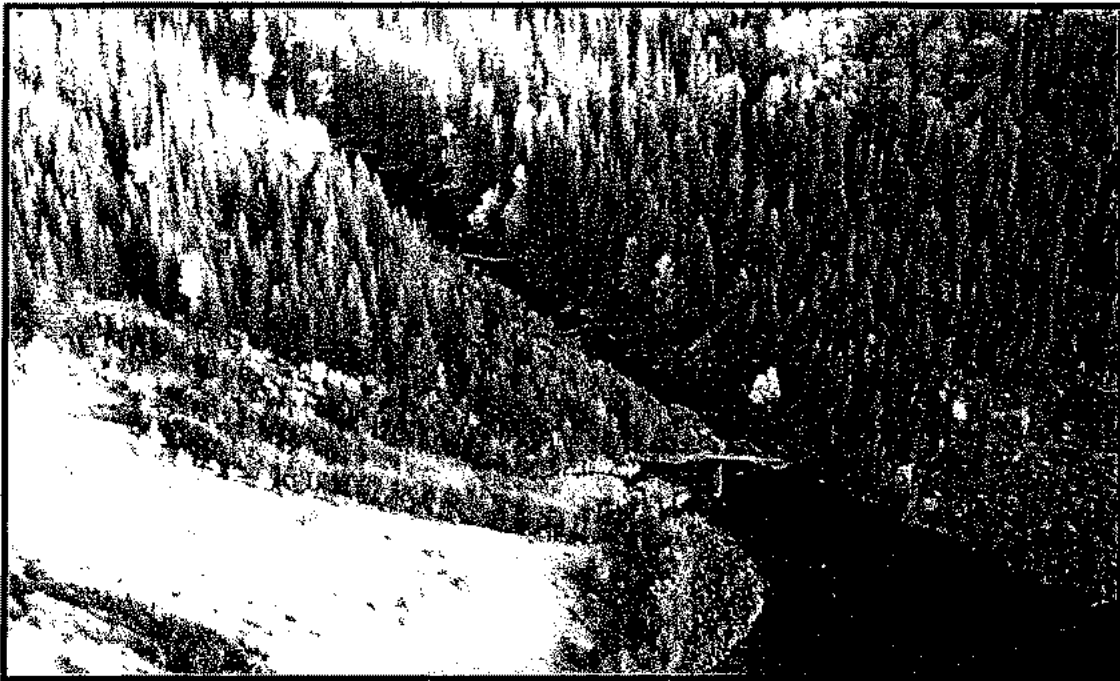
MM 02 - 92 - 13A

Plate 4.3.1-6 Looking downstream showing the outlet of Scour Hole Lake. This section of channel is flowing over bedrock (Km 7.3)

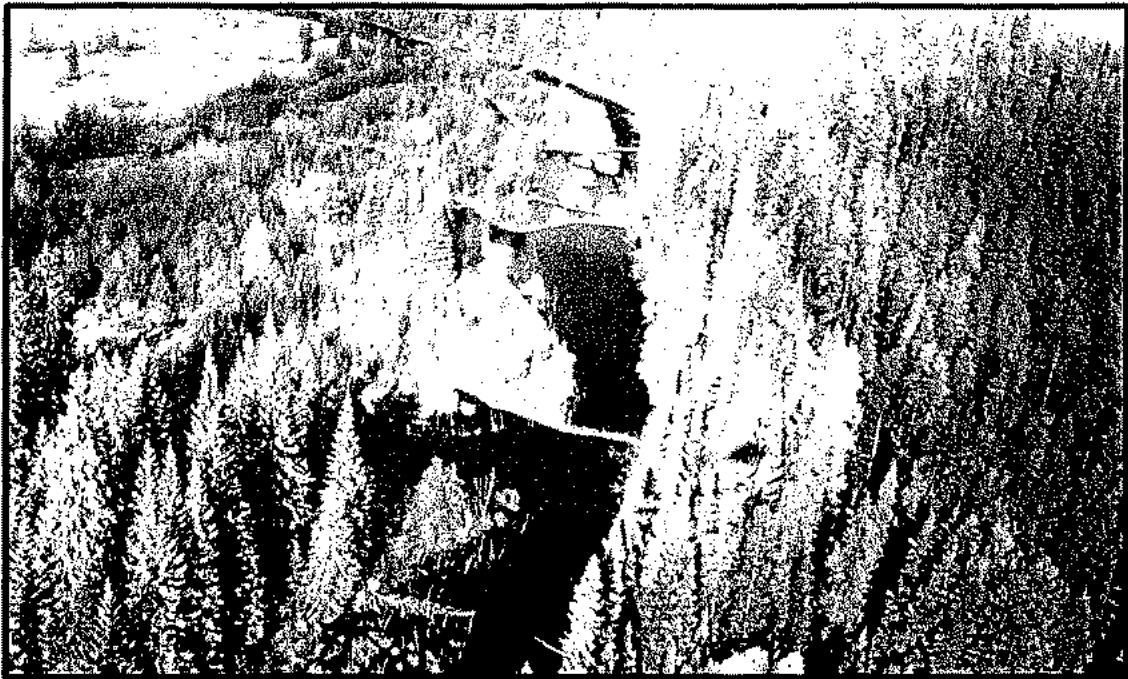
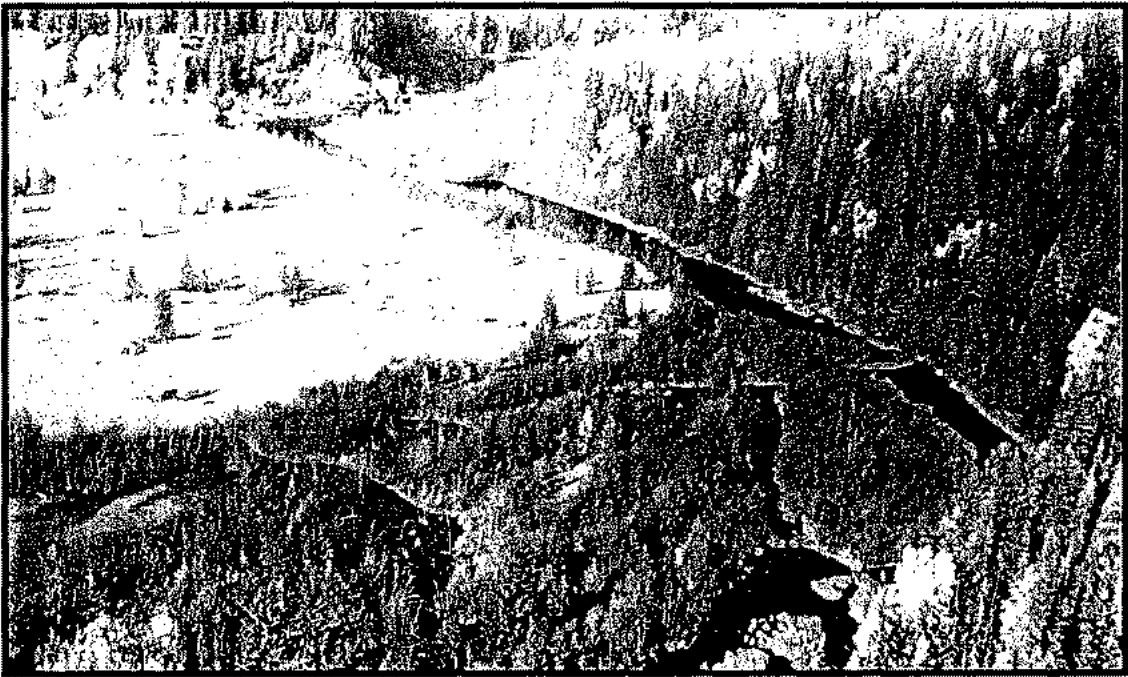
Plate 4.3.1-8 The channel is comparatively poorly defined in the middle section of the fan. Note the gentle slope of the left bank and the presence of numerous beaver dams

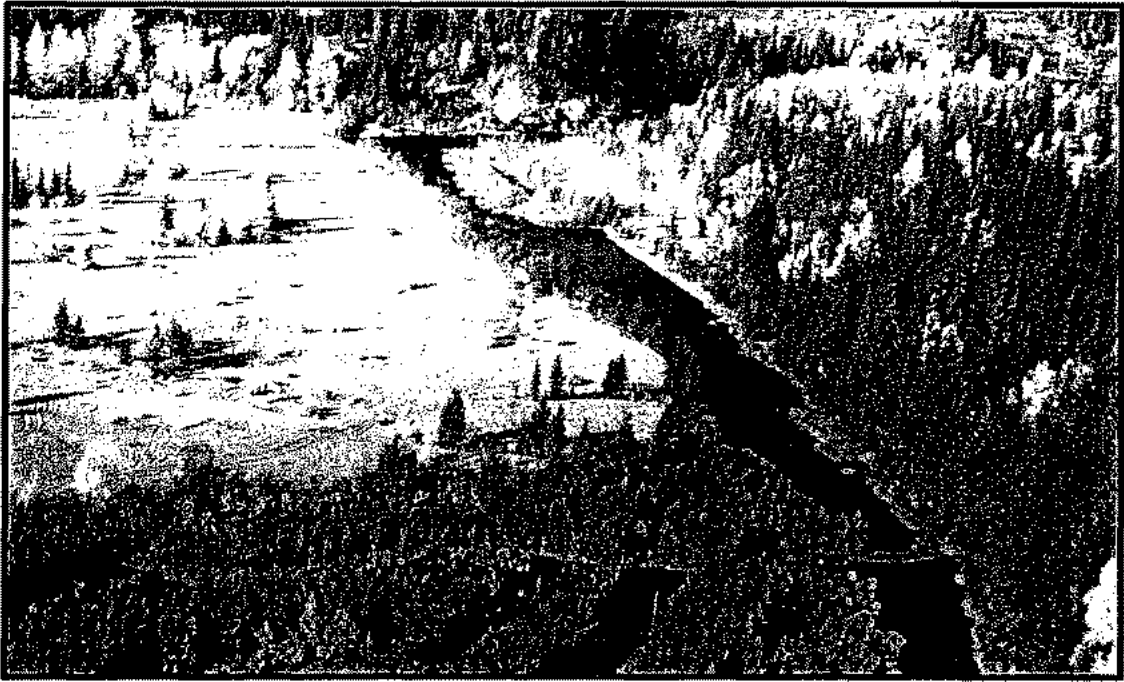
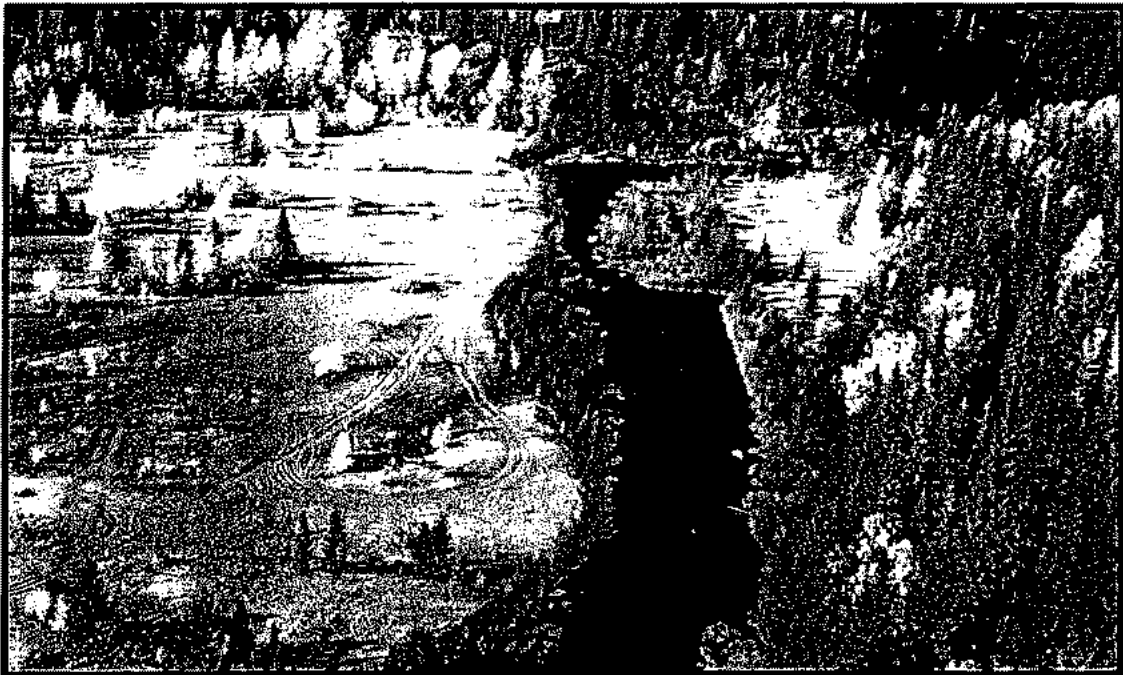
Plate 4.3.1-9 The lower section of channel around Cheslatta Fan has well defined banks and no beaver dams

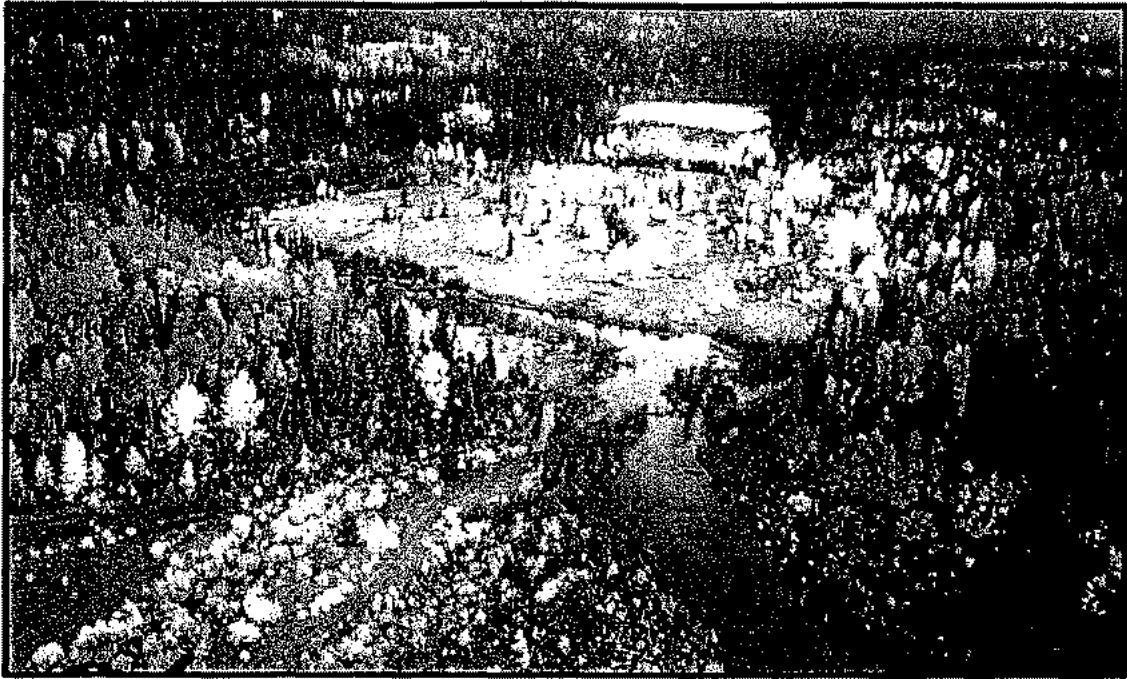
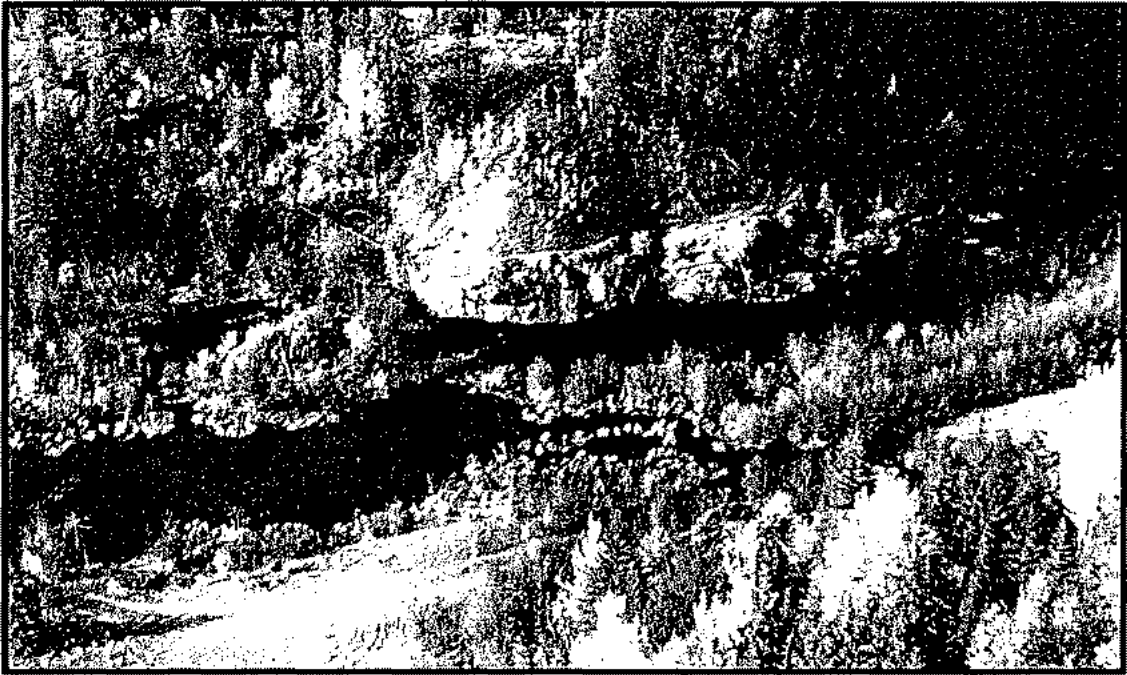
Plate 4.3.1-10: A bedrock constriction, locally referred to as "the neck" occurs at Km 8.25.

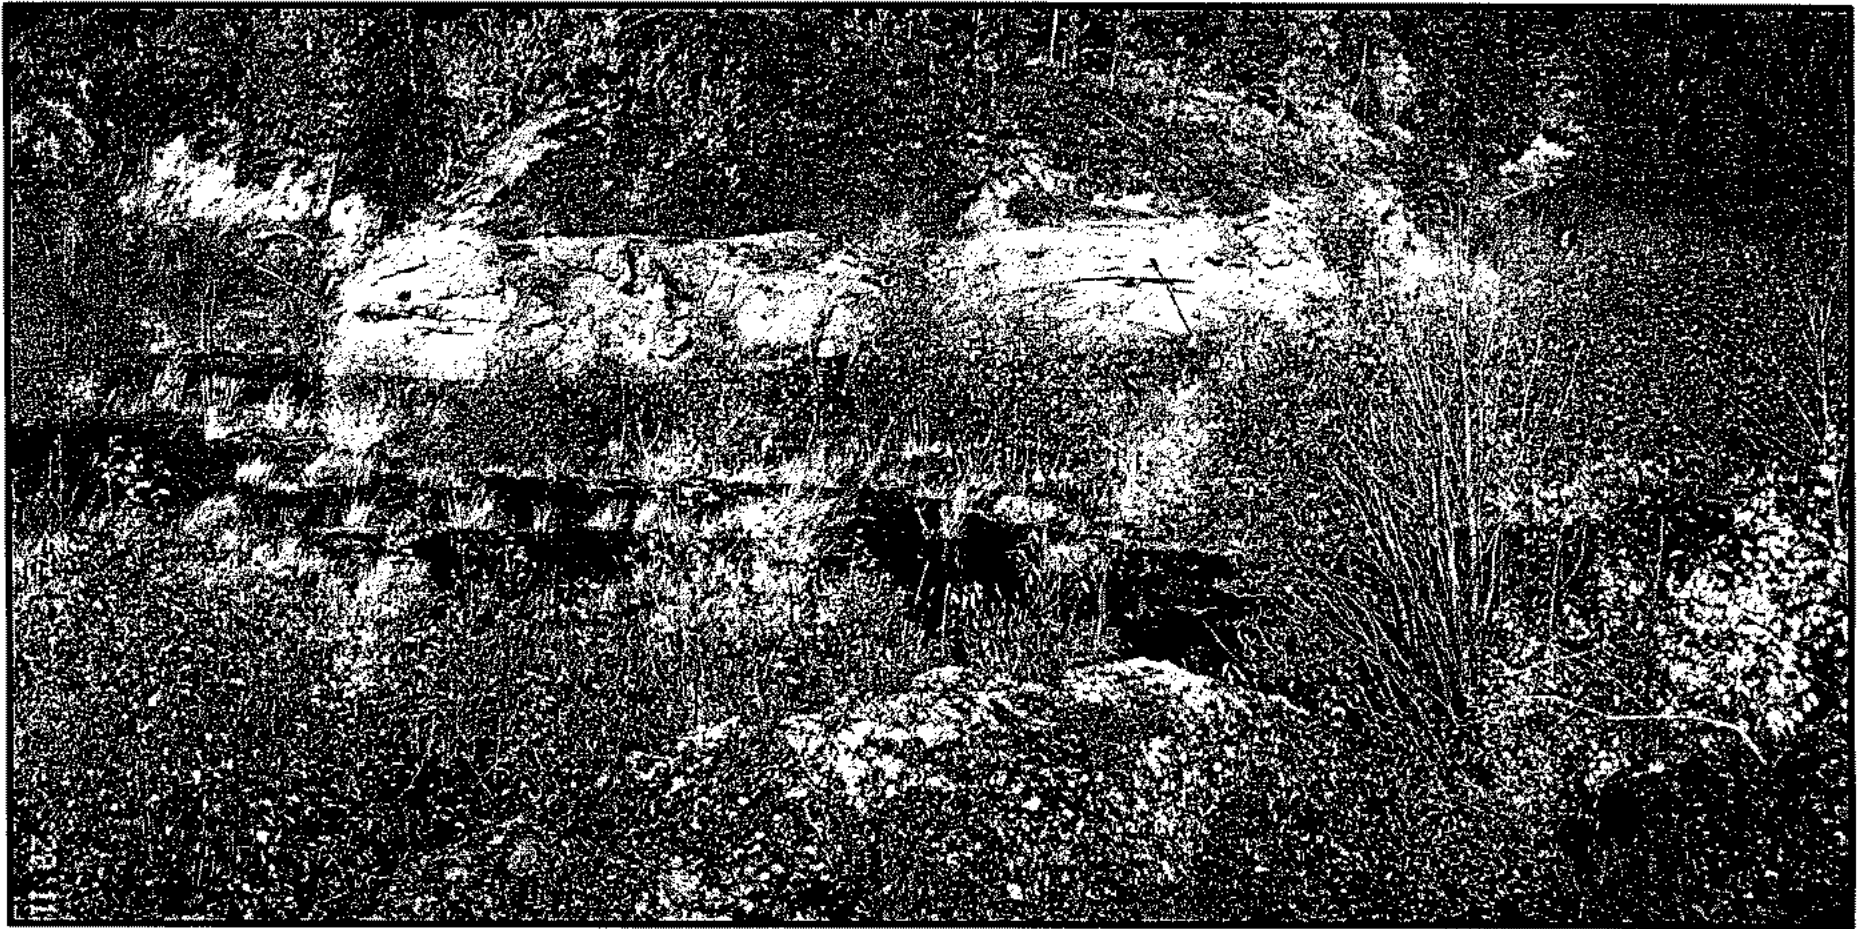
Plate 4.3.1-11 Looking north over "the neck" showing the water washed rocks which indicate the height of former high water levels.

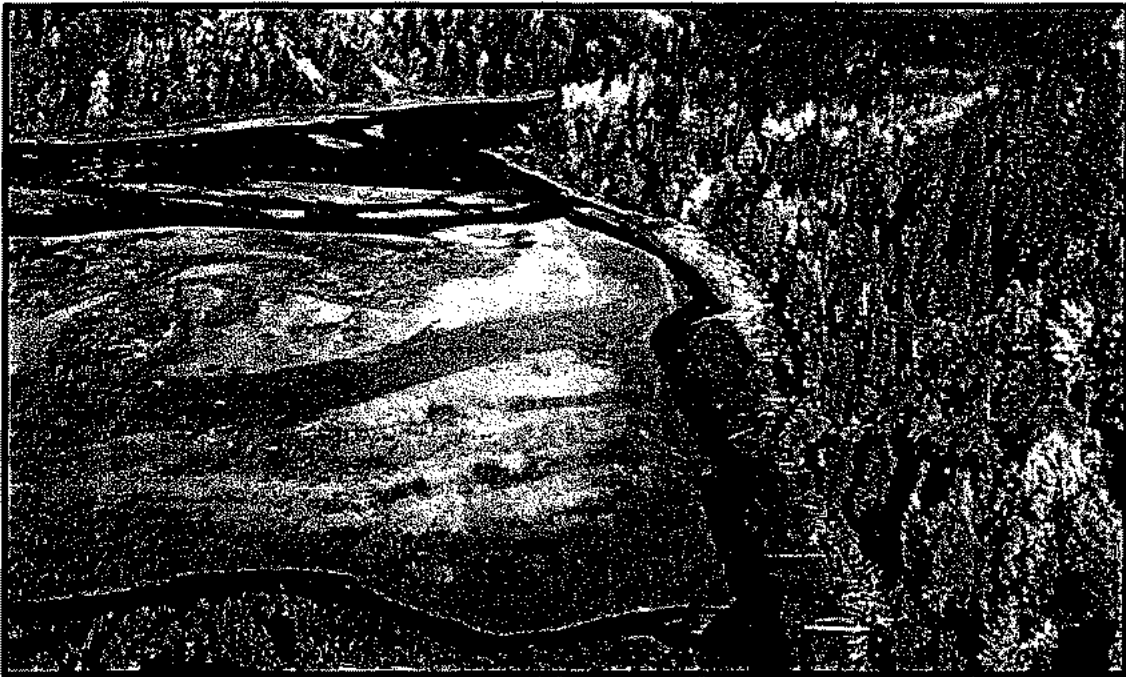
Plate 4.3.1-12 Photographs of the channel which has developed between "the neck" and the Cheslatta confluence

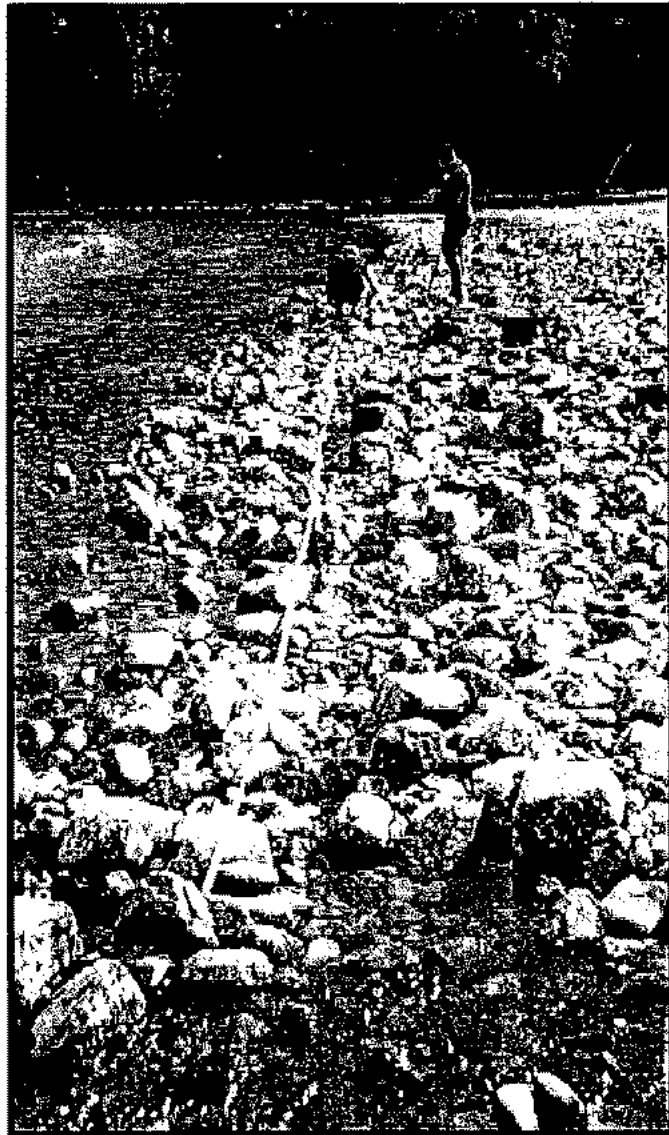
MM 02 - 84 - 16A

Plate 4.3.1-13 Bed material size analyses were taken along the waters edge and on the surface of the bar located downstream of Cheslatta Falls (see Plate 4.3.1-14)

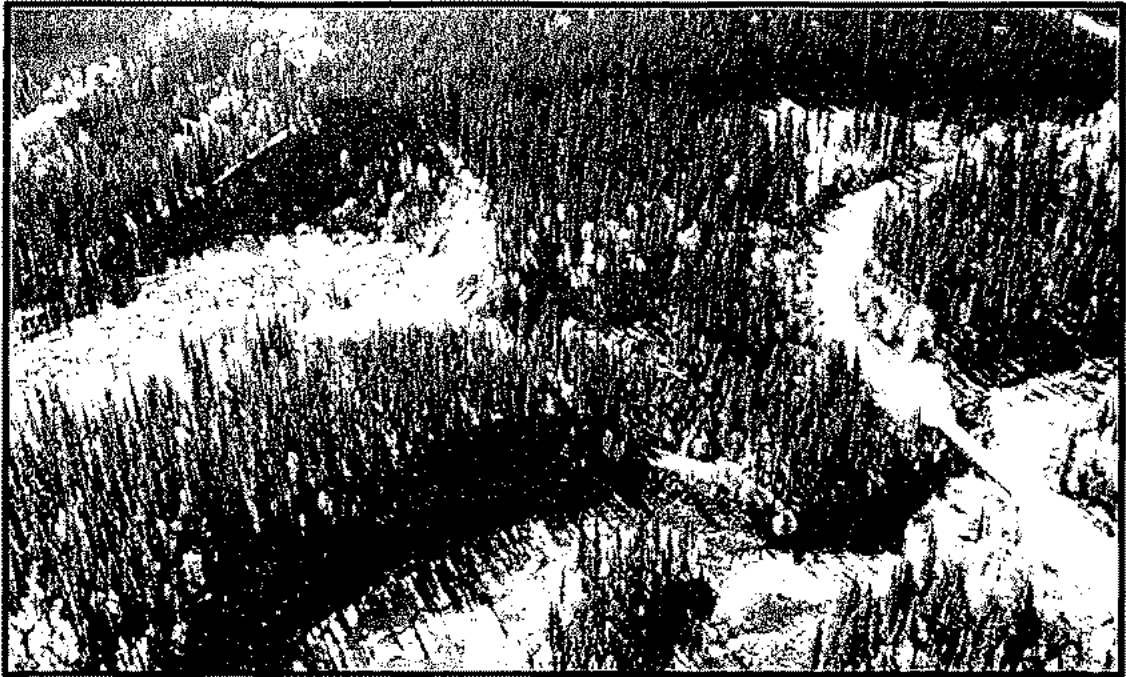
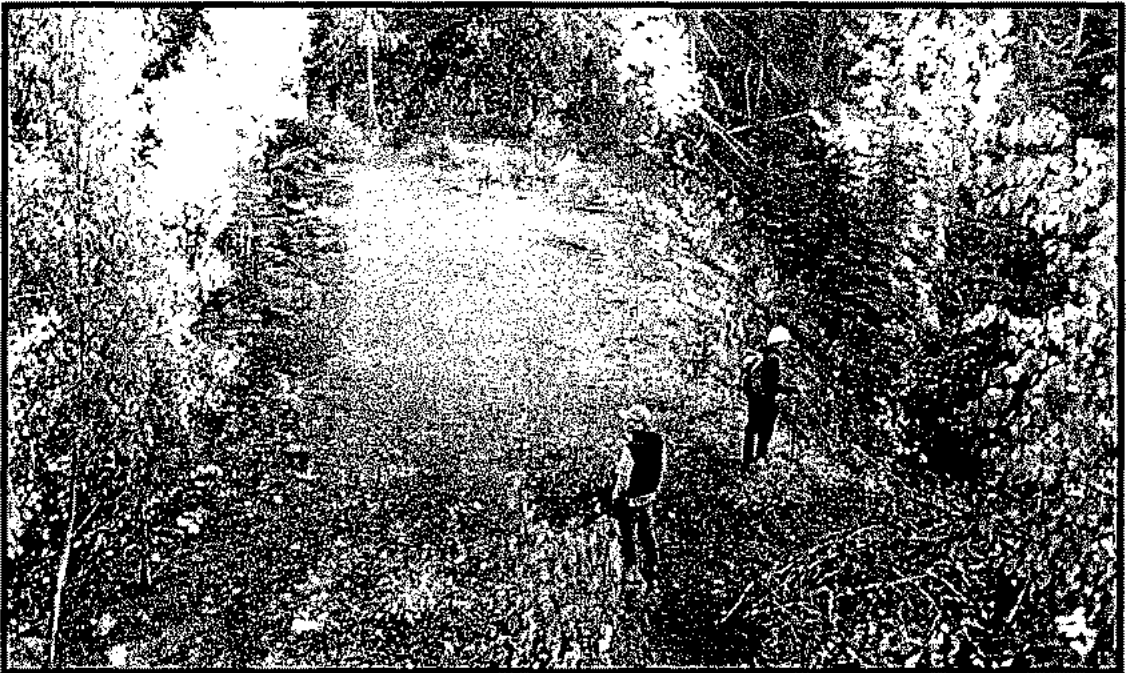
Plate 4.3.1-15 Looking upstream to the saddle dam constructed on the right bank of Cheslatta River at the inlet to the Cheslatta Fan erosional gully

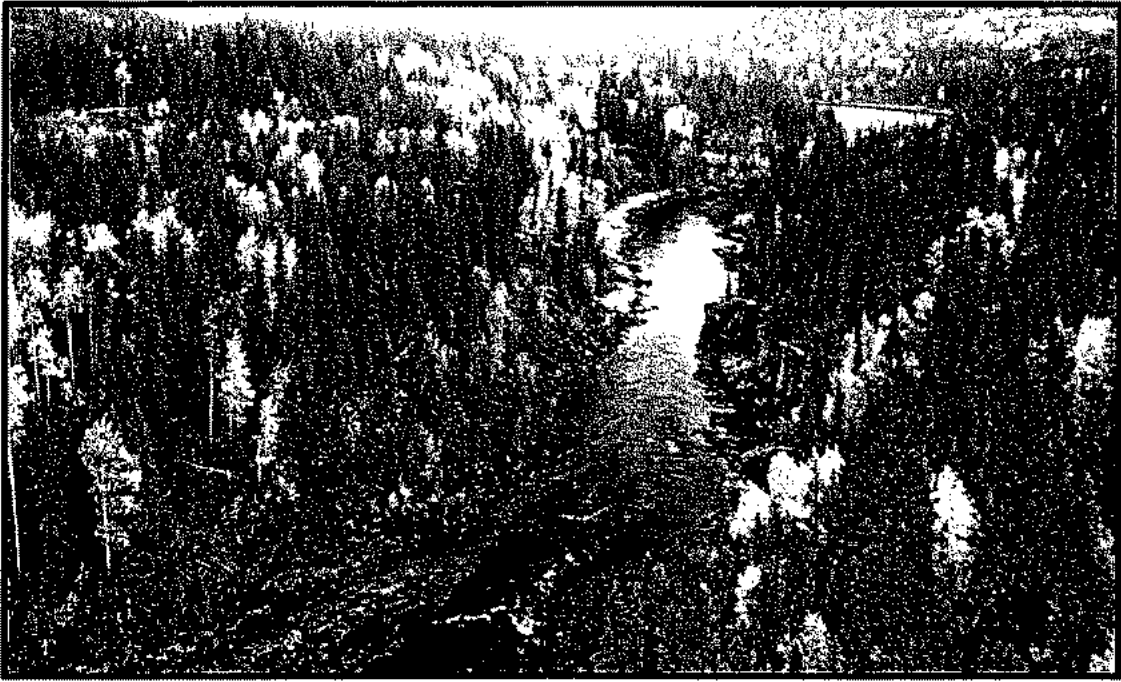
MM 02 - 87 - 15A

The Nechako River narrows downstream of the Cheslatta confluence and a bedrock constriction occurs between Km 9.5 and 10.2 (Plate 4.3.1-16). The river widens downstream from this point and large quantities of woody debris have been deposited on the right bank valley flat (Plate 4.3.1-17). This organic material could be derived from the Cheslatta Fan erosion gully or (more likely) post diversion bank erosion which has occurred further upstream on the Cheslatta-Skins Lake system (see Kellerhals et al. 1979).

Plate 4.3.1-16 Looking downstream to the bedrock constriction which occurs between Km 9.5 and 10.2

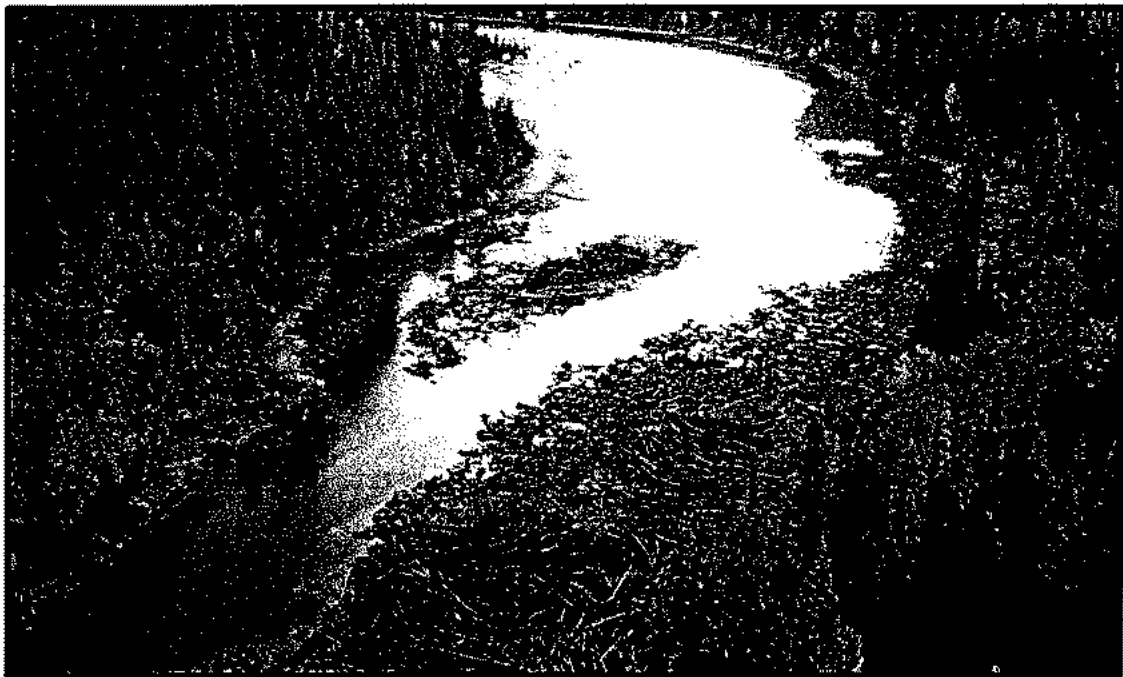
MM 02 - 87 - 24A

Plate 4.3.1-17 Looking downstream to the bedrock constriction at Km 10.2, showing the extensive large woody debris deposits

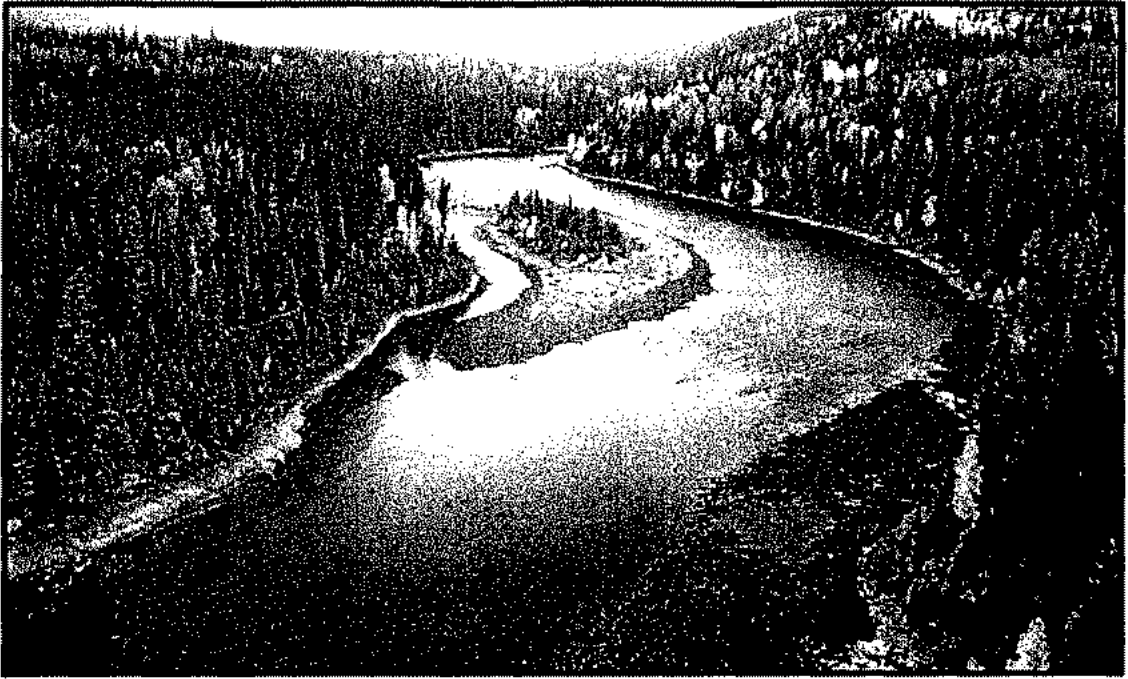
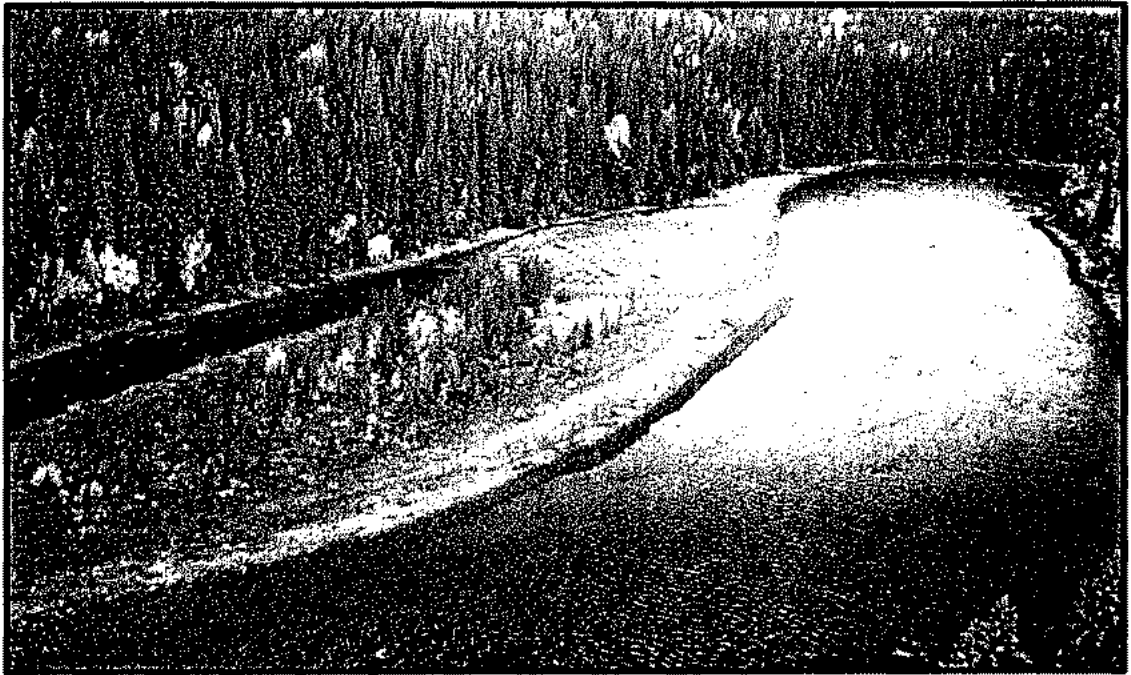
The river forms an irregular channel downstream of Km 10.2. As indicated on Plate 4.3.1-18, there is little wood adjacent to the commonly wetted banks, the bed material is weathered or lichen covered (which suggests it is generally immobile), and riparian vegetation is developing in formerly wetted areas along the channel banks and on mid-channel bars or islands.

Plate 4.3.1-18 An irregular "underfit" channel has formed downstream of the bedrock constriction at Km 10.2

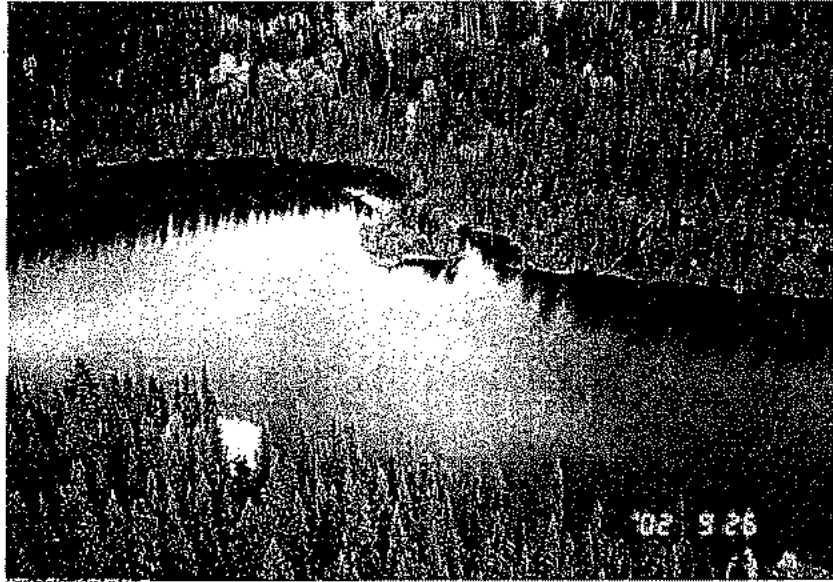
At the outlet of Nechako Canyon, the western margin of Scour Hole Lake displays the two distinct forest stand age classes that are typical of many locations in the canyon. Plate 4.3.2-1 shows a band of young spruce that established in the dewatered area just above the present water level in Scour Hole Lake. Larger cottonwood, spruce, and lodgepole pine occur upslope of the dewatered area.

**Vegetation adjacent to Scour Hole Lake.**

There are presently two distinct forest stand age classes along the western margin of Scour Hole Lake, just south of Cheslatta Fan, where a band of young spruce has established in the dewatered area just above present lake level. Larger cottonwood (yellow foliage in photograph above), spruce, and lodgepole pine occur upslope of the dewatered area. This vegetation zonation could be altered by flushing flows that might raise the shoreline shown above or by a fully commissioned channel that might lower water levels by as much as 1 m in this lake (refer to Section 4.4.5). Location: view westward over Scour Hole Lake at the north end of Nechako Canyon, approximately 7.2 km downstream of Kenney Dam.

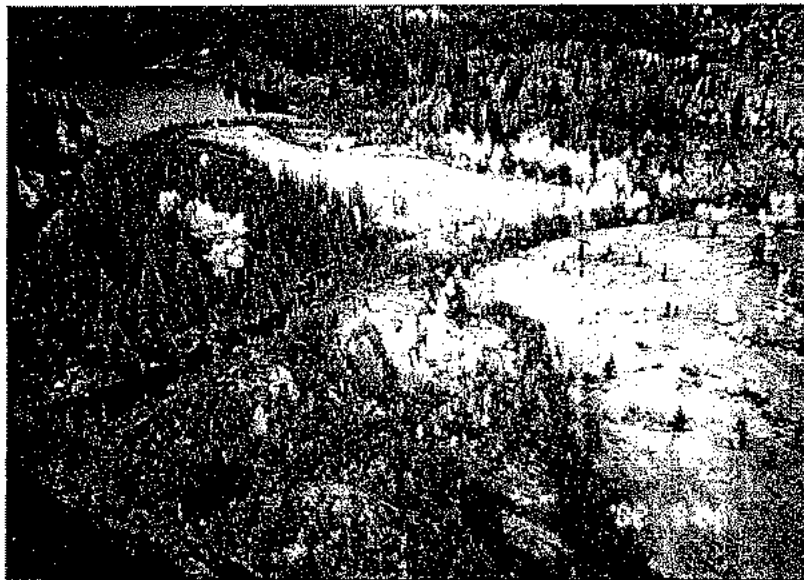
Plate 4.3.2-2

For the entire length of the study area from Kenney Dam to the vicinity of Cheslatta Falls, the most significant accumulation of woody biomass near the potential reactivated channel is the coniferous stand at the southeastern edge of Cheslatta Fan (Plate 4.3.2-2). One of the largest trees in this stand, with a breast height diameter of 49.1 cm and an estimated height of 27 m, had a breast height age of 113 years (sample tree no. 7, Table 3.3.1-2). There was no September 2002 field tally of the total number of relatively large trees in this stand but approximate tree counts on available aerial photos indicates that between 1950 and 1990 there appeared to be at least 40 relatively large spruce in this stand (Table 4.3.2.1). Eight to twelve relatively large cottonwoods that were visible on 1950 and 1961 aerial photos were not present on 1974 or later photos, presumably a result of their loss during deposition of additional alluvial material on Cheslatta Fan. The degree to which this treed area may be disturbed by establishment of a self-forming natural channel in this vicinity has not been determined.

**Vegetation on the southern portion of the Cheslatta Fan.**

There is a remnant stand of relatively large old spruce located at the southeast edge of Cheslatta Fan. On 1950 to 1971 aerial photographs, this forest stand existed on an island between channels of the Nechako River. Sample tree no. 7, with a breast height-age of about 113 years and an estimated height of 27 m (see Table 3.3.1-2), occurs near the eastern edge of this conifer stand. Location: southeastern edge of Cheslatta Fan, viewed to the southwest over Scour Hole Lake, approximately 7.6 km downstream of Kenney Dam.

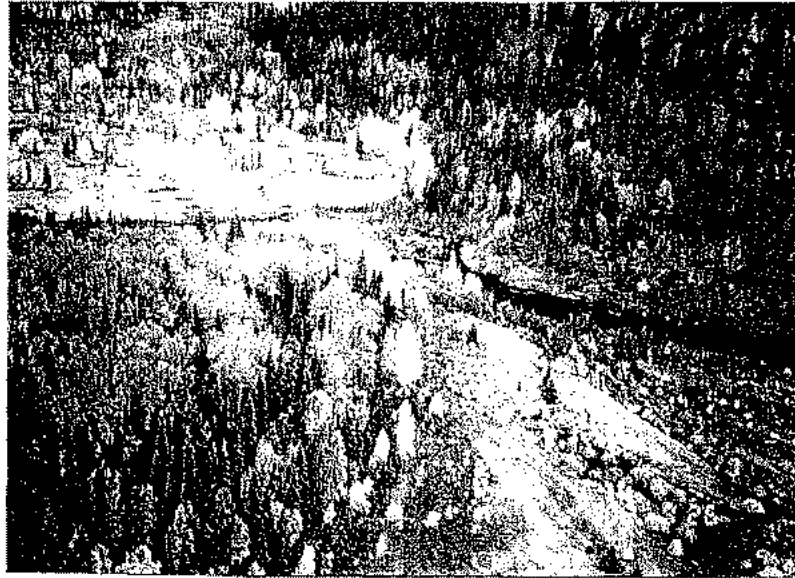
When relatively high flushing flows are activated, passage through the ‘Neck’ area shown in Plate 4.3.2-3 will likely involve removal of some of the conifers and broadleaf deciduous trees that occur on the southeast side of the ‘Neck’. The opposite shoreline, on the northwest side of the ‘Neck’, would experience little vegetation disturbance, as there is presently very little vegetation cover on this rocky prominence.

Vegetation at the “Neck,” looking upstream from the Cheslatta confluence.

The edge of the mixed spruce-aspen stand on the lower left of this photograph would be subject to disturbance, depending on the design of the channel through the bedrock-controlled ‘neck’ that exists in the mid portion of the Cheslatta Fan. Sample tree no. 9, a large spruce with a breast height age of 135 years and estimated height of 29 m (see Table 3.3.1-2), is located near the channel margin of this mixed wood stand. Location: Cheslatta Fan approximately 8.3 km downstream from Kenney Dam.

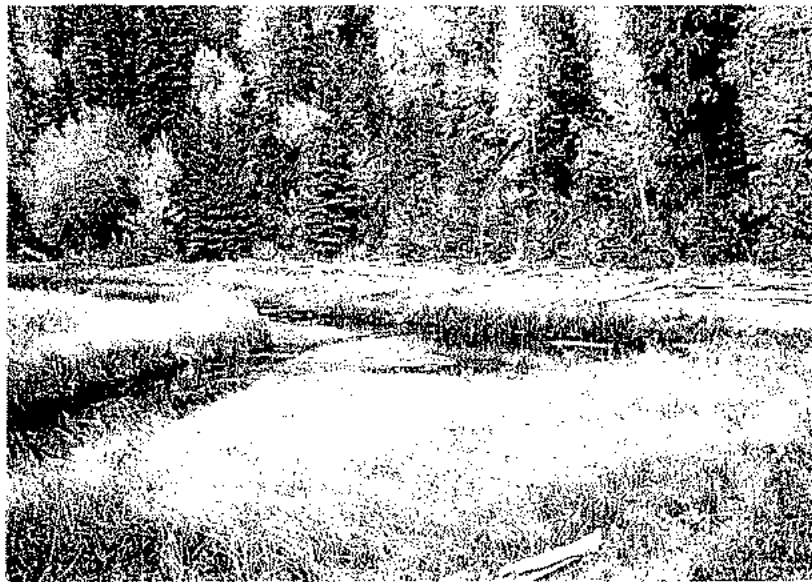
Downstream of the ‘Neck’ area, the existing vegetation is predominantly an untreed grass and shrub cover on alluvial materials, with adjacent slopes covered by young mixed stands of spruce, birch, and aspen (Plate 4.3.2-4). Depending on the chosen location of a self-forming channel downstream of the ‘Neck’, and also depending on location and design of a potential gravel/boulder berm on the southeastern edge of the new channel, the area of the valley bottom portrayed in Plate 4.3.2-4 has the greatest potential for innovative assisted revegetation after the new channel’s flows are established.

Typical young mixed stand of spruce, birch, and aspen along the eastern edge of lower Cheslatta Fan.

The degree to which vegetation boundaries would be altered in this area by flushing flows and by a fully commissioned channel has not been determined. Location: eastern edge of present floodplain approximately 8.8 km downstream of Kenney Dam, 300 m south of Cheslatta Falls.
