PRELIMINARY ASSESSMENT OF THE MURRAY-CHESLATTA SYSTEM

Submission Date: October 12, 2000

northwest hydraulic consultants
#2 - 40 Gostick Place
North Vancouver, B.C.
V7M 3G2

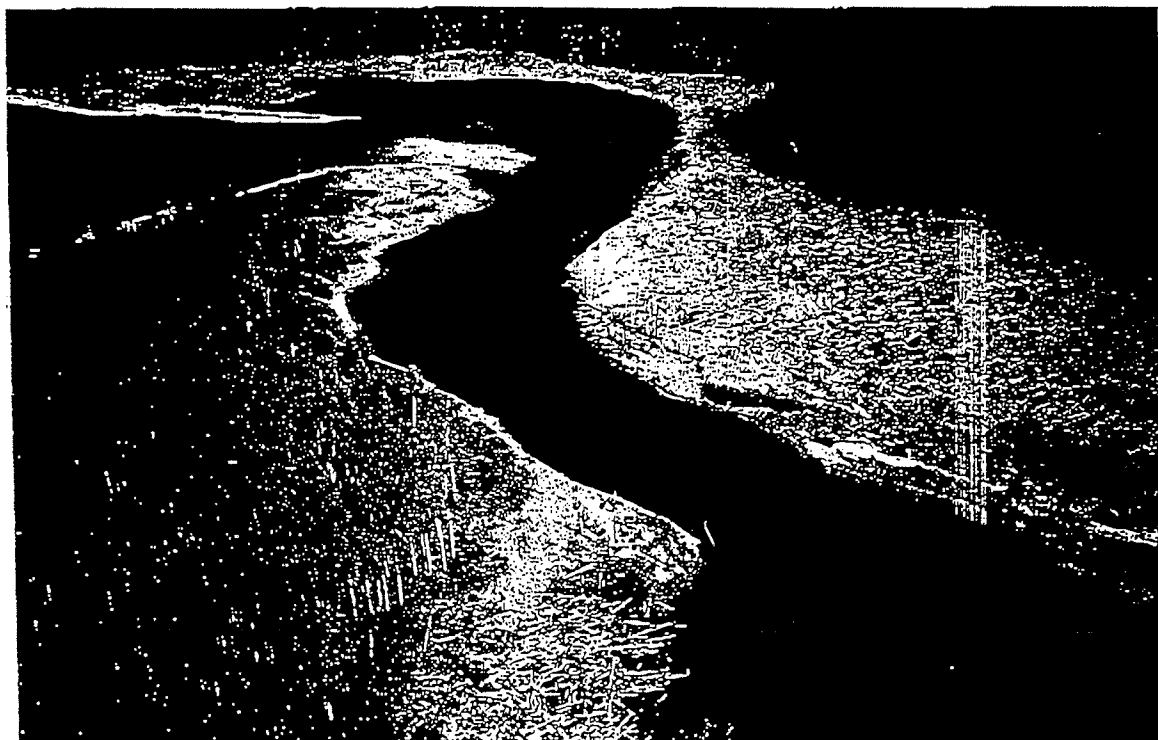
Photo 10. Cheslatta/Murray Lake foreshore at connection between the two lakes. Note the standing snags.

The natural shoreline of Murray, Cheslatta, and Skins Lakes supported a community of trees and shrubs. In many areas along the lake shorelines remnants of these trees can be seen in the form of standing snags (photo 10). We recommend that an inventory of the lake shorelines be conducted to prioritize which areas should be planted first. Planting could include the broadcast spreading of seeds as well as planting of shrub cuttings and tree seedlings. The plant species should be determined in consultation with the Ministry of Forests and the Regional Wildlife Biologist from MoELP.
