Annual Report September 1, 2014 to March 31, 2015

Submitted to NEEF

Nechako Environment and Water Stewardship Society – NEWSS

NEEF Project name: Nechako River Sustainability

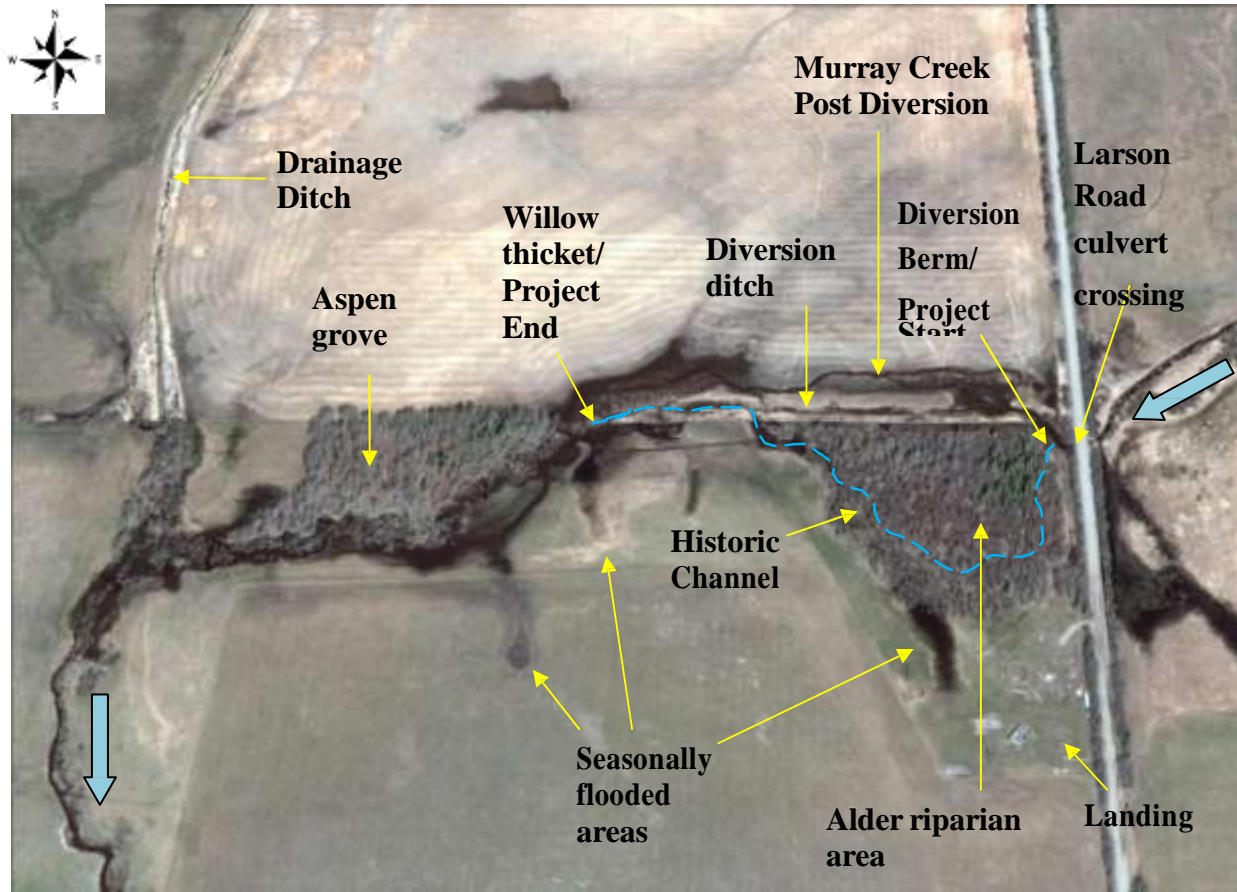
The most significant impact to Murray Creek in the Project area is the loss of approximately 640m of quality rearing habitat (**Figure 4**) for juvenile salmonids, adult rainbow trout and potentially other cool water species such as mountain whitefish (*Prosopium williamsoni*) and burbot (*Lota lota*) that are otherwise common to the region. Adult and juvenile rearing habitat is available in the newly cut channels and diversion ditch under high flow conditions; however, there is a potential for fish stranding to occur in these habitats during base flow conditions. Furthermore, due to a lack of riparian vegetation, temperatures within the newly formed channels and diversion ditch may become unsuitable or unfavourable to cool water species from late spring to early fall. Any overwintering or spawning habitat that was available within the dewatered section of historical channel was lost following the diversion. The diversion has resulted in the flooding and cutting of new channels through the neighbouring farm field to the north resulting in lost productivity to the farm owners.

Figure 4, suggests that active channel erosion is continuing which could potentially inhibit fish passage downstream as a result of channel aggradation. The later construction of a diversion ditch to prevent further flooding and erosion of the farm field may have further contributed to downstream sedimentation, elevated stream temperatures and reduced fish passage.

Figure 4. The 640 meters of Historic Murray Creek Channel (dashed line) prior to restoration and surrounding active farm fields on May 05, 2013. The blue arrows indicate direction of flow.

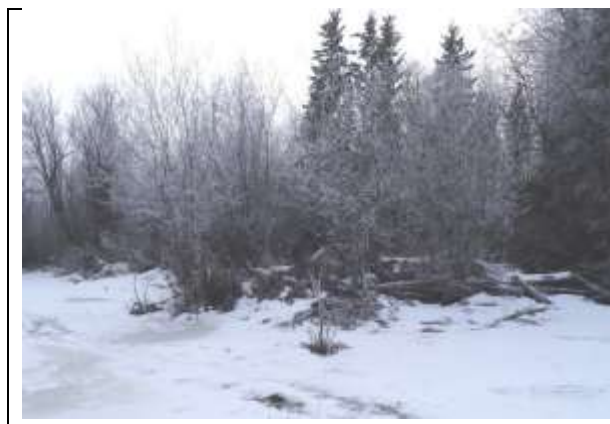
Photo 5. The earthen berm, photographed on March 02, 2015, that caused the channel

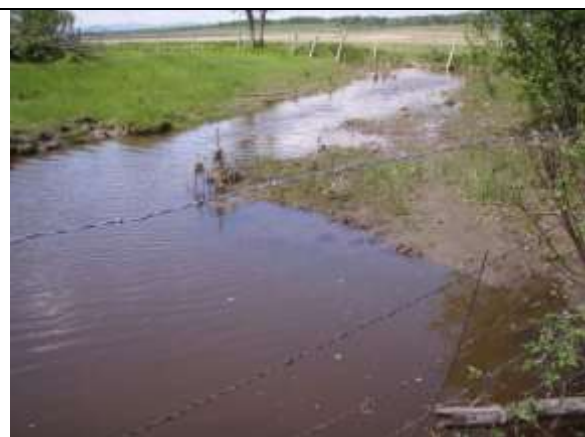
Photo 6. The diverted channel coursing towards the North farm field and diversion

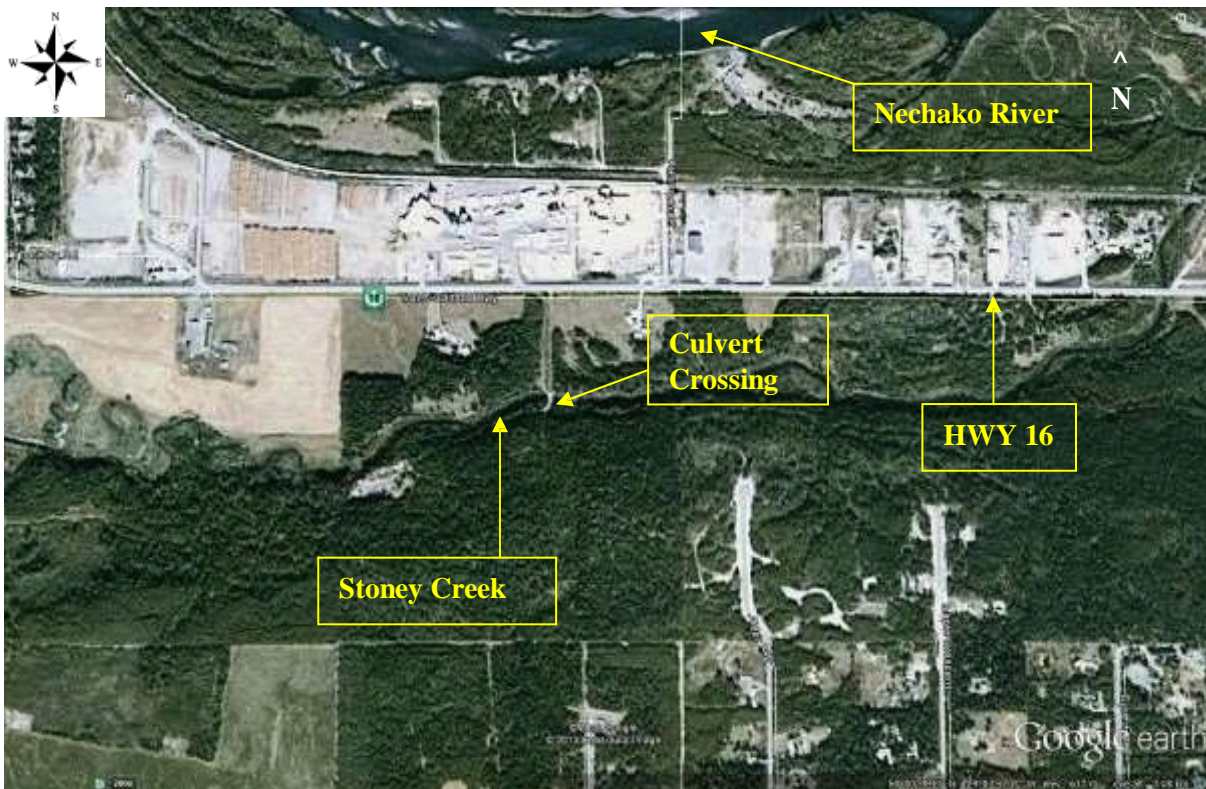
Figure 5. The culvert crossing location on Stoney Creek where the replacement of three culverts with a beam bridge was completed in order to provide fish passage under all flow conditions and to allow natural stream processes to occur.

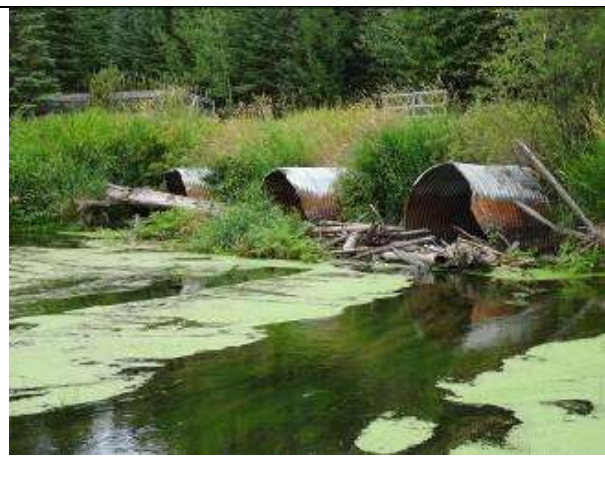
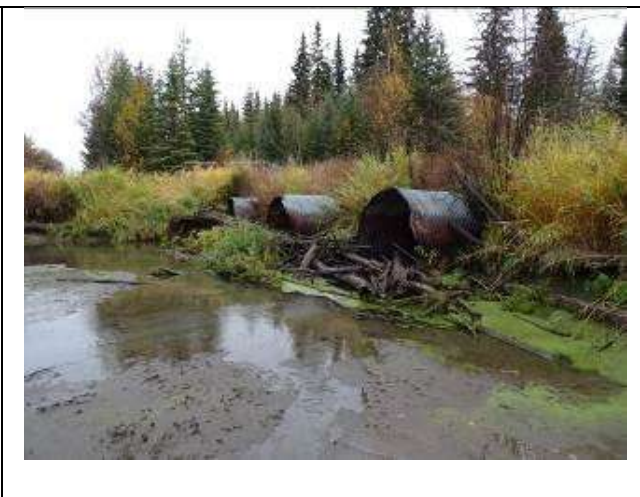
<p>Photo 3. Upstream view of L&M culverts during looking Northeast prior to removal (summer).</p>	<p>Photo 4. Upstream view of L&M culverts looking Northeast during the fall prior to removal.</p>

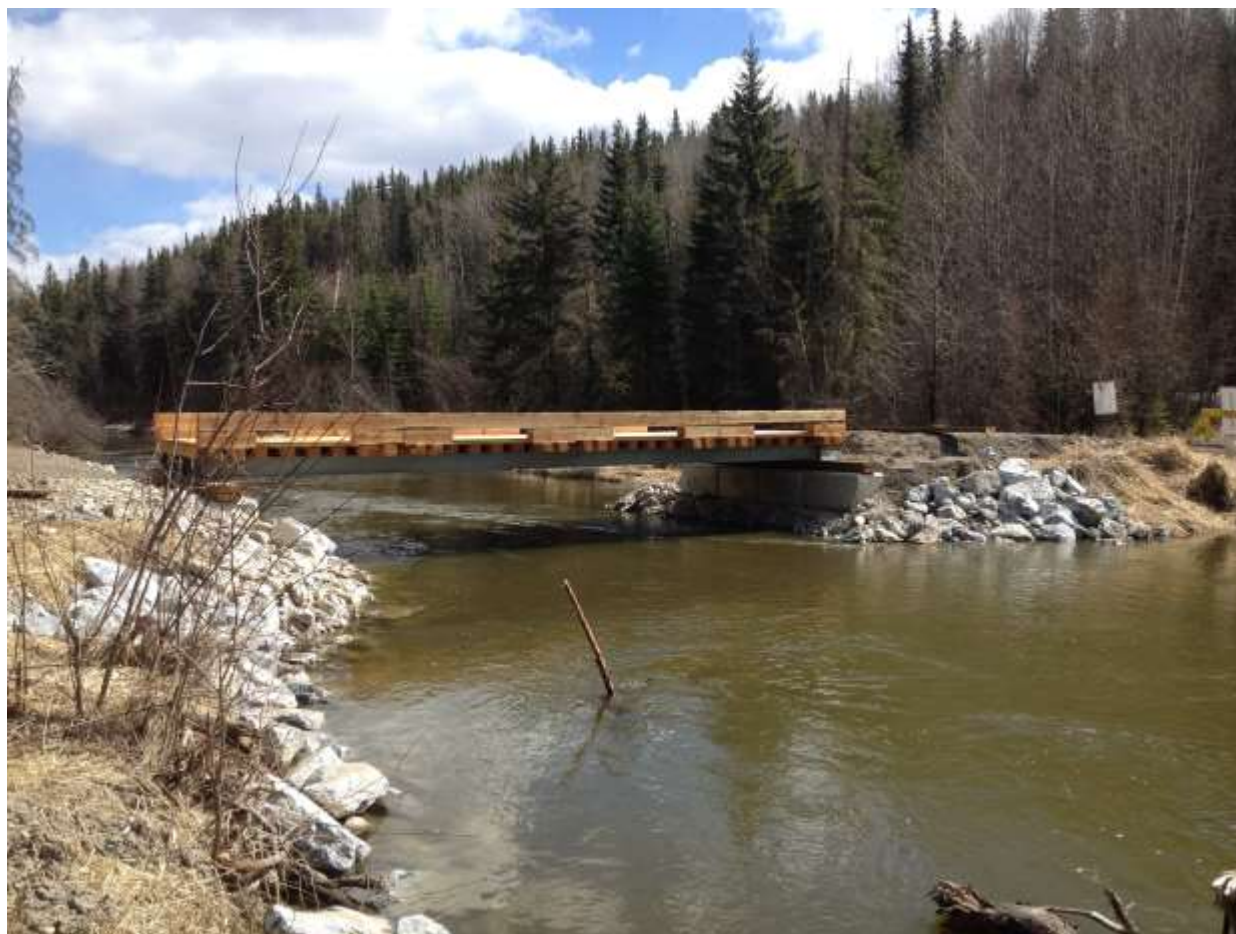
Photo 13. The L& M Bridge photographed on April 14, 2015, looking downstream.

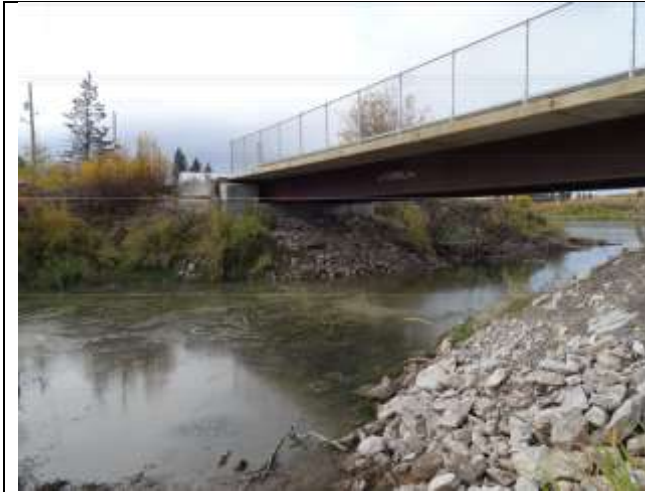
Photo 29. Stoney Creek at the Douglas Street bridge/Nechako River confluence illustrating the bank erosion occurring upstream of the bridge.

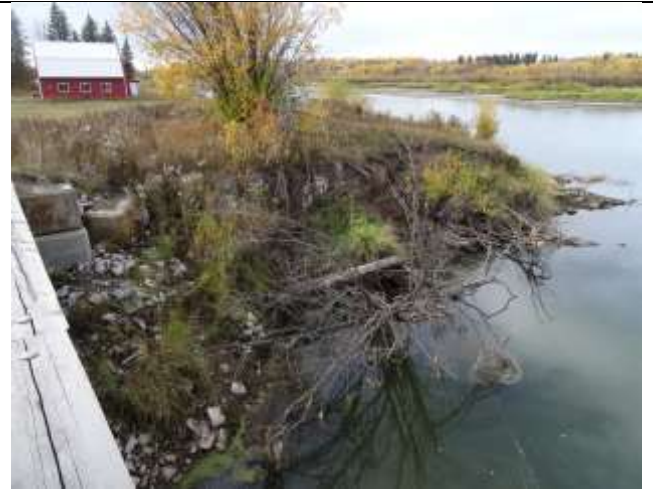
Photo 30. Stoney Creek at the Douglas Street bridge/Nechako River confluence illustrating the bank erosion occurring downstream of the bridge.

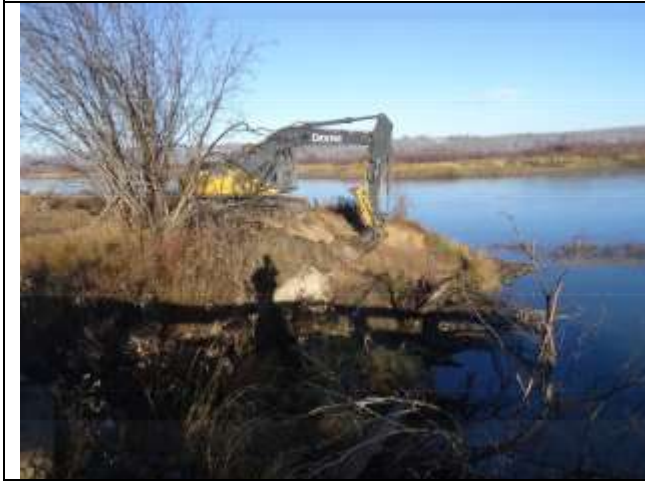
Photo 31. Re-sloping of the West bank of the mouth of Stoney Creek.

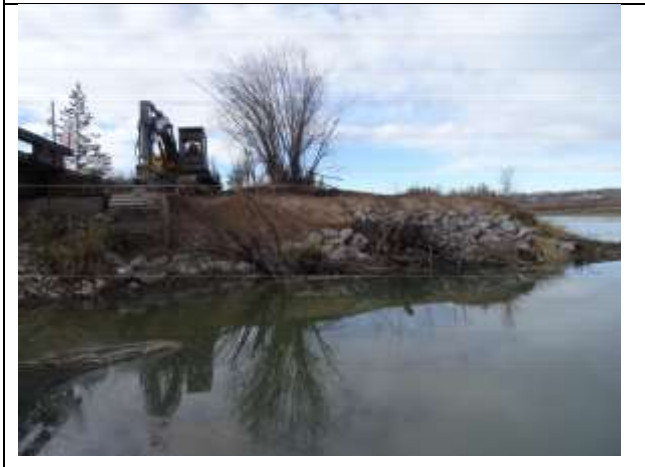
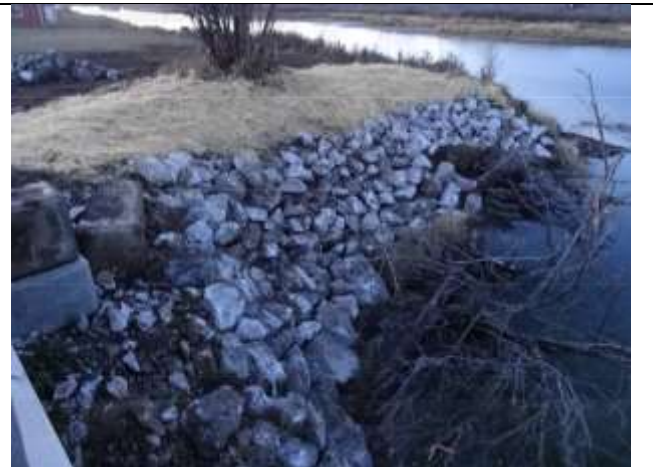
<p>Photo 33. Armouring and installation of LWD at the west bank of Stoney Creek at the Nechako River confluence.</p>	<p>Photo 34. Armouring and LWD additions completed at the mouth of Stoney Creek at the Nechako River confluence.</p>

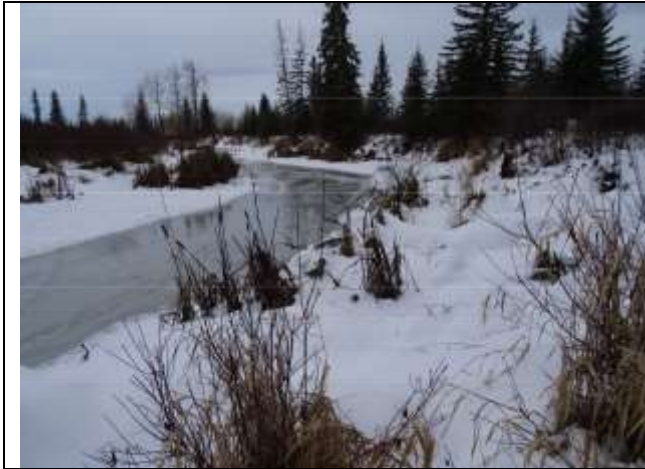
Photo 39. Stoney Creek at KP2+175 prior to habitat restoration activities.

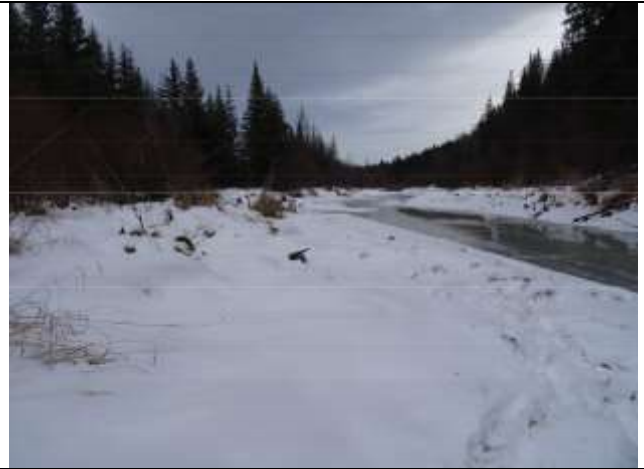
Photo 40. Stoney Creek at KP2+175 prior to habitat restoration activities.

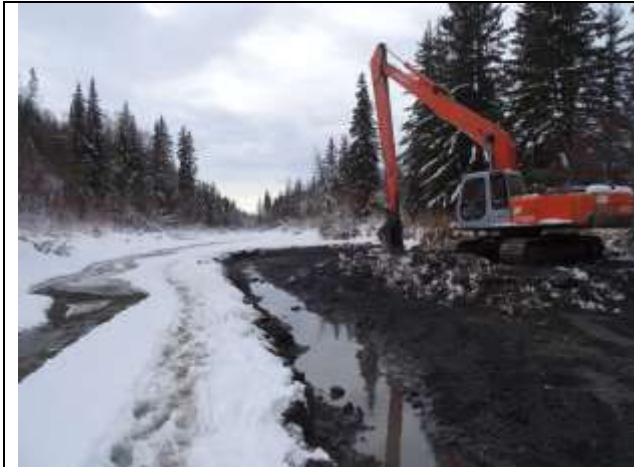
Photo 48. Area immediately upstream of the beaver dam being dredged. Note the earthen platform from which the excavator is being operated and away from the wetted channel.
