# 2024-2025 Nechako River Substrate Monitoring

## Final Report

**Northwest Hydraulic Consultants Ltd.**

November 20, 2025  
Final Report, Rev. 1

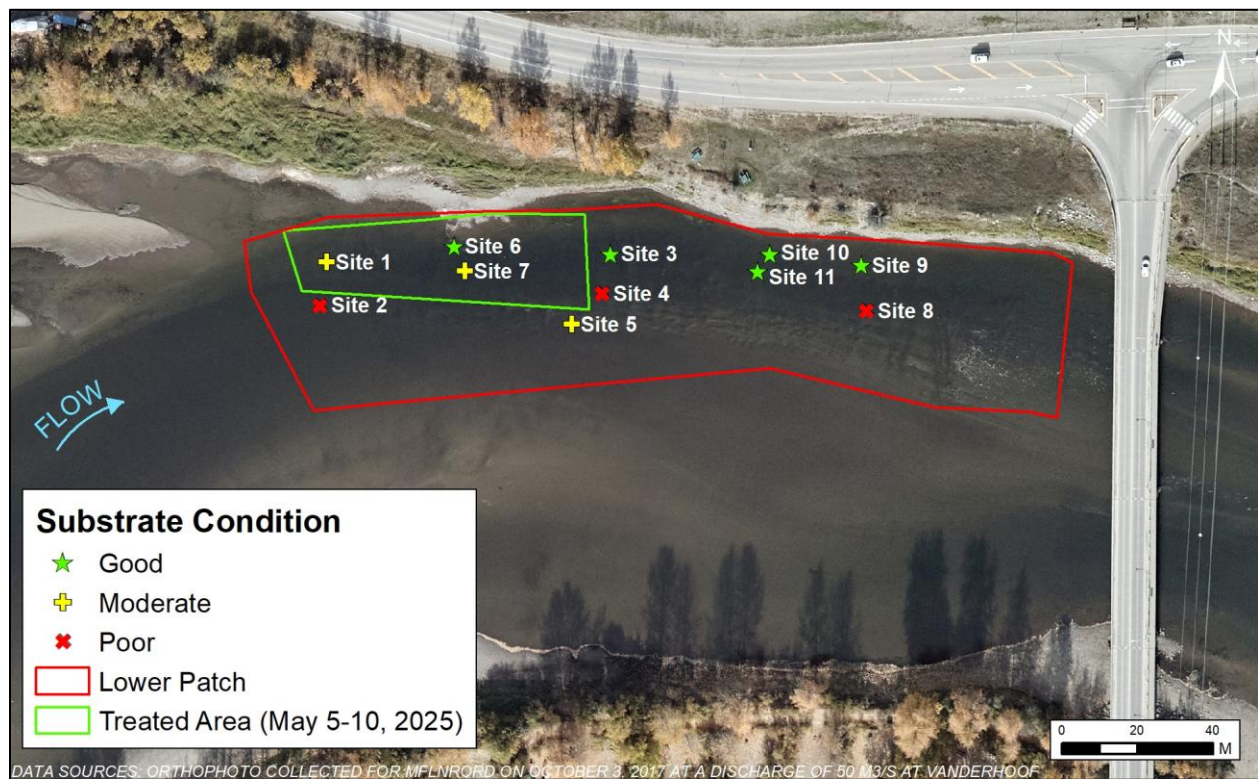
**Figure 3.3 Visual classification of pre-treatment substrate conditions observed on April 23-25, 2025; substrate descriptions provided in Table 3.2.**

**Table 3.2 Site-specific descriptions of pre-treatment substrate characteristics observed on April 23-25, 2025 ; shading reflects the substrate classification shown on Figure 3.3 (Green = good, Moderate = yellow, Poor = red).**

Sample Location	Substrate Characteristics	
	Surface (camera)	Subsurface (freeze core)
Site 1	Gravels and cobbles embedded into surficial sand matrix. Organic debris also present, indicating relatively slow near-bed flow velocities.	High proportion of cobbles in the upper 10 cm of the core embedded into sand matrix; no clean interstices observed. Lower 20 cm of the core is predominantly fine to coarse gravel embedded into sand matrix with no cobble. Lack of cobbles at-depth suggests that cobbles placed in 2011 have not been buried and remain within the upper 10 cm of the substrate.
Site 2	Fine to medium gravels intermixed with high proportion of sand. Only a few cobbles visible, some of which are arranged into local clusters.	Relatively uniform mixture of fine to medium gravels in a sand matrix; no apparent layering or stratification. Ice within the upper 10 cm of the core suggests a local surficial layer of coarse gravels and cobbles was present above the core. <i>While the core indicates that good quality interstitial habitat was present, review of underwater imagery suggests that surficial cobbles were highly localized; the conditions shown by the core are not considered generally representative of the surrounding substrate.</i>

Site 3	High proportion of cobbles and medium to coarse gravels with very limited surficial sand; relatively large voids visible between some cobbles.	Relatively high proportion of medium to coarse gravels with trace cobbles in a sand matrix. Gravels intermixed throughout the core. Upper 7 cm of core contains layer of coarse gravels with clean interstitial voids to a depth of two to three grains thick.
Site 4	Poorly sorted mixture of fine gravels to cobbles with high proportion of sand.	Relatively uniform mixture of fine to coarse gravels in a sand matrix; no apparent layering or stratification. Pockets of sand up to 5 cm thick.
Site 5	Fine gravels to cobbles with moderate surficial sand. Small voids visible between the fine gravels but voids are likely limited to surface (depth of one grain thick, or approx. 1 cm).	Relatively uniform mixture of fine to medium gravels in a sand matrix, with transition to predominantly sand horizon with fewer gravels and trace cobbles approximately 30 cm deep.

Site 6	High proportion of cobbles and coarse gravels with very limited surficial sand; relatively large voids visible between some cobbles. Numerous mussels present.	Surficial layer of cobbles and large gravels (and a mussel) underlain by predominantly sand matrix with trace gravels.
Site 7	Cobbles and mixed fine to coarse gravels embedded into surficial sand matrix.	Layer of fine to coarse gravels in upper 10 cm of core underlain by uniform matrix of sand and very fine gravel. Limited presence of clean voids observed between coarser gravels of the upper core.
Site 8	Poorly sorted mixture of fine gravels to cobbles with high proportion of sand.	Gravels intermixed throughout the core in a sand matrix. Upper 10-15 cm of core contains greater

Sample Location	Substrate Characteristics	
	Surface (camera)	Subsurface (freeze core)
	Organic debris is also present, indicating relatively low near-bed flow velocities.	proportion of coarser gravels. Limited presence of clean voids observed between coarser gravels of the upper core.
Site 9	High proportion of cobbles and coarse gravels with very limited surficial sand; relatively high abundance of voids visible between cobbles and gravels. Numerous mussels present.	Layer of coarse gravels (and mussels) in upper 5-10 cm of core underlain by uniform matrix of sand with trace gravels. Core shows clear demarcation from brown to grey sand matrix at a depth of 5-15 cm.
Site 10	High proportion of cobbles and coarse gravels with very limited surficial sand; relatively high abundance of voids visible between cobbles and gravels. Numerous mussels present.	Medium to coarse gravels in grey sand matrix. Ice within the upper 5-7 cm of the core suggests a local surficial layer of coarse gravels and cobbles was present above the core. Increasing proportion of fine gravel in lower 10 cm of the core.

Site 11	N/A	High proportion of large cobbles throughout the core in a sand and fine gravel matrix. Ice within the upper 5 cm of the core suggests a local surficial layer of coarse gravels and cobbles was present above the core.

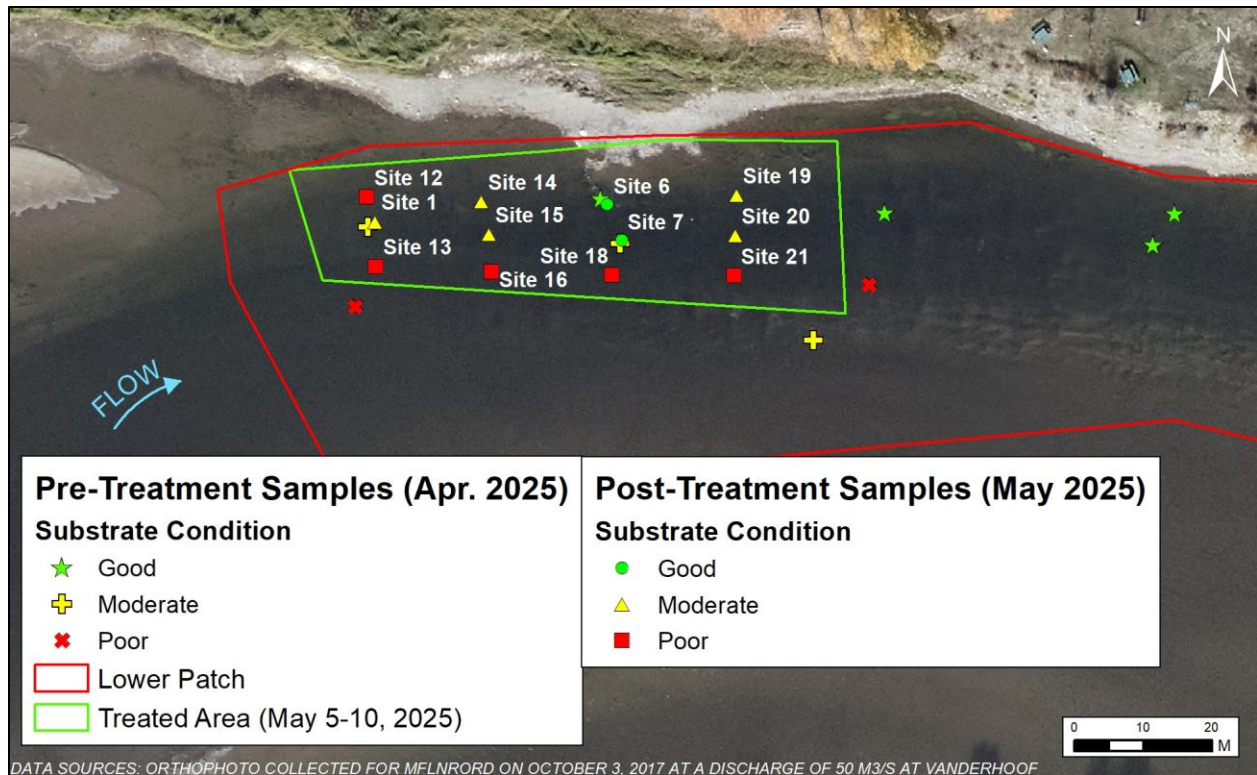
**Figure 3.5 Visual classification of post-treatment substrate conditions observed on May 12-13, 2025, compared to pre-treatment conditions observed on April 23-25, 2025; substrate descriptions provided in Table 3.2 and Table 3.3.**

**Table 3.3 Site-specific descriptions of post-treatment substrate characteristics observed on May 12-13, 2025; Sites 1, 6, and 7 (bolded) are the repeat sampling sites from pre- and post-treatment conditions. Sites are ordered from upstream to downstream, north to south (see Figure 3.4). Shading reflects the substrate classification shown on Figure 3.5 (Green = good, Moderate = yellow, Poor = red).**

Sample Location	Substrate Characteristics	
	Surface (camera)	Subsurface (freeze core)
Site 12	Substrate appears recently disturbed with high proportion of surficial sand draped over fine to coarse gravels and trace cobbles.	High proportion of fine to coarse gravels in upper 10 cm and lower 10 cm of core embedded in a sand matrix, separated by approximately 15 cm thick layer of predominately sand matrix with fine gravels.
<b>Site 1</b>	Gravels and cobbles embedded into surficial sand matrix. Thin sand drape overlying much of the area with localized accumulations of gravels providing some, albeit highly limited, interstitial voids.	High proportion of fine to coarse gravels distributed uniformly throughout core, limited sand matrix. Upper 10 cm of core contains layer of coarse gravels and cobbles containing clean interstitial voids. Ice within the upper 4 cm of core suggests a local surficial layer of coarse gravels and cobbles was present above the core to a depth of two to three grains thick.  <i>While the core indicates that good quality interstitial habitat was present, review of underwater imagery suggests that the substrate conditions were highly variable; the localized conditions shown by the core are not considered generally representative of the surrounding substrate.</i>

Sample Location	Substrate Characteristics	
	Surface (camera)	Subsurface (freeze core)
		and cobbles was present above the core to a depth of two to three grains thick. <i>While the core indicates that good quality interstitial habitat was present, review of underwater imagery suggests that the substrate conditions were highly variable; the localized conditions shown by the core are not considered generally representative of the surrounding substrate.</i>
Site 16	Surficial layer of sand moving as bedload overtop of gravels and cobbles.	Predominantly sand matrix with fine to medium gravels in upper 20 cm of core, with increasing proportion of medium to coarse gravel in lower 10 cm of core embedded in sand matrix.
Site 6	High proportion of cobbles and coarse gravels with little to no surficial sand; high abundance of voids visible between the gravels and cobbles.	Layer of medium to coarse gravels in upper 5 cm of core underlain by uniform matrix of sand and fine gravel. Limited clean interstitial voids observed between gravels. Ice within the upper 2-3 cm of core suggests a local surficial layer of coarse gravels and cobbles was present above the core.

Site 7	High proportion of cobbles and coarse gravels with little to no surficial sand; high abundance of voids visible between the gravels and cobbles.	Predominantly sand matrix with fine to medium gravels in upper 15 cm of core, with increasing proportion of fine gravel at-depth. Ice within the upper 6-7 cm of core suggests a local surficial layer of coarse gravels and cobbles was present above the core.
Site 18	Surficial layer of sand moving as bedload overtop of gravels and cobbles.	Fine to coarse gravels intermixed throughout the core in a sand matrix.
Site 19	Poorly sorted mixture containing sand, fine to coarse gravels, and cobbles overlying a sandy matrix. Substrate appears recently disturbed. Gravels and cobbles do not appear sufficiently thick to create interstitial voids to a depth greater than one grain thick.	Poorly sorted mixture of sand, fine to coarse gravels, and cobbles in upper 15 cm of core. Core shows clear demarcation to uniform grey sand matrix at a depth of 15 cm.

Site 20	Poorly sorted mixture containing sand, fine to coarse gravels, and cobbles overlying a sandy matrix.	Fine to coarse gravels intermixed throughout core in sand matrix. Upper 5 cm of core contains layer of medium to coarse gravels with clean interstitial voids. Ice within the upper 2-3 cm of core suggests a local surficial layer of coarse gravels and cobbles was present above the core.
Site 21	High proportion of surficial sand moving as bedload through gravels and cobbles.	Predominantly sand matrix with fine to medium gravels in upper 15-20 cm of core, with increasing proportion of medium to coarse gravel in lower 10 cm of core embedded in sand matrix.

In comparison to the sites discussed above, the treatment did produce very good results at Site 6 and Site 7 (Figure 3.5). The pre-existing substrate at these sites contained a high proportion of gravels and cobbles and relatively low proportion of surficial sand (Table 3.2; Figure 3.3). The restoration methods used in May 2025 may therefore be effective at restoring moderately degraded habitat, such as a veneer of sand otop of gravels and cobbles, but less effective in highly degraded habitats with high sand content. This finding has important implications for the planning of future restoration efforts within the spawning reach, where the focus may shift from remediation or cleaning of existing substrate to placement of additional spawning substrate to effectively coarsen the composition of the surficial sediment mixture (see Section 5).

- The effectiveness of mechanical remediation of existing substrate on the Lower Patch (using the tools to date) appears to be limited due to the insufficient proportion of coarse gravels and cobbles and high sand content contained within the bed sediment mixture. Two recommendations stem from this finding:

- Should remediation of existing substrate remain the NWSRI's preferred approach, it is recommended that additional remediation techniques be investigated that can effectively remove and displace the sand contained within the sediment mixture (e.g., specialized dredge).
- A more effective approach may be to shift the focus from remediation or cleaning of existing substrate to placement of additional spawning substrate to effectively coarsen the composition of the surficial sediment mixture. Should this approach be selected, NHC recommends further study be conducted prior to implementation, including: sediment transport and substrate monitoring at candidate sites; sediment tracer studies to assess gravel mobility; and numerical modelling to assess potential increases in flood risk associated with the substrate placement.

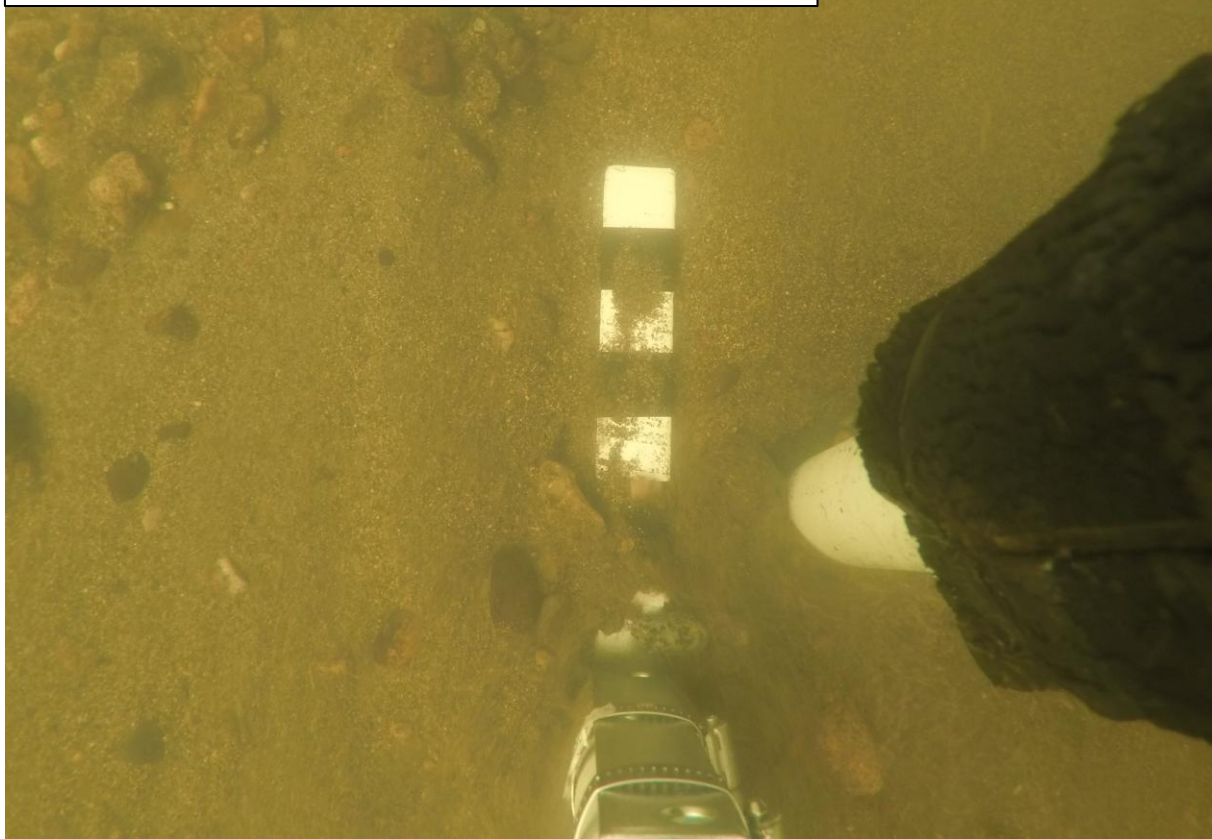
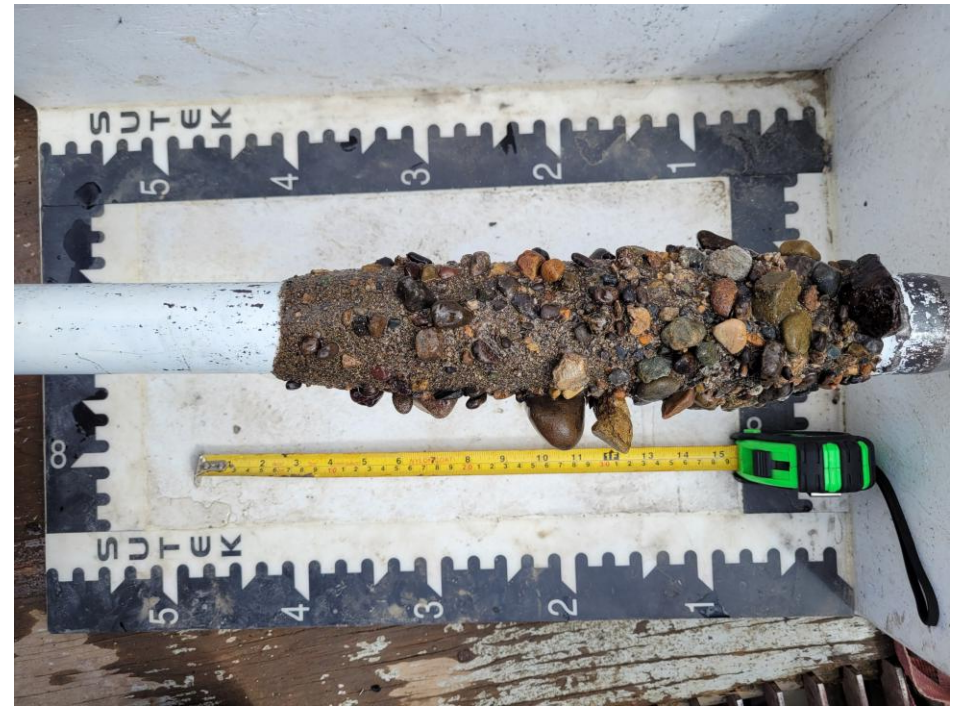
## SITE 13

The lack of large gravels and cobbles is particularly evident along the upstream, southern portion of the Lower Patch spawning pad (see Sites 13 and 16 in Appendix B). These locations were found to contain only a very limited number of cobbles, presumed to have been placed during construction of the spawning pad in 2011. It is uncertain whether the lack of cobbles in these areas reflects: inconsistent/non-uniform material placement in 2011; inaccurate mapping of the spawning pad extents; burial by finer sand and gravel; or downstream transport of the placed cobbles. Of the potential explanations listed above, it is most likely that the lack of coarse substrate in these areas reflects inconsistent placement and/or inaccurate mapping; no survey of the thickness nor extent of the placed substrate was done following construction, which complicates the analysis and is recommended for future gravel placement work. Burial of the placed cobbles by finer sand and gravel is also possible; however, the cores showed no evidence of a buried cobble layer to depths of 40 cm at Sites 13 or 16 (Appendix B). In contrast, Sites 18 and 21, located further downstream on the spawning pad, showed greater evidence of placed cobbles both on the surface and at-depth (Appendix B). The varying proportion of coarse gravels and cobbles in the pre-existing substrate has direct implications for the potential effectiveness of different restoration treatments; for example, insufficient gravels and cobbles would limit the effectiveness of dredging or mechanical raking, as digging through sandy gravel will likely still result in a sandy gravel substrate. Further recommendations regarding potential restoration treatments and their effectiveness are provided in Section 5.
