AN INVENTORY OF THE OOTSANEE LAKE DRAINAGE,
TRIBUTARY TO CHESLATTA LAKE, AND STREAMS
TRIBUTARY TO THE SOUTH BANK OF CHESLATTA LAKE

Stream Inventory

Fish & Wildlife Branch

February, 1978

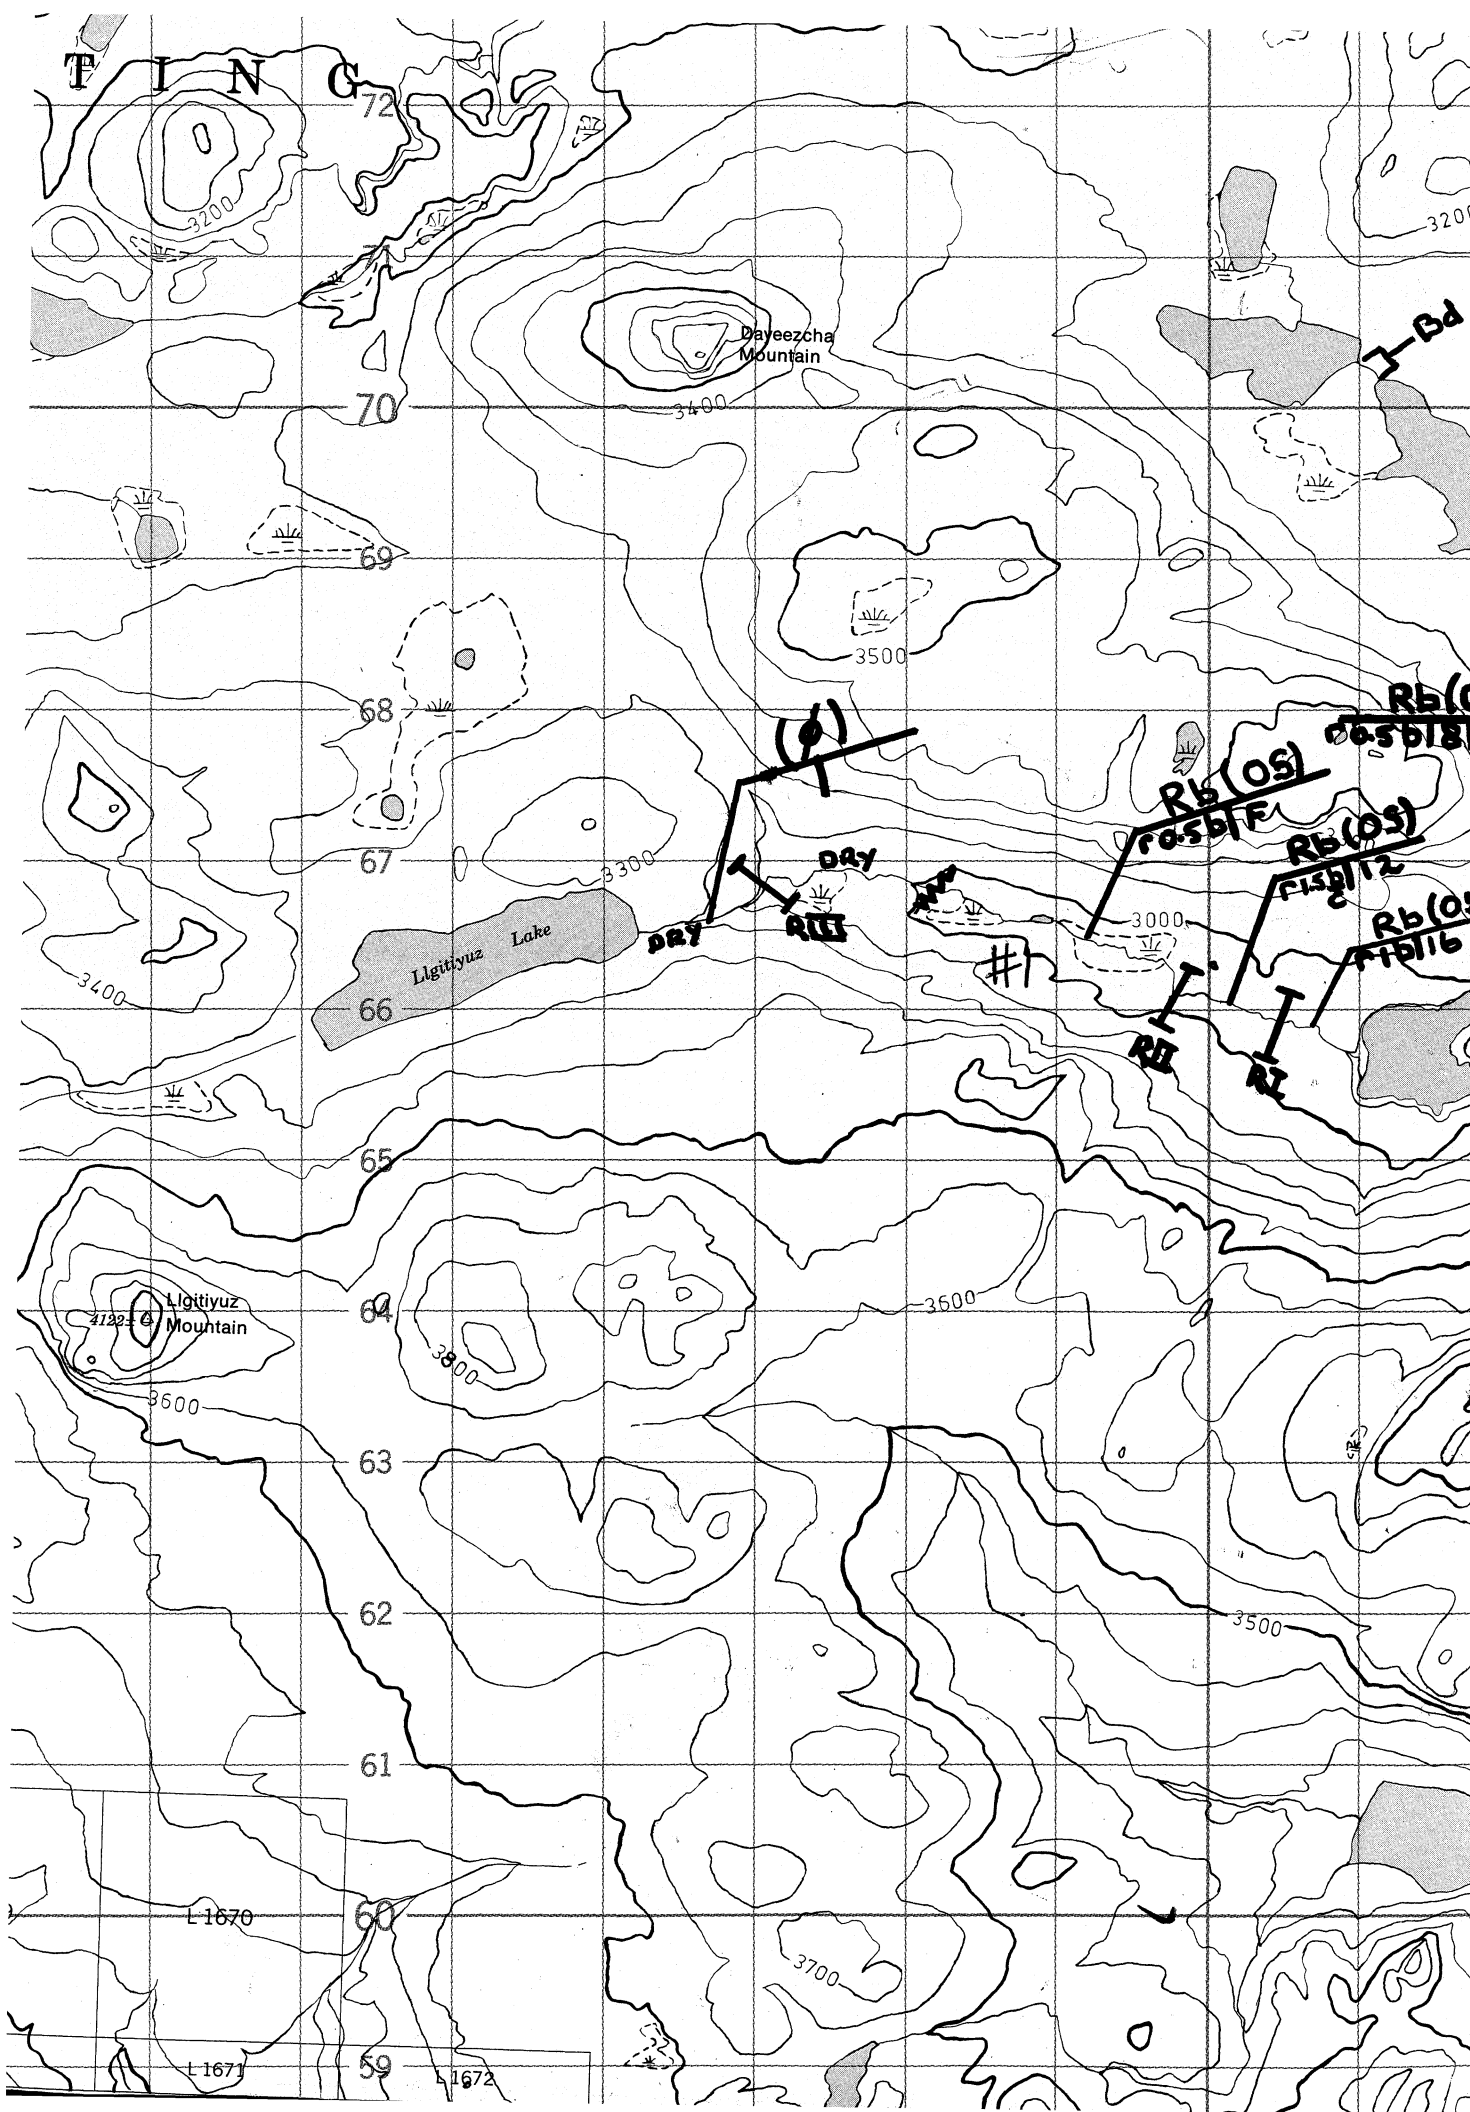
Map 3

Ootsanee Lake Drainage

Aquatic Systems Mapping

1:50,000

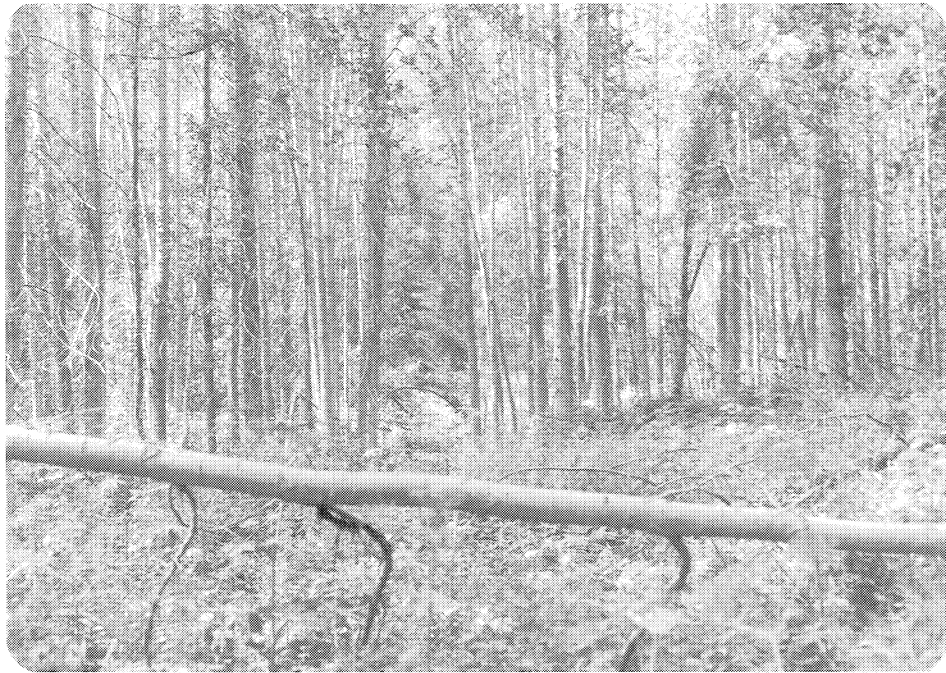
Photo 1: Typical forest of lower kilometer

The lower 0.5 Km is predominantly small alder (90%) and cottonwood with spruce (see picture) becoming dominant above. Crown closure is 10-20% in the lower 0.5 Km increasing to 20-30% above. The understory is generally quite low, offering 20-40% cover.

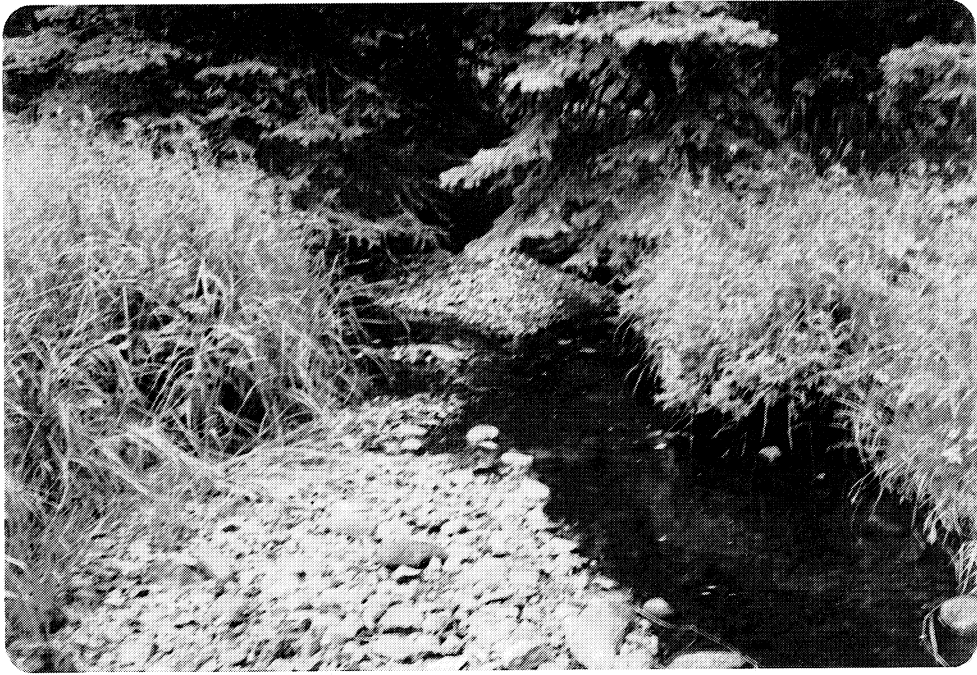
Photo 2: Typical section of Reach I, Tributary #1 to Ootsanee Lake.

The surrounding terrain is well vegetized, very low profile and subsequently quite stable. Minor bank undercutting is evident throughout the reach.

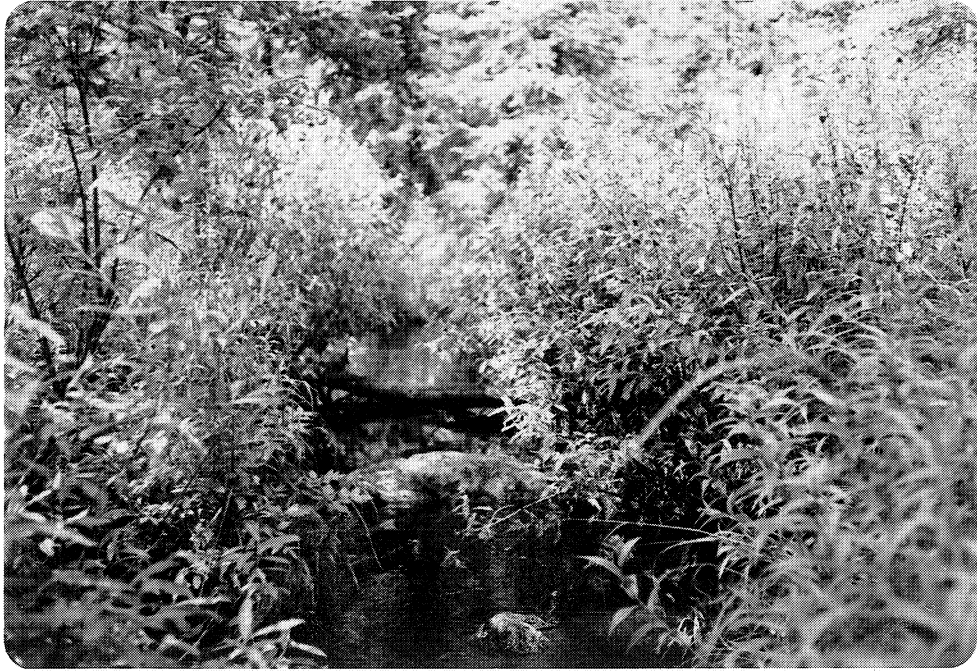
Photo 3: Typical section of Reach II, Tributary #1 to Ootsanee Lake.

Pool: 40% average depth 0.15 m

Run: 60%

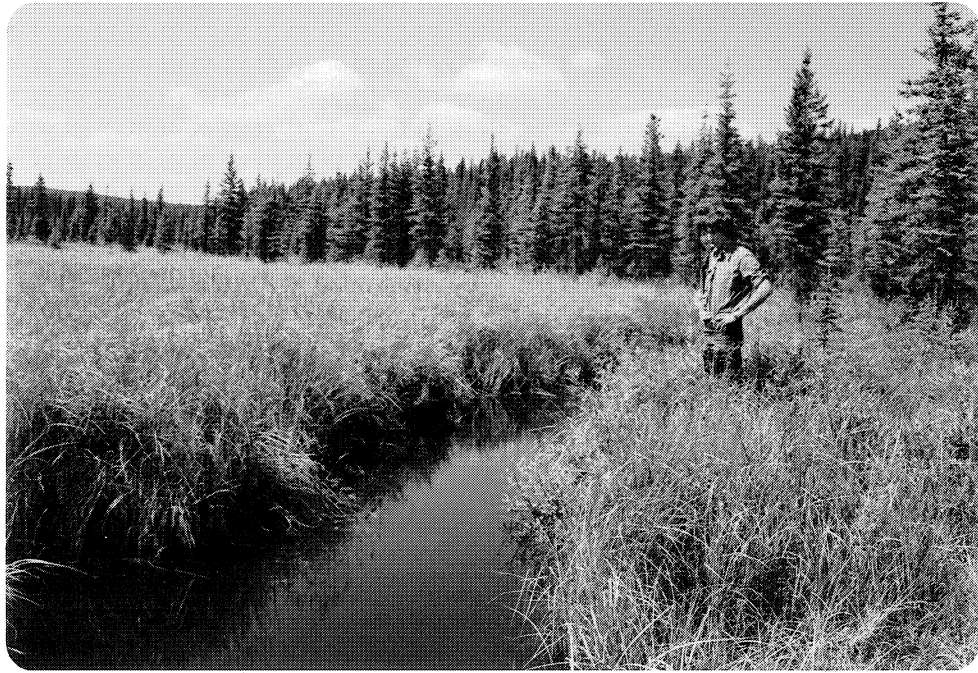
Photo 4: Typical slow moving placid run of Reach III,
Tributary #1 to Ootsanee Lake,

The stream channel proper disappears immediately above the second marsh area. It appears that flow between Llgitiyuz Lake and this point is underground, limiting accessibility above this point.

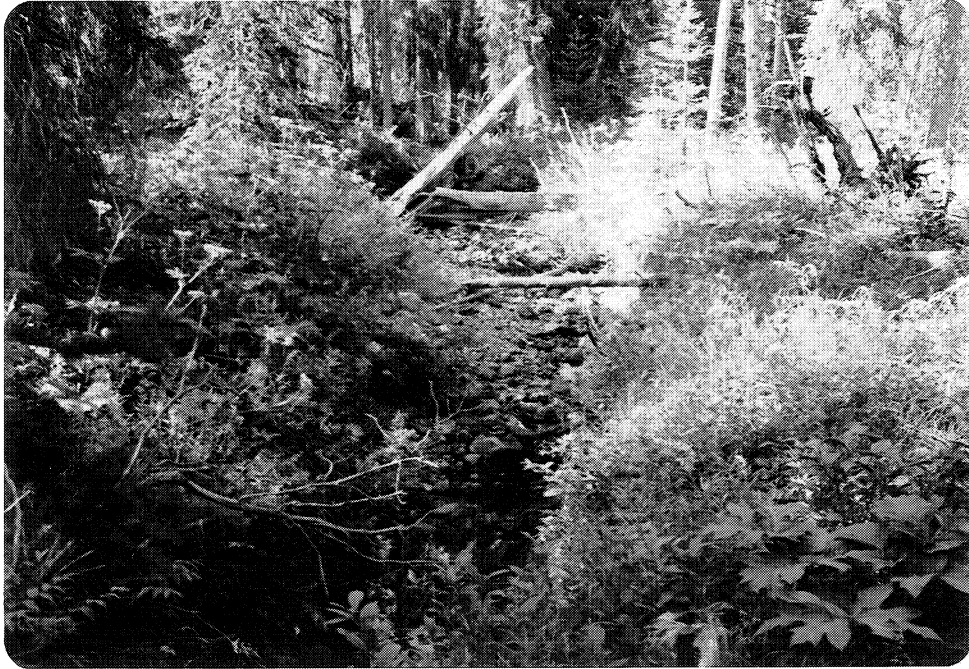
Photo 5: Typical section of Reach I, Tributary #2 to Ootsanee Lake.

Rainbow fry (3-5 cm) were noticeably abundant to the first beaver dam at 1.0 Km. None were observed above.

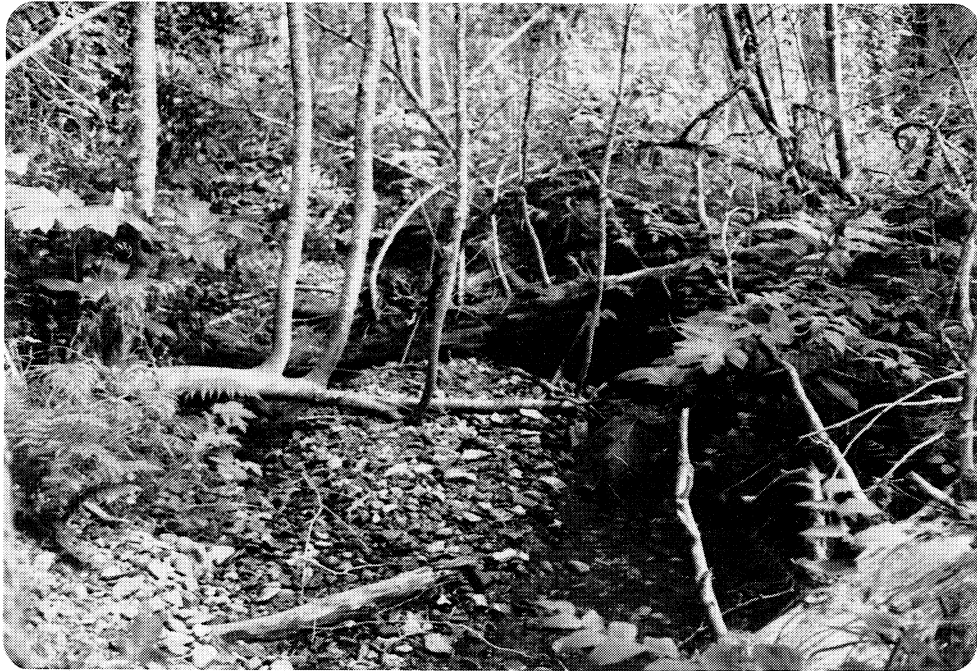
Photo 6: Typical section of Reach I, Tributary #3
to Ootsanee Lake.

Rainbow fry to 4.0 cm were observed to be quite abundant.

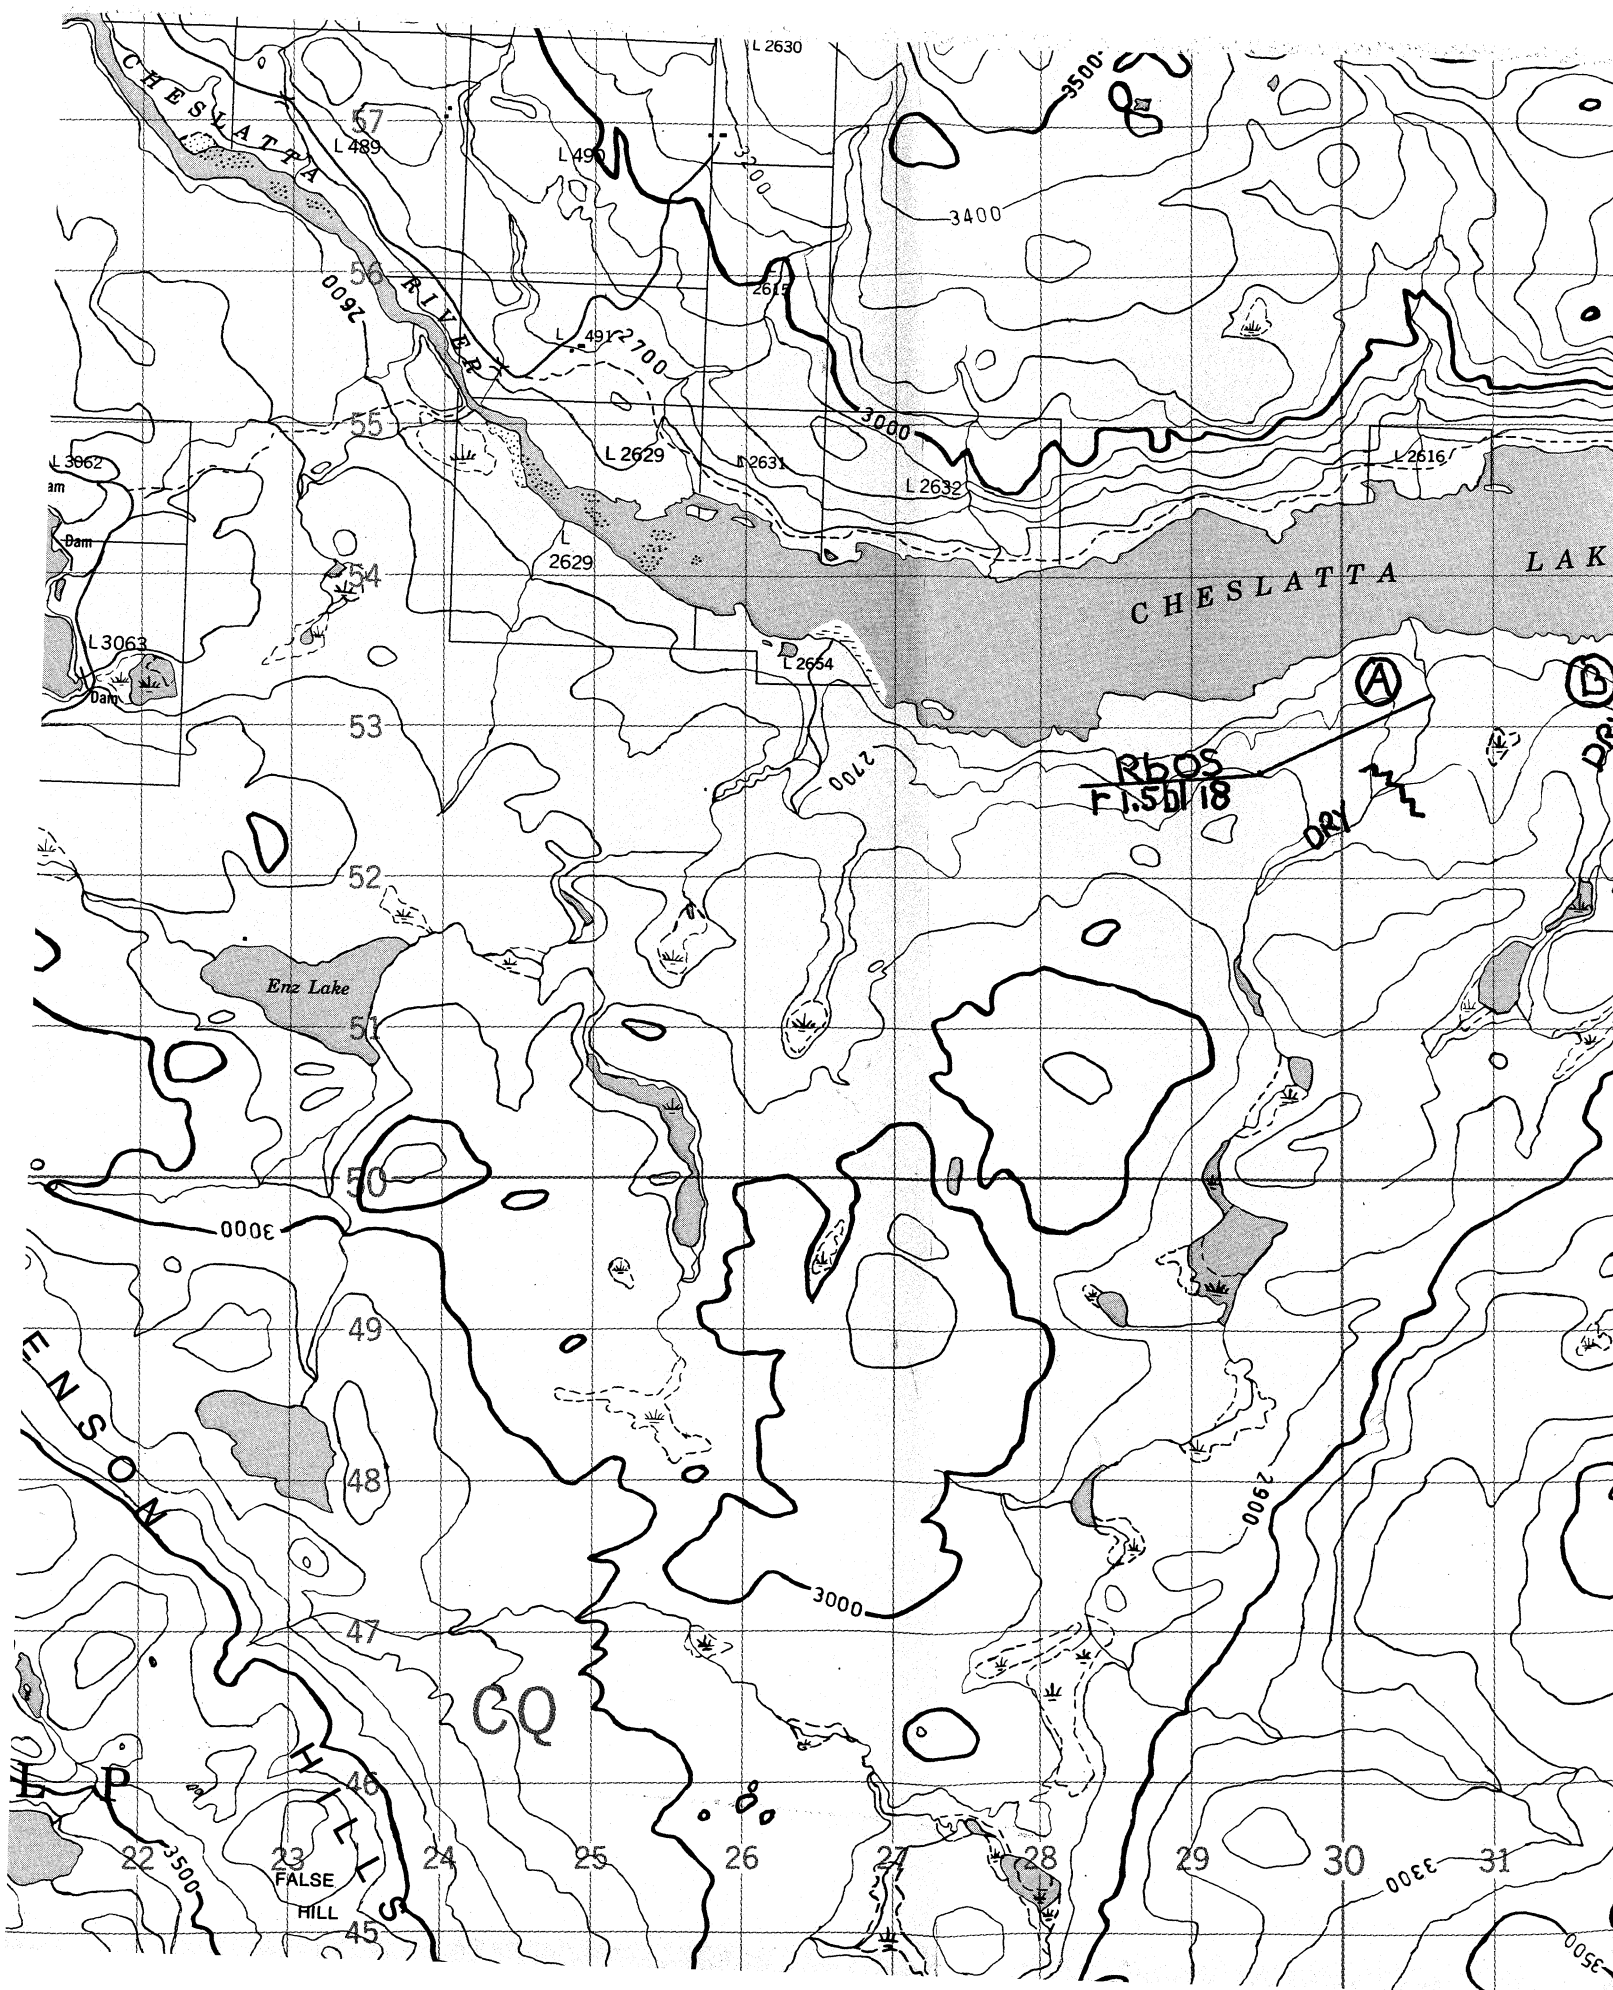
Aquatic Systems Mapping

1:50,000

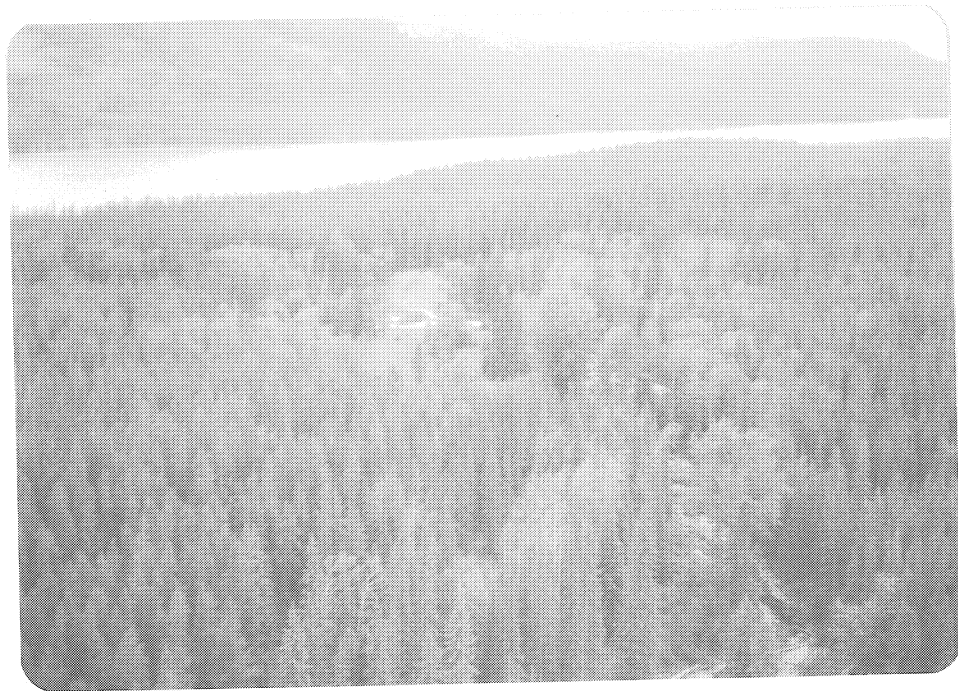
Photo 8: Aerial view of lower Tributary C illustrating large slumping bank (refer to map 4).

Overall stability throughout the drainage is very high. The only critically unstable section noted was a large slumping bank on lower Tributary C. The steep ridges above 1.0 Km on Tributary C and the loose banks of Tributary F were also noted as being potentially unstable but were presenting no problems at time of survey because of thick forest growth.

Land use should be well away from the steep ridges above 1.0 Km.
