## **WATER QUALITY MONITORING AGREEMENT**

### **WATER QUALITY ASSESSMENT OF Nechako River AT PRINCE GEORGE (1985 – 2004)**

L. G. Swain, P. Eng.

March 2007

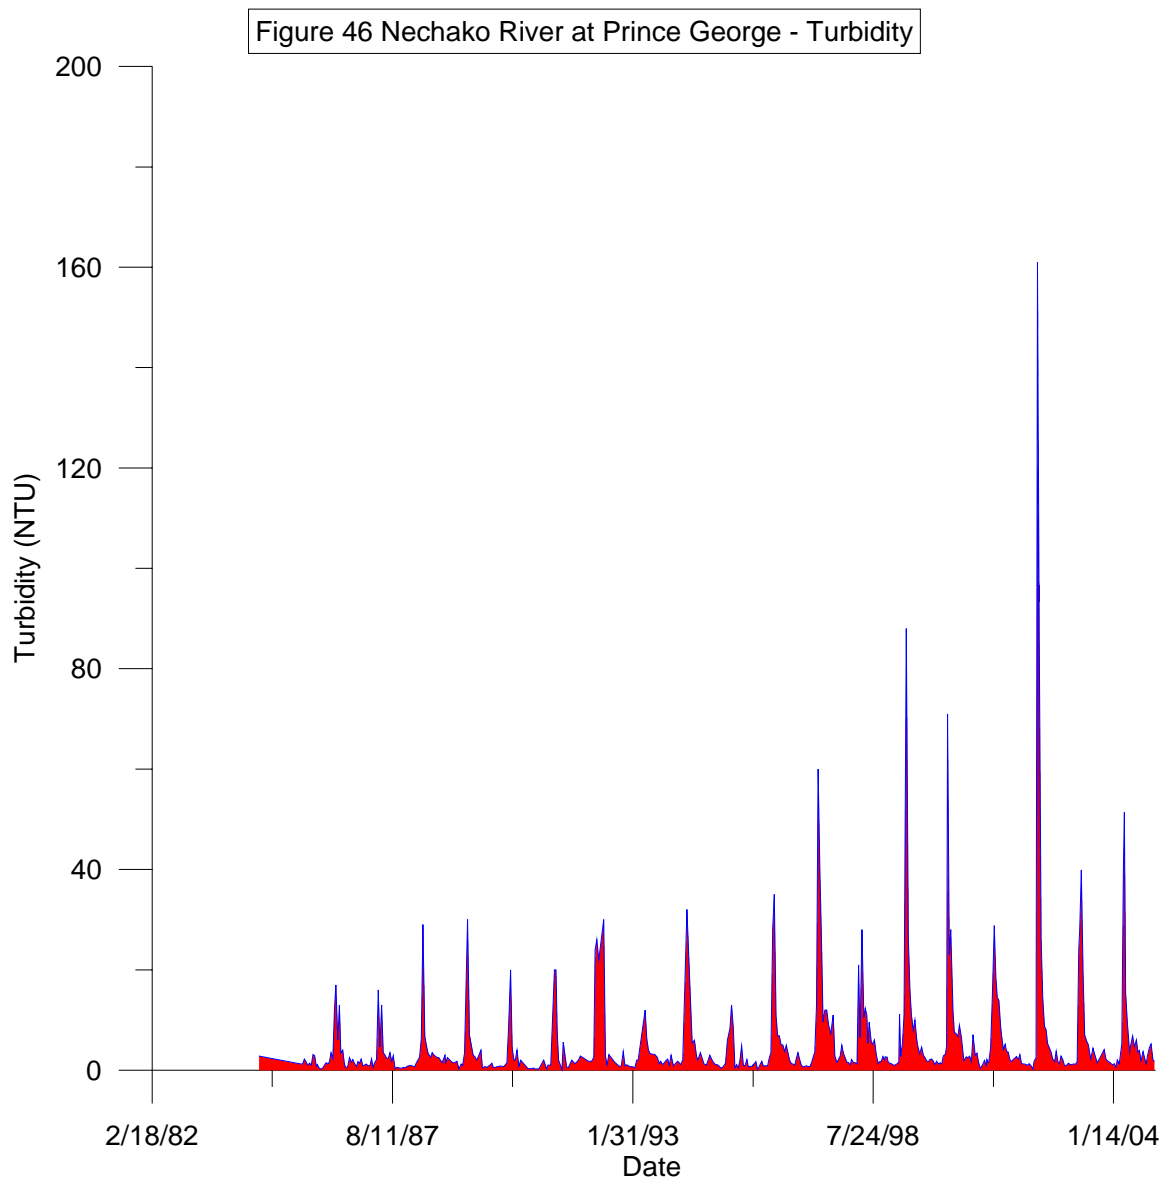
**Turbidity** values frequently exceeded both the drinking water guideline for health (1 NTU), and occasionally exceeded the aesthetic drinking water guideline (5 NTU) (Figure 46). This indicates that the water would require partial treatment (*e.g.*, filtration) plus disinfection before use as drinking water. Turbidity values appear to be increasing slightly over the years, although this needs to be confirmed using appropriate statistics. The strong correlation between flow and turbidity values is shown in figure 47.

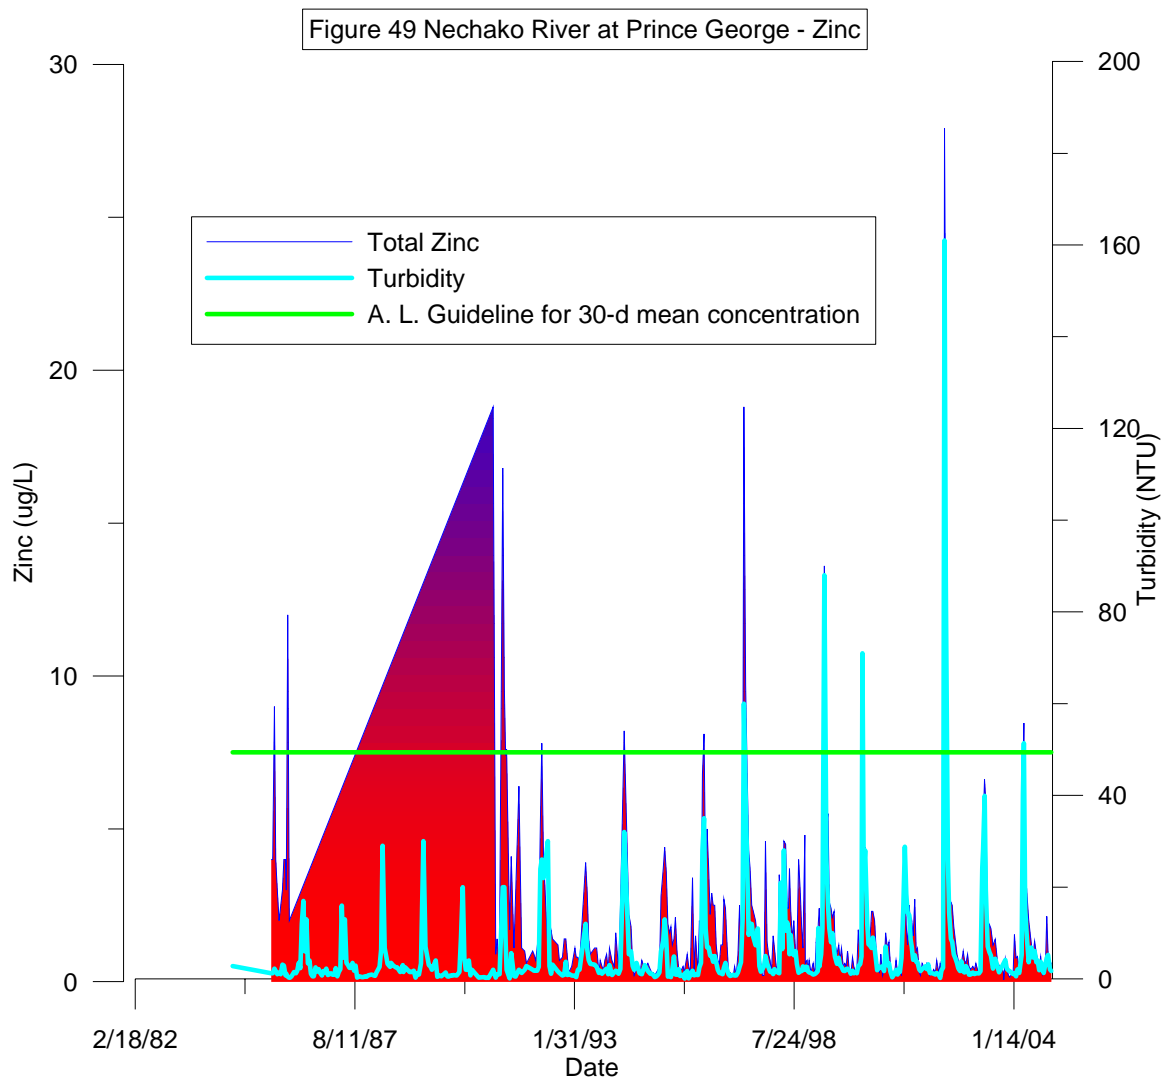
**Total zinc** levels appear to be correlated with turbidity events. The aquatic life guideline, which is hardness-dependent, is a 30-day average of  $\leq 7.5$  µg/L. Some individual total zinc values exceeded this guideline; however, these are correlated with turbidity (Figure 49), and therefore likely unavailable to aquatic life. It does not appear that zinc concentrations are changing over time at this site. There are no known anthropogenic sources of zinc in the Nechako River watershed.
