In the summer of 1996, Triton Environmental Consultants Ltd. was contracted by West Fraser Mills Ltd., Skeena Sawmills Division to perform reconnaissance level stream inventories of 17 watersheds within TFL 41 and FL A16820. This report describes the findings of the reconnaissance level stream inventory of the Upper Kemano River.

The Upper Kemano watershed is located ~ 30 km upstream from the mouth of the Kemano River at Kemano Bay. Three reaches in the Upper Kemano mainstem (Reaches 4 - 6) and four major tributaries were surveyed.

**Fish and Fish Habitat Inventory Project: TFL 41**

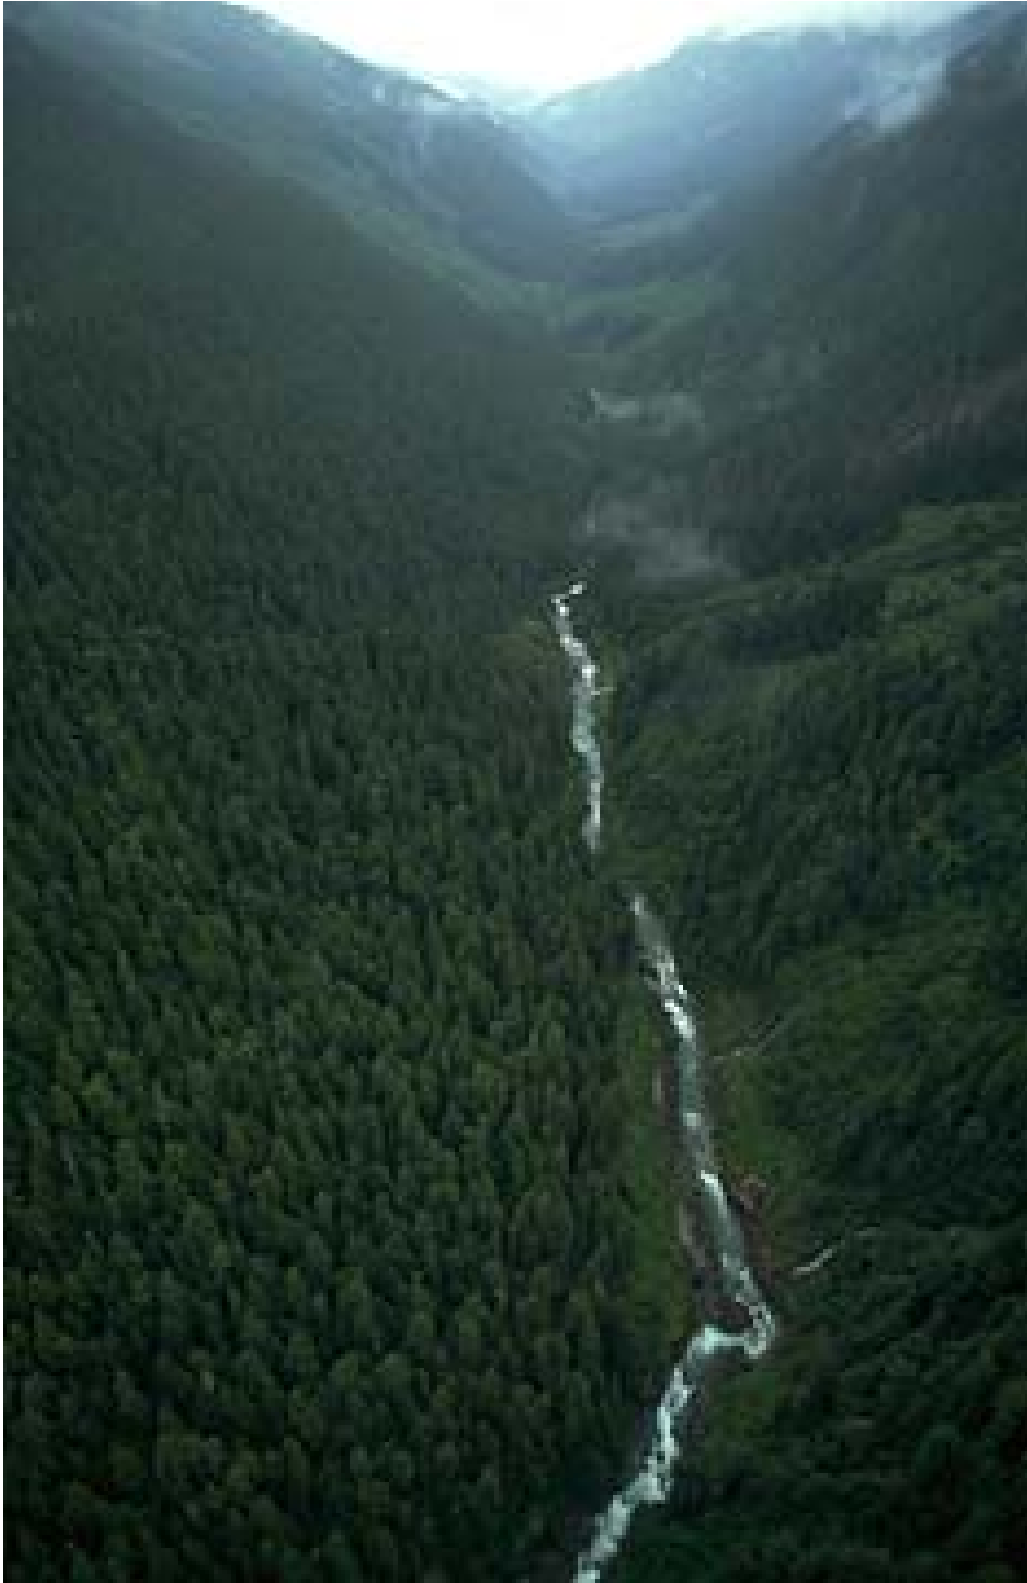
Photo 10:

R5	S7	Upstream view, above Site 7.	7-Sep-96	CD# 2292:	77
----	----	------------------------------	----------	-----------	----

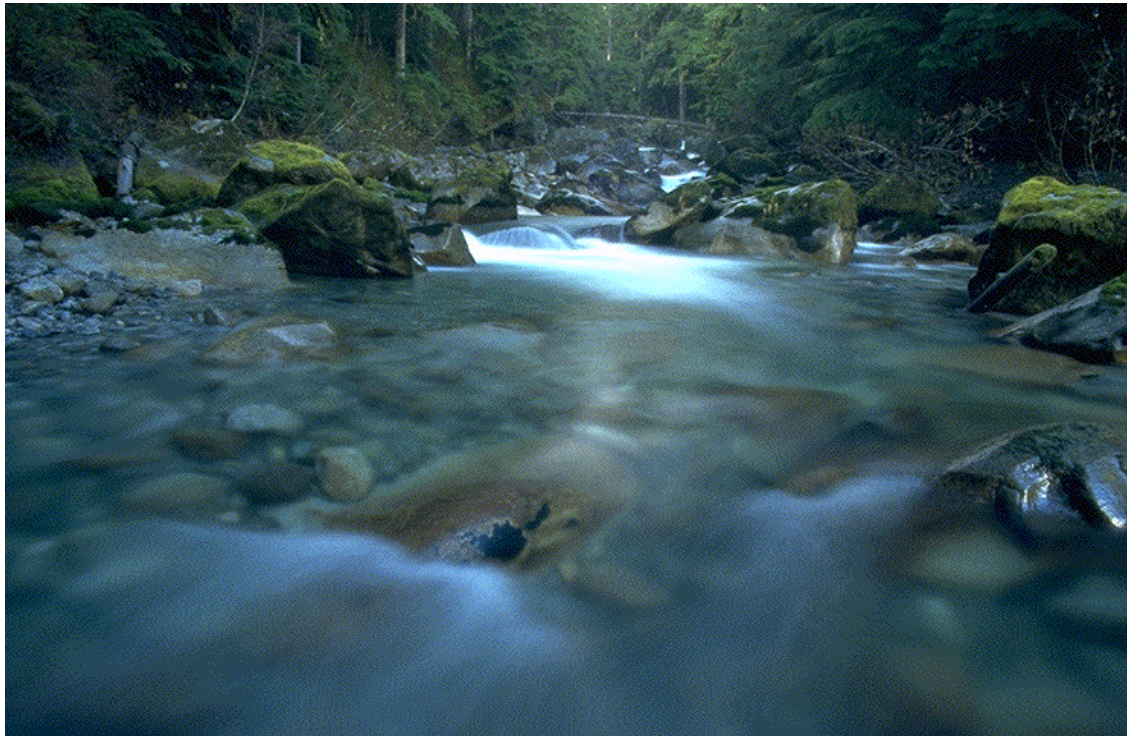
Photo 22:

R2	S11	Km31.7 trib.	25-Oct-96	CD# 2292:	59
----	-----	--------------	-----------	-----------	----
