Upper Cheslatta River Fish Stranding Hydrologic Assessment

Prepared for: **Cheslatta Carrier Nation and the Nechako Environmental Enhancement Fund**

Prepared by: **DWB Consulting Services Ltd. on behalf of Noot'senay Consulting Limited Partnership**

Date: May 5, 2025 | Noot'senay Consulting LP file No.: N2490-091 NE | Revisions: 0

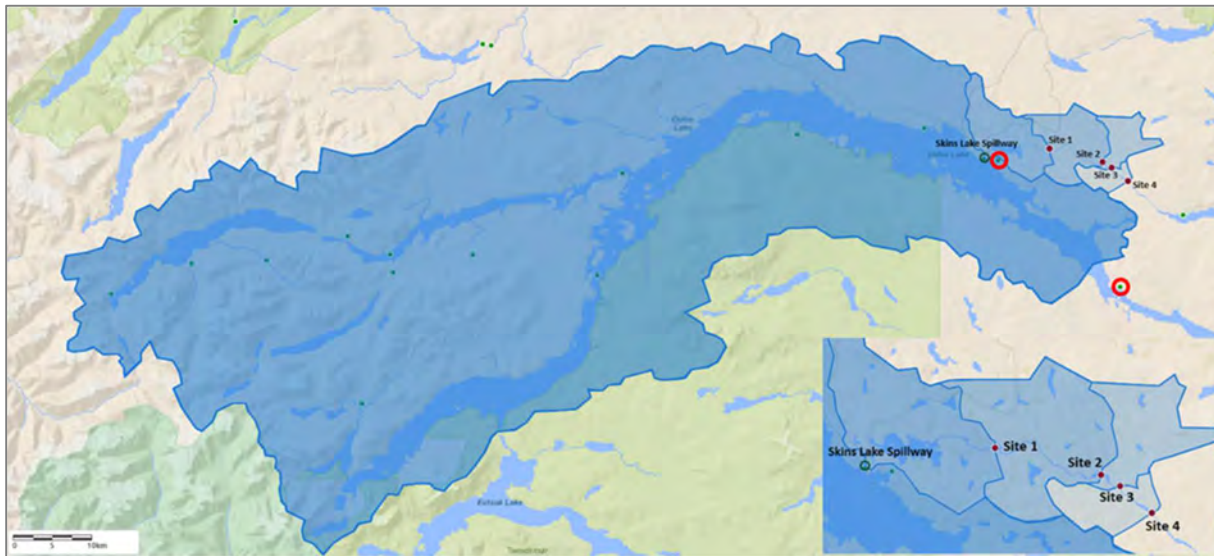
Figure 2: Catchment Area of the Cheslatta River Fish Stranding Study Sites (iMapBC, 2025)

The location of the Cheslatta River Fish Stranding Study sites and the corresponding catchment areas are 4,263km², 4,330km², 4,372km², and 4,390 km² for Sites 1, 2, 3, and 4 respectively (as presented in Table 1). The catchment area of the sites (as shown in Figure 2) were delineated using iMapBC (iMapBC, 2025). The highest elevation of the catchment area reaches 2,080m, while the lowest point at the site is approximately 800m above mean sea level. The catchment has an average gradient of about 1.0% and is primarily covered by mature forest, water bodies and high mountains. According to the BC Soil Map (BC Soil Tool, 2025), the majority of the region is characterized by type A and B hydrologic group soils, indicating predominantly moderately to well-drained soil types within the catchment.

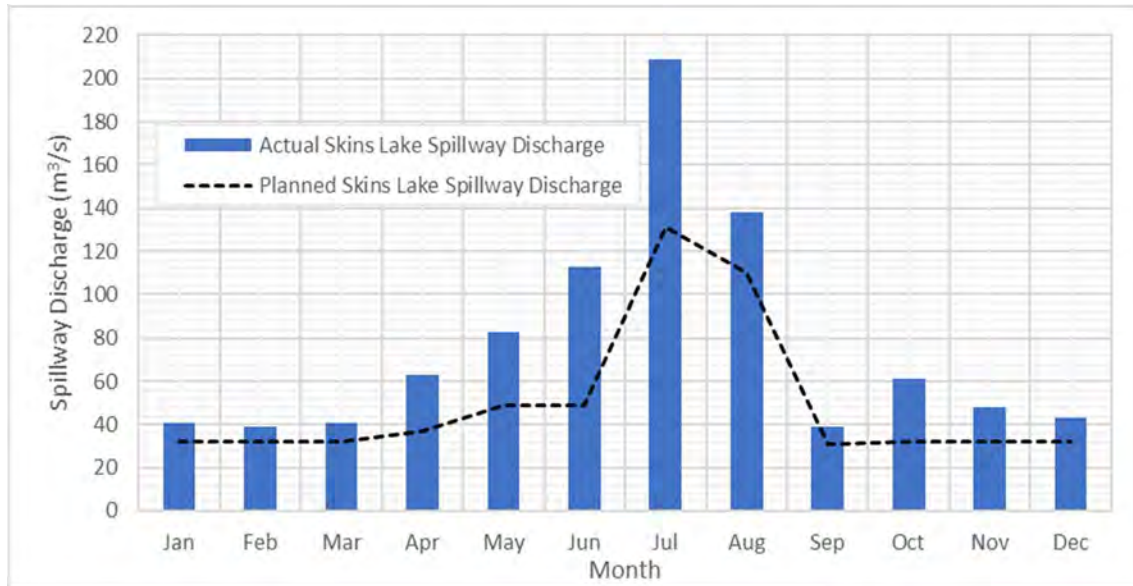
Figure 3: Mean Monthly Spillway Discharge from the Skins Lake Dam

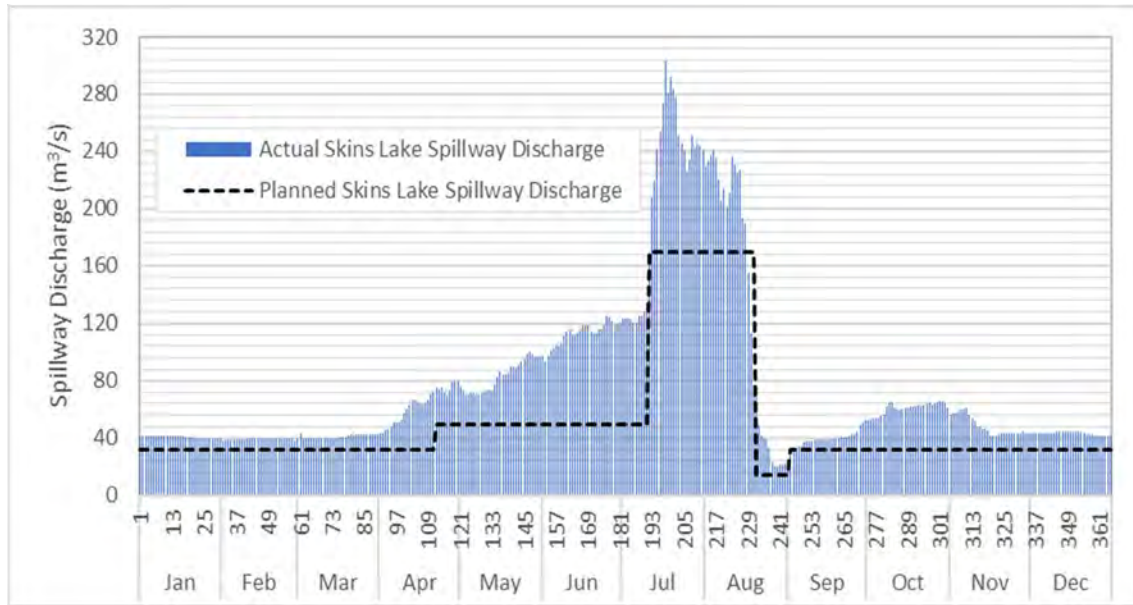
Figure 4: Mean Daily Spillway Discharge from the Skins Lake Dam

However, there were 183 days during which actual flows dropped below the minimum planned flow of $14.2\text{m}^3/\text{s}$. Such deviations could disrupt downstream ecosystems, particularly during critical periods for fish habitats, as low flows can increase the risk of fish stranding or reduce habitat availability. These deviations highlight potential challenges in aligning operational needs, such as reservoir filling, level management and hydropower requirements, with ecological objectives outlined in the ramping plan.

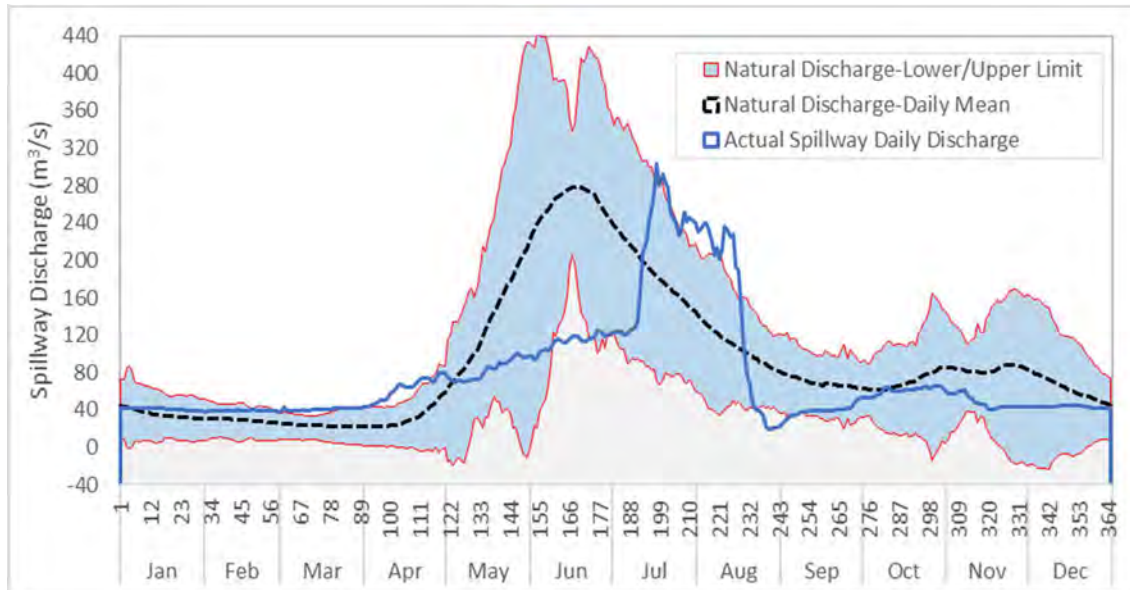
Figure 5: Actual/Regulated and Natural Daily Mean Discharge at the Spillway Location

A comparative analysis between the estimated natural daily mean discharge and the actual (regulated) measured discharge following spillway operations is presented in Figure 5. The figure also includes the upper and lower bounds of the natural discharge, corresponding to the 75th and 25th percentiles. As this graph is a representative comparison of natural vs regulated flow regimes, it does not include climate change factors or predictive models.

The comparison indicates that peak natural flows typically occur between mid-May and mid-July, whereas maximum spillway discharges are observed between mid-July and mid-August. This shift suggests that high natural inflows are retained within the reservoir during the early high-flow season, with releases occurring later once the reservoir has reached its maximum or desired operational storage capacity.

It should be noted, however, that the time periods for the natural and regulated discharge analyses differ. As described earlier, the natural discharge estimates are based on the 1930–1952 period, while the actual (regulated) discharge data covers the 1990–2024 period.

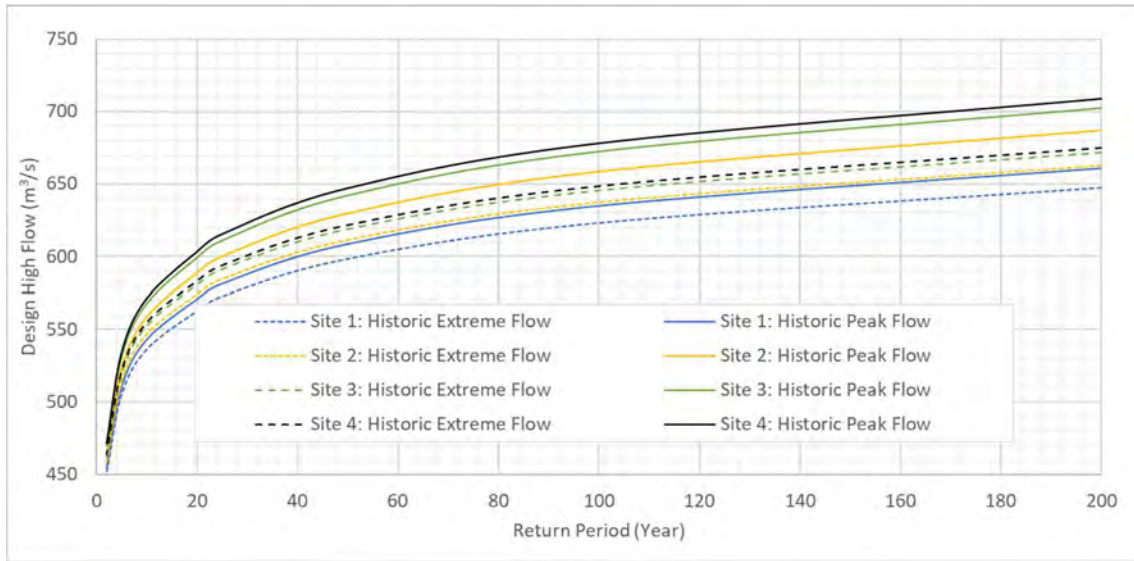
Figure 6: Comparison of Historic Flows at Cheslatta River Fish Stranding Sites

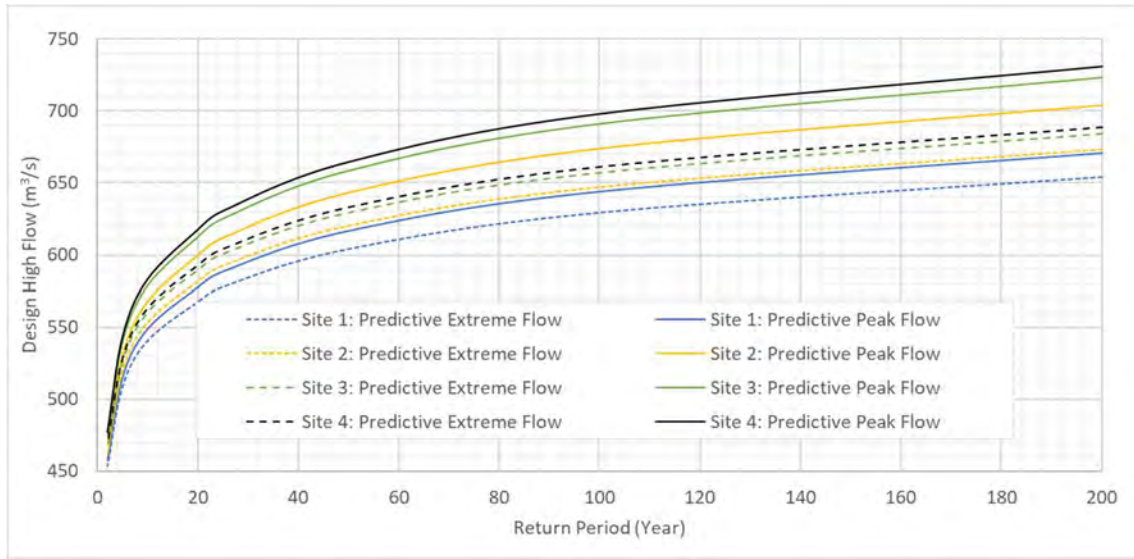
Figure 7: Comparison of Predictive Flows at Cheslatta River Fish Stranding Sites

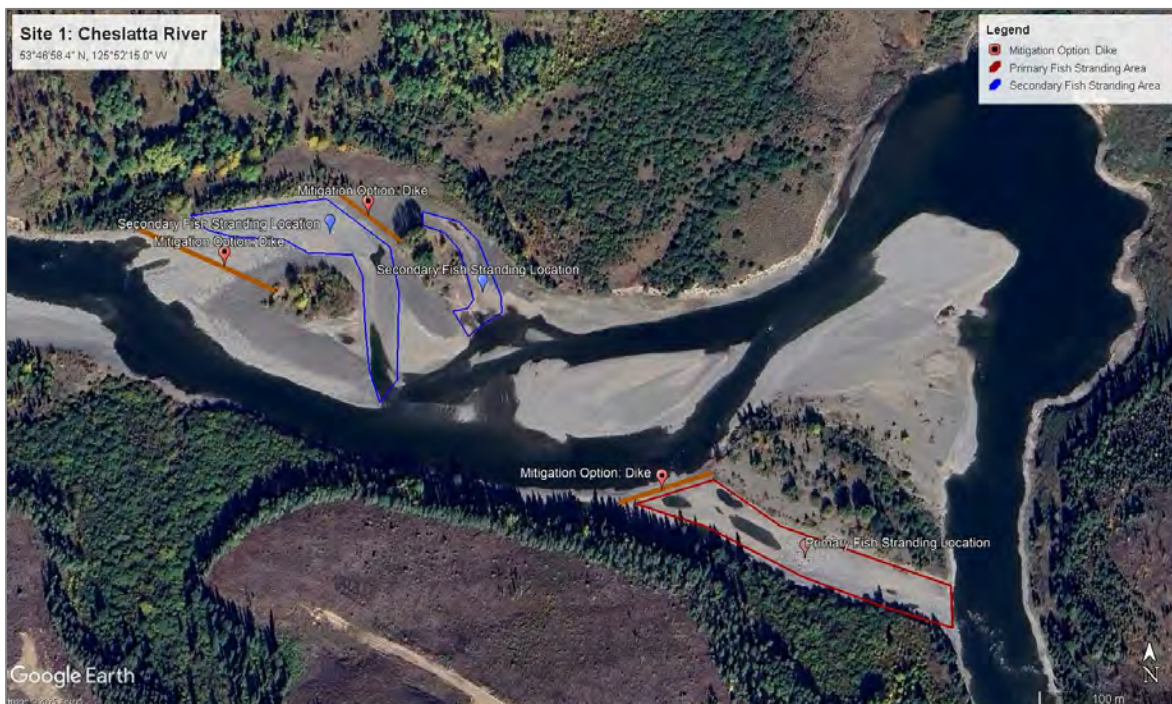
On the right bank, adjacent to a single island in the lower part of the site, a side channel approximately 30 meters wide was identified and is considered the primary fish stranding area. This channel contains six pools with varying sizes, where fish are at risk of stranding. The largest pool within this channel has an estimated surface area of approximately 250m², while the smallest measures approximately 12m².

On the left bank, two side channels were identified adjacent to two islands in the upper part of the site. This area is classified as a secondary fish stranding area. The side channels are approximately 20 meters and 12 meters wide, respectively, and each contains three distinct pools where the potential for fish stranding exists. The largest pool within this area covers an estimated surface area of 500m², while the smallest spans approximately 4m².

Figure 17: Annotated Map of Potential Fish Stranding Locations at Site 1 (Google Earth, 2025)

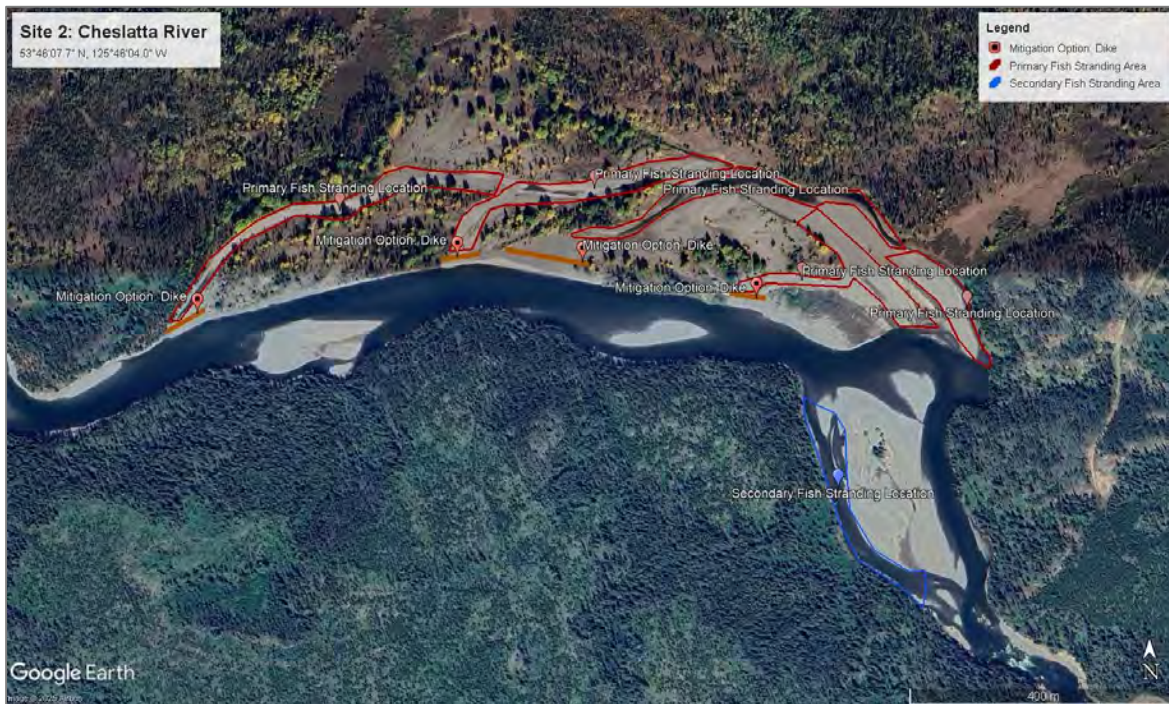
On the left bank, four side channels were identified in proximity to three islands, with approximate widths of 9 meters, 40 meters, 20 meters, and 11 meters. These side channels are considered the primary fish stranding area for this site. Each channel contains multiple pools where fish stranding may occur. The largest of these pools covers an estimated surface area of approximately 1,700m², while the smallest measures about 100m².

On the right bank, no permanent side channels were observed; however, morphological changes in the river channel suggest the potential for side channel formation, which may increase the risk of fish stranding in this area.

Figure 18: Annotated Map of Potential Fish Stranding Locations at Site 2 (Google Earth, 2025)

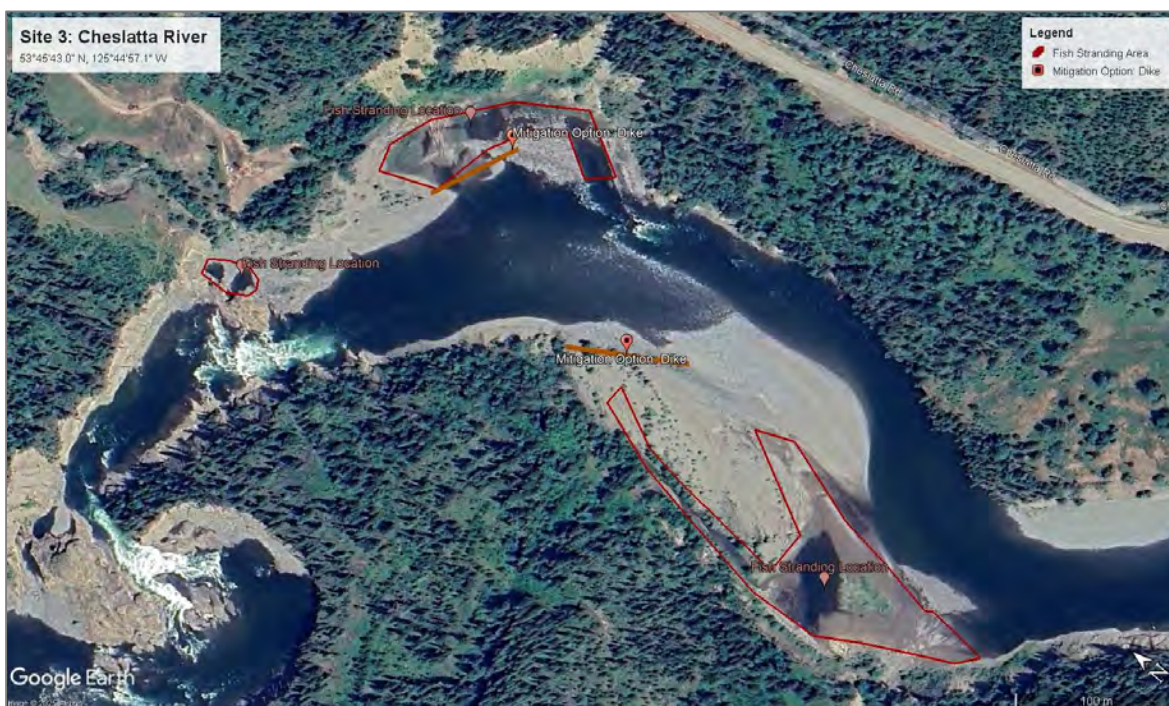
On the left bank, a side channel was found at the downstream end of the site, ranging in width from 6 to 10 meters. This channel contains four pools where fish stranding may occur. In addition, two isolated pools were observed adjacent to a waterfall at the left bank. The largest pool in the area spans an estimated surface area of approximately 250m², while the smallest measures around 30m².

On the right bank, a narrow side channel approximately 3 meters wide was identified, containing a single large pool with an estimated surface area of approximately 800m².

The presence of bedrock and the intricate nature of the channel downstream of the waterfalls increases the complexity and considerations required to develop an effective mitigation design for this site.

Figure 19: Annotated Map of Potential Fish Stranding Locations at Site 3 (Google Earth, 2025)

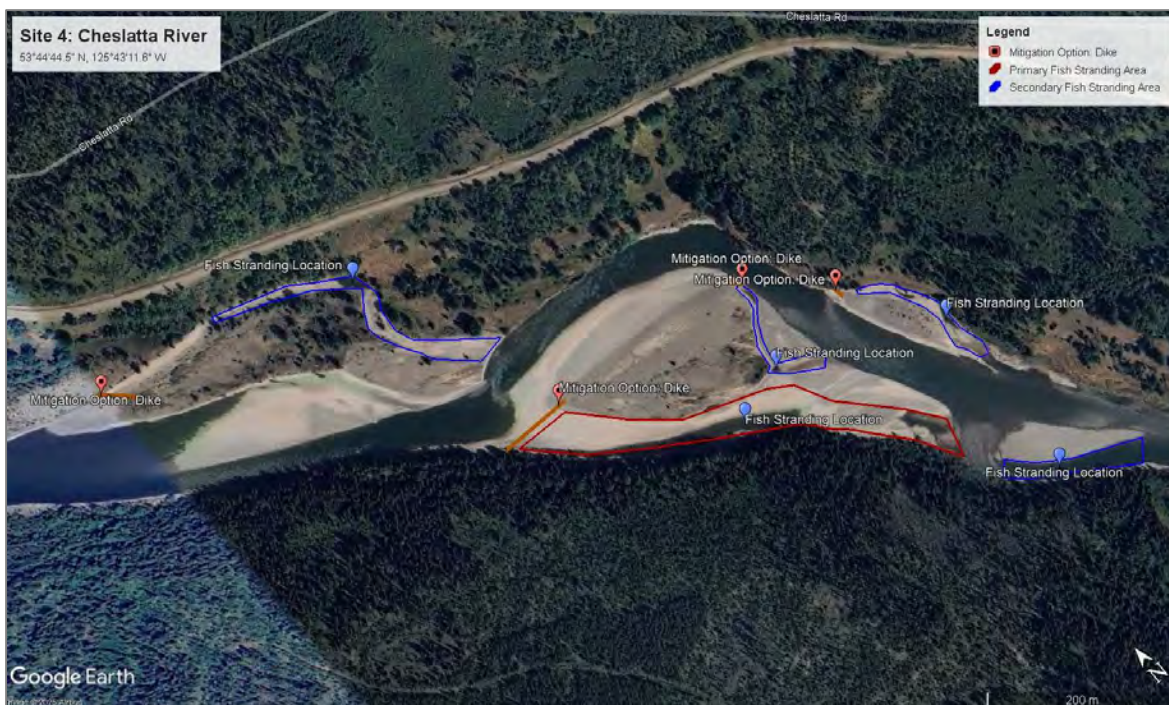
On the left bank, two side channels were identified- one located at the upstream part of the site and the other at the downstream end. These channels are approximately 7 meters and 9 meters wide, respectively. Each channel contains two discrete pools where fish stranding is likely to occur. The largest pool covers an estimated surface area of approximately 180m², while the smallest spans about 30m².

On the right bank, similar to the observations at Site 2, no permanent channels are currently present. However, morphological changes in the riverbed suggest the potential formation of two channels, thereby increasing the risk of fish stranding in this area. Based on the observed morphology, the area within the red polygon is considered a primary area of potential fish stranding due to its susceptibility to flow isolation during low flow conditions.

Figure 20: Annotated Map of Potential Fish Stranding Locations at Site 4 (Google Earth, 2025)
