NOOT'SENAY

CONSULTING LP

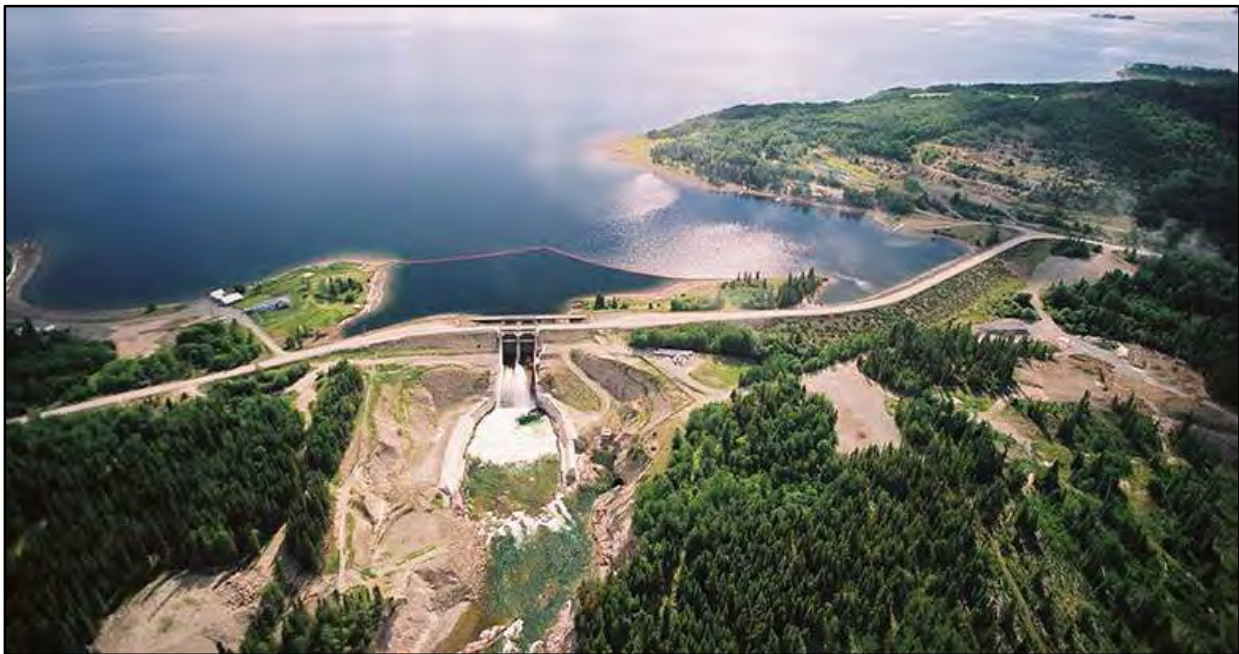
Figure 1. Skins Lake Spillway separating the Nechako Reservoir and the Cheslatta River (Credits: Visit Burns Lake, 2024).

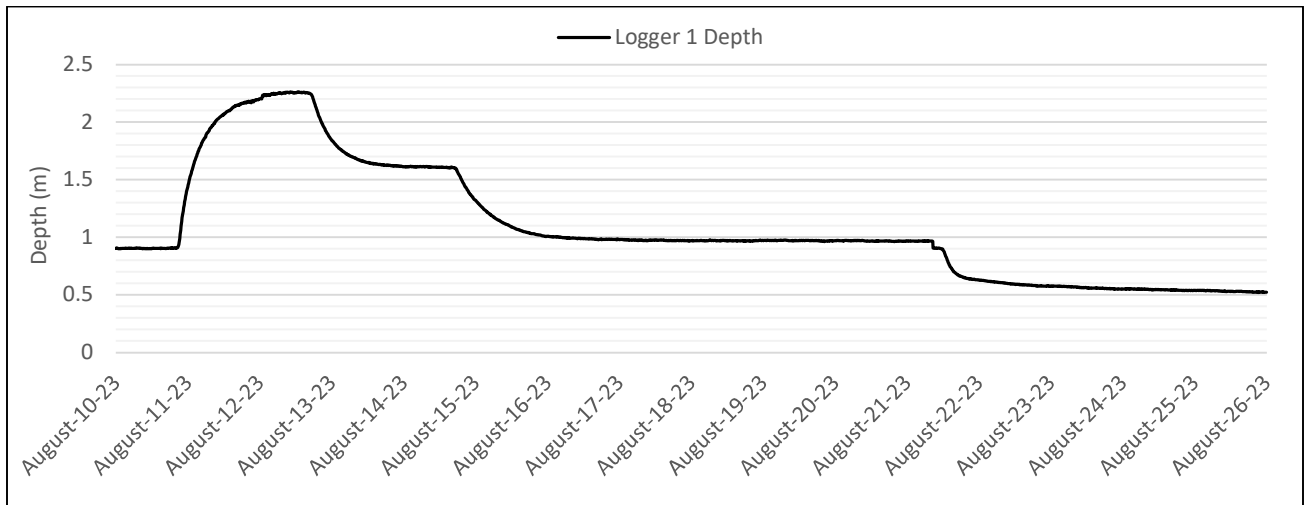
Figure 8. Variation in depth observed at the Site 1 logger location

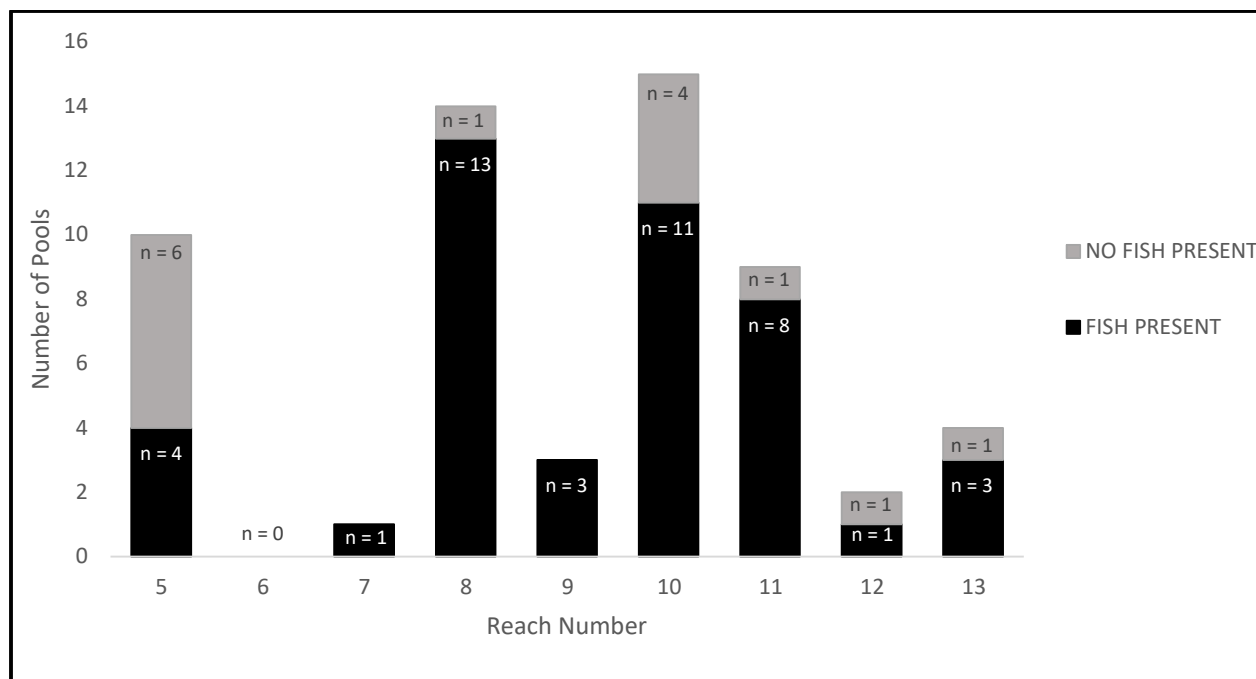
Figure 11. Number of pools with fish presence and absence within each assessed reach.

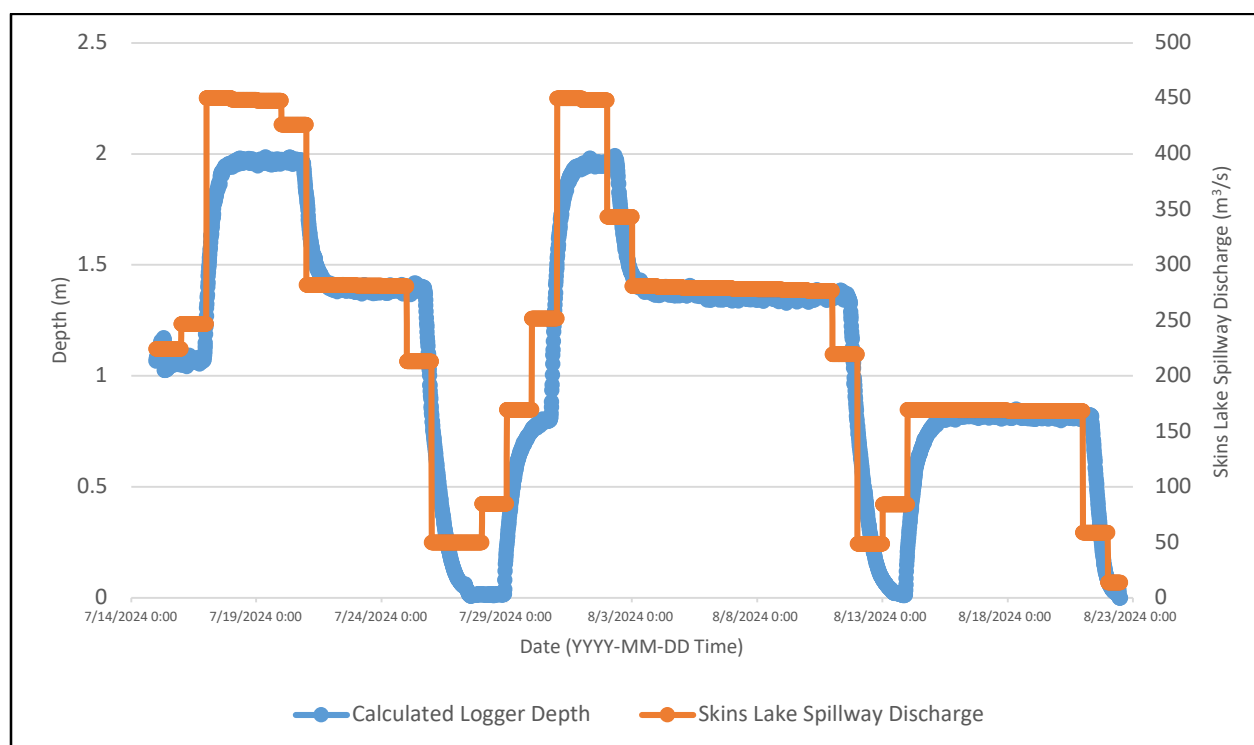
Figure 13. The calculated depth data from Logger 1 compared to the Skins Lake Spillway discharge values.

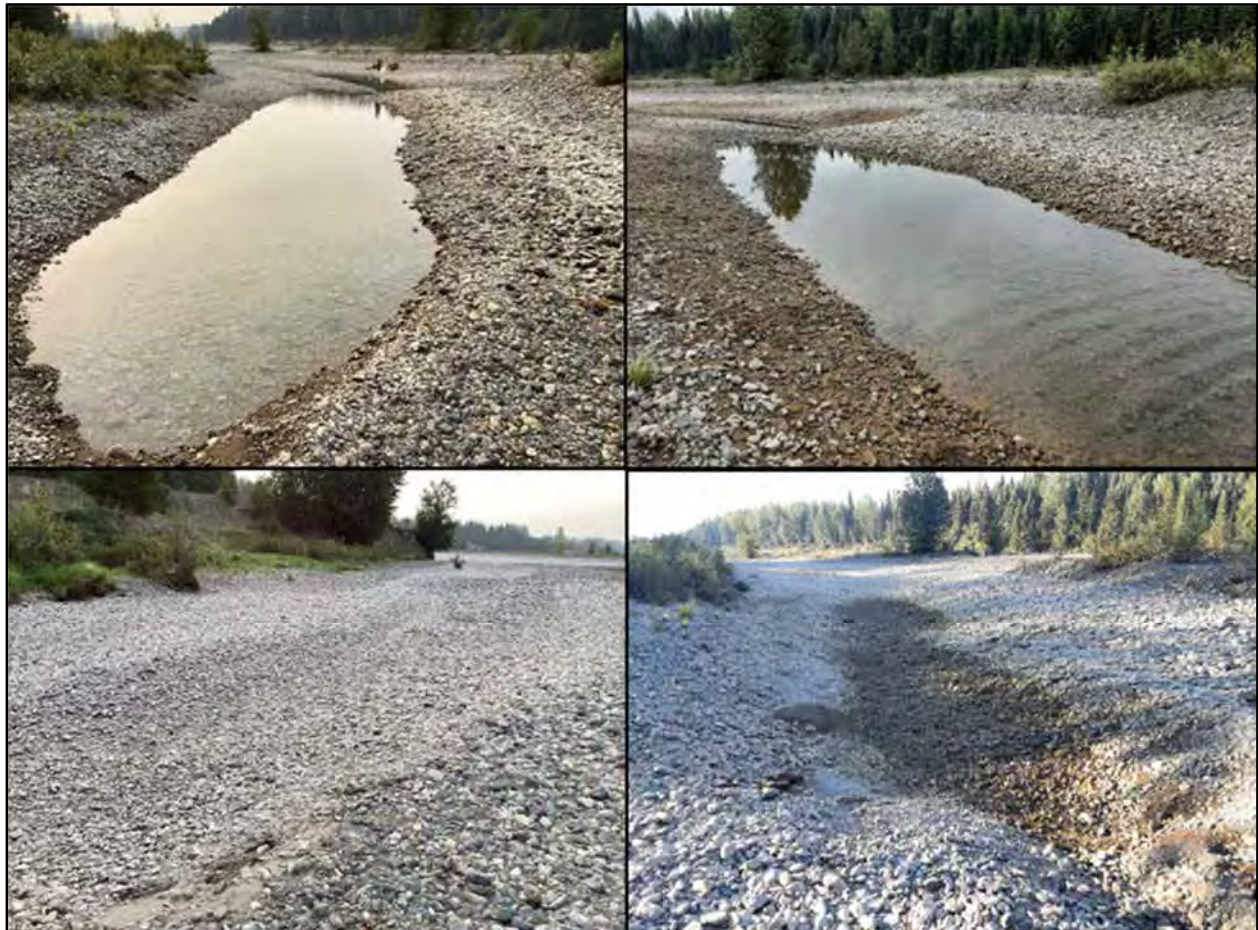
Figure 15. Comparison of Stranding Pool (Pool 998) between 2023 (Left) and 2024 (Right). The top images were captured one day after gate closure at the Skins Lake Spillway, while the bottom images were taken two days following gate closure.

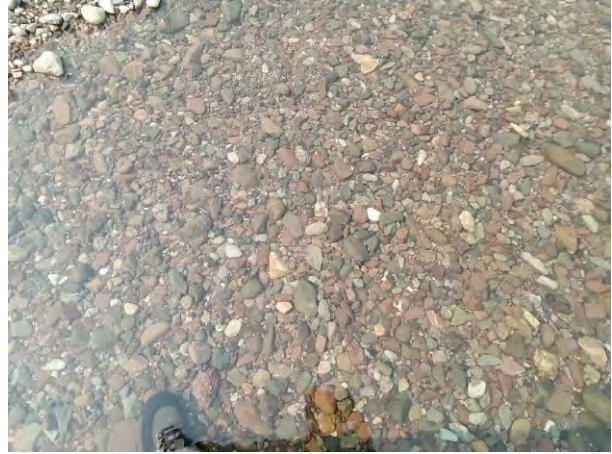
Photo 14. Typical substrate and depth observed during assessment at Pool 6 (Photo date: August 21, 2023).

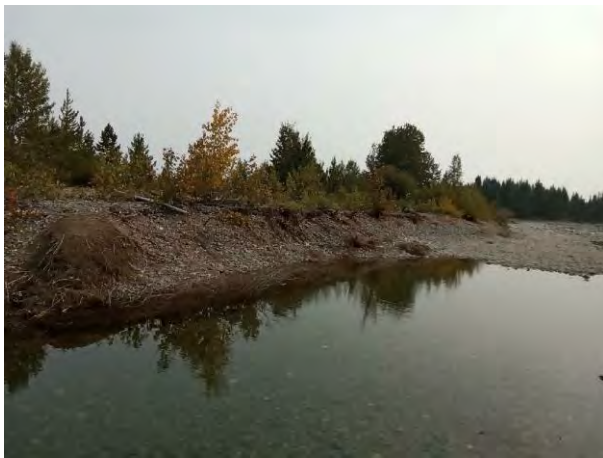
Photo 15. Overview of Pool 7 (Photo date: August 21, 2023).

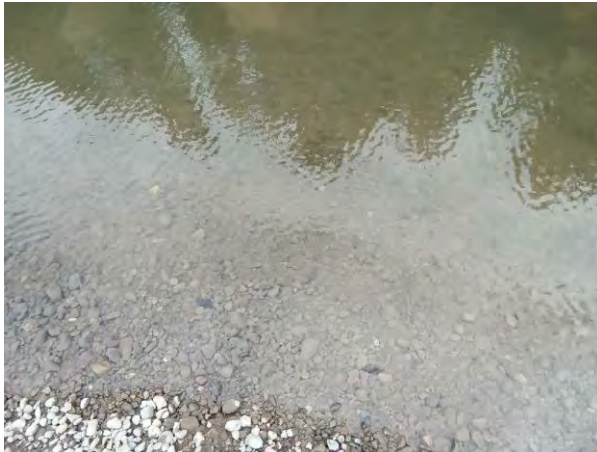
Photo 119. Decreased water quality and visibility noted at Pool 996 (Photo date: September 7, 2023).

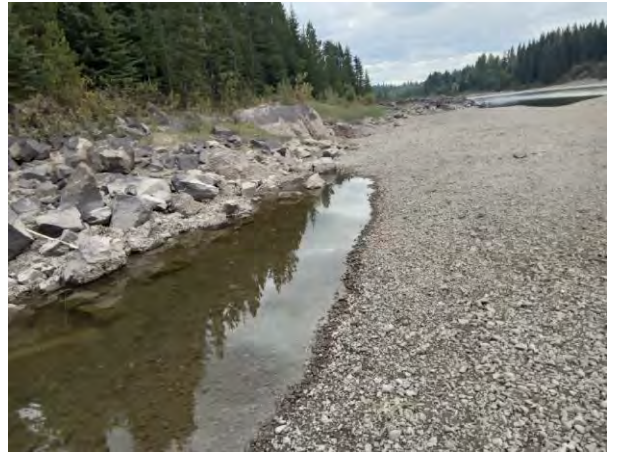
Photo 120. Overview of the distance to the mainstem from Pool 996. Increased algal growth on boulders noted (Photo date: September 7, 2023).

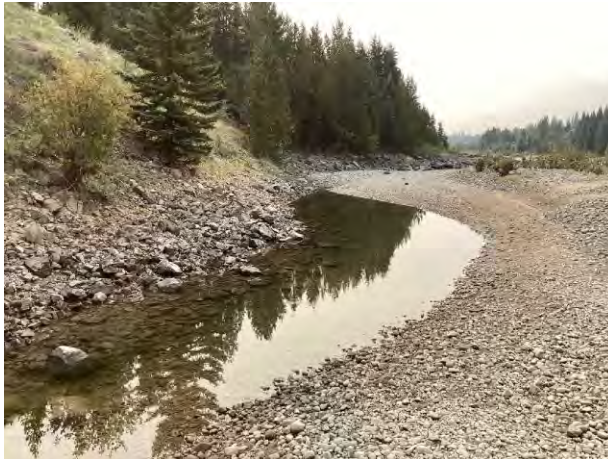
Photo 121. Overview of Pool 997 (Photo date: August 23, 2023).

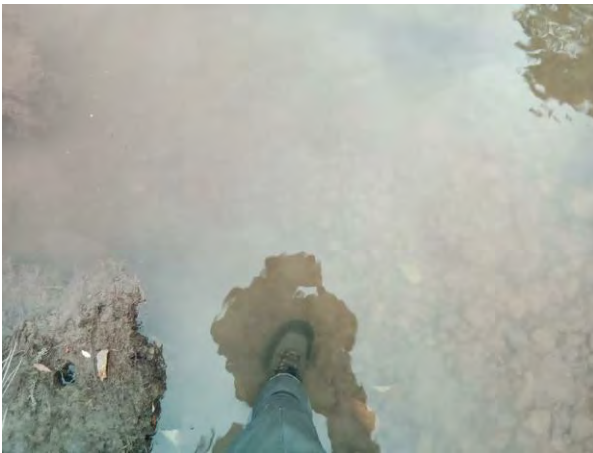
Photo 125. Decreased water quality and visibility noted at Pool 999 (Photo date: September 7, 2023).

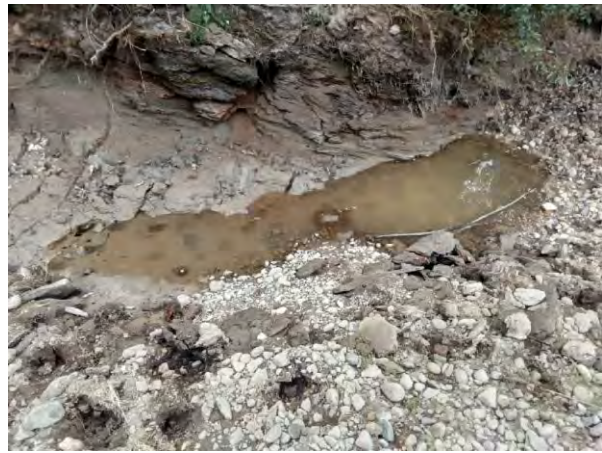
Photo 126. Additional (not recorded) stranding pool created at Pool 999 site during water level recession (Photo date: September 7, 2023).

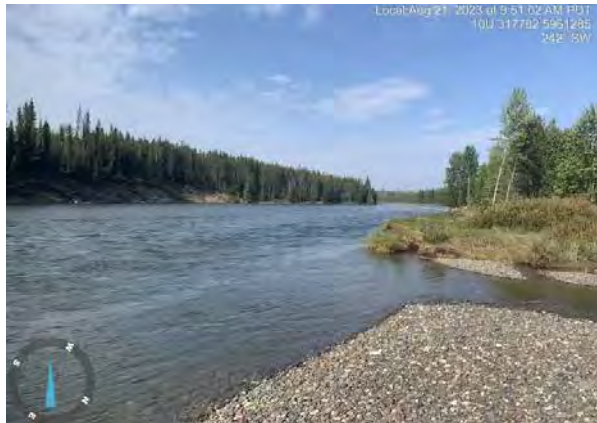
Photo 131. Standard photo point (#1) on August 21st showing the pre-STMP flow conditions along the Cheslatta River (Section 8).

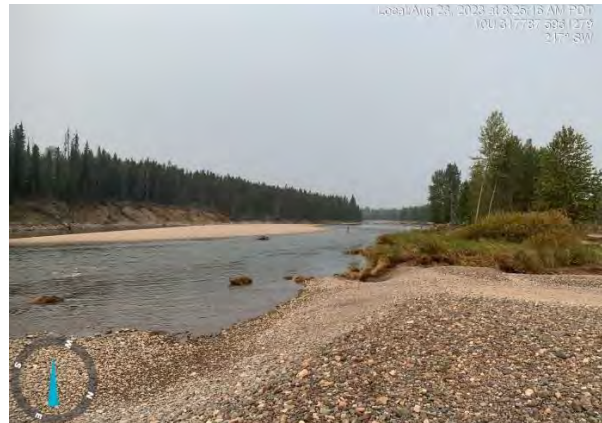
Photo 132. Standard photo point (#1) on August 23rd showing the post-STMP flow conditions along the Cheslatta River (Section 8).

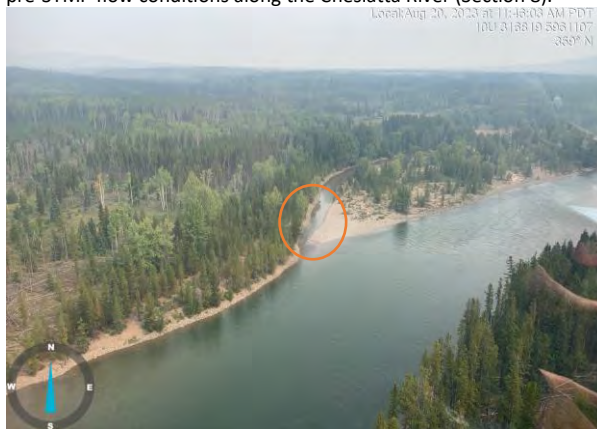
Photo 133. Potential isolated pool site identified during the August 20th aerial reconnaissance survey (Section 8). Orange circle outlines the location of the isolated pool shown in Photo 134.
