2024-2025 Nechako White Sturgeon Habitat Restoration

Angie Coulter and Steve McAdam

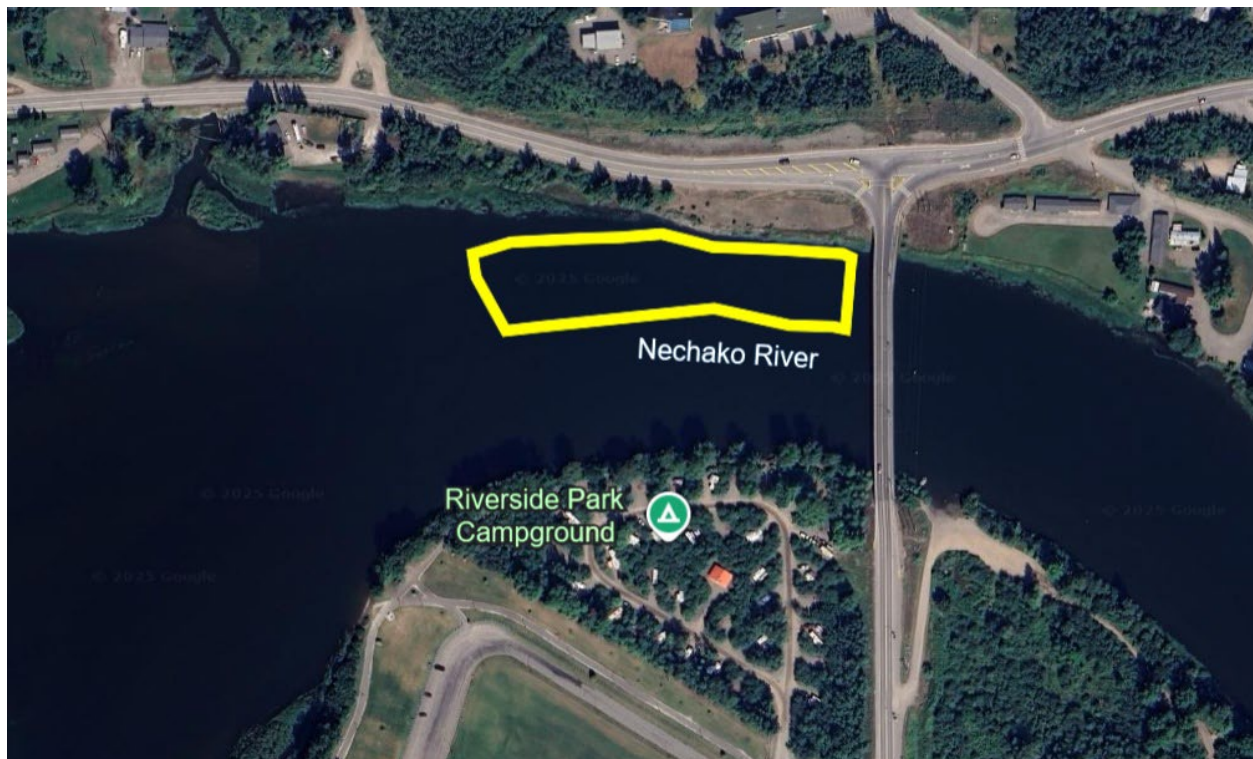
Figure 1. The Lower Patch restoration site in the Nechako white sturgeon core spawning area. The yellow polygon denotes the 40 m x 200 m gravel and cobble pad installed in 2011.

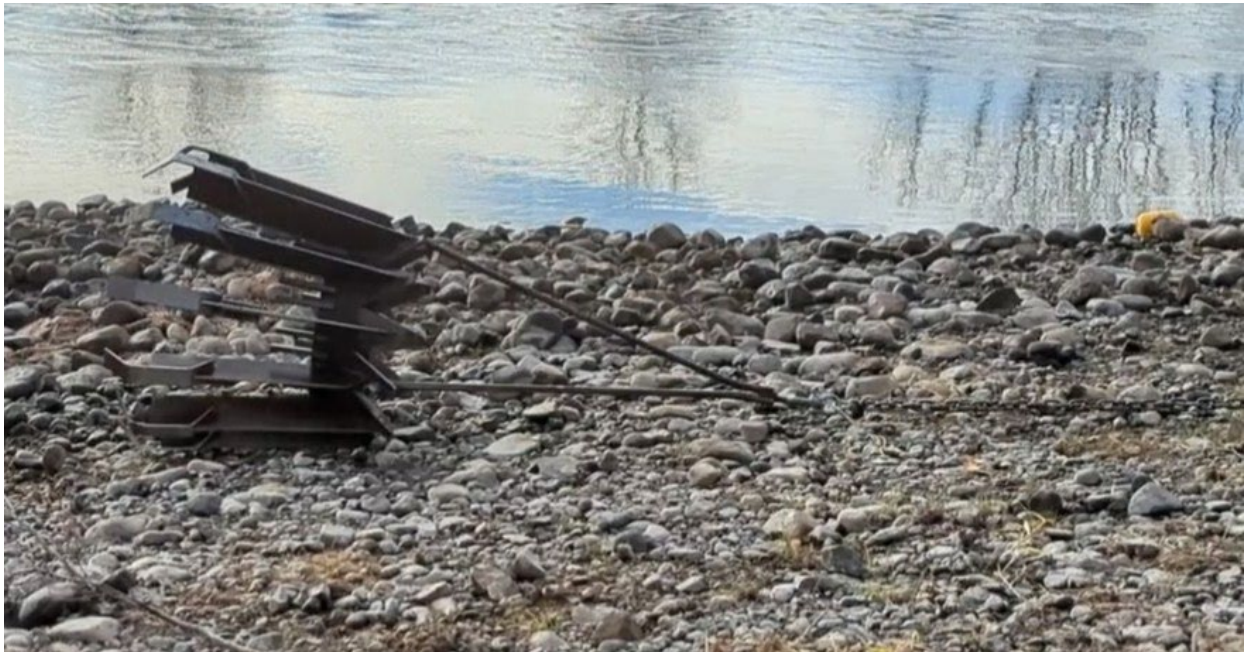
Figure 2. Tubescreen substrate sorting tool on the bank of the Nechako River at the Lower Patch white sturgeon spawning site.

The goal of the October 2024 field testing was to evaluate the effectiveness of the previously designed tubescreen (Figure 2), under realistic conditions of the Nechako white sturgeon spawning habitat. Our expectation was that the tubescreen would be effective within mainstem habitats. However, it was important to confirm this, as well as any additional

The tubescreen was tested on October 29th at the Lower Patch gravel restoration site, a high use site for sturgeon spawning. Water depth was approximately 1.5 m. The tubescreen was pulled over near-shore habitats using a shore-based excavator that held a long bar within the excavator claws. The tubescreen was pulled in an upstream direction by rotating the excavator with its arm holding the tow-bar extended. The use of 6 m of chain between the tow-bar and the tubescreen as well as the downward angle of the tow-bar allowed the tubescreen to be towed horizontally (i.e. running across the riverbed) rather than causing the tubescreen to tilt upward. After pulling the tubescreen over the test area, it was fully lifted out of the water by the excavator and repositioned at the downstream end of the test section to be pulled upstream again. Each of these ‘pulls’ affected an arc that was about 20 cm wide (due to the rounded nature of the tubescreen) and 4 m long. This meant that multiple ‘pulls’ were required to achieve one cleaning ‘pass’ over the test section. The initial goal was to test the effectiveness of 2, 4, 6, and 8 passes over 2 m x 4 m treatment patches. The effectiveness of this pilot treatment was monitored using an underwater camera deployed from the tender boat.

When initial pulls showed that the tubescreen was not effectively cleaning the test areas, the treatment plan had to be modified. The test area was largely comprised of compacted cobble substrate embedded in sand and small gravel. Our observation in near shore tests showed that the tubescreen teeth could not ‘engage’ with the cobble dominated substrate.

Although some cobble grains were turned over, most grains were simply pushed by the tubescreen. When the tubescreen encountered cobble that it could not push, the tubescreen rolled laterally rather than penetrating the substrate. The cleaning effects demonstrated in the 2022 tests were therefore not reliably repeatable at this location. After inspecting the 2022 field study site, it was clear that substrate at that location was less compacted than in the Lower Patch, which explained the more limited effectiveness of the October 2024 tests.

In response to the poor initial performance of the tubescreen within actual spawning habitat, we modified the setup for onshore testing by adding rock anchors upstream from the tubescreen to scarify the substrate in the tubescreen path. The rock anchor successfully scarified the substrate when suitably oriented, which allowed the tubescreen to 'engage' with the substrate and provide the desired sorting effect. Using a smaller rock anchor provided the best effect, apparently due to the width of the scarified furrow caused by the narrow spacing of the anchor tines. The rounded edge of the tubescreen teeth engaged fairly well with the disturbed substrate between the two furrows created by the anchor tines. When successfully deployed, this arrangement allowed loose unconsolidated material to move through the tubescreen in a manner similar to the 2022 tests. Unfortunately, the rounded shape of the tubescreen allowed it to roll laterally when the rock anchor faced resistance, and rolling caused the rock anchor to 'disengage' from the substrate (e.g. it would lie on its edge and push surface cobbles rather than scarifying). Despite limitations, using these two tools in combination appeared to be effective when applied to a restricted area (~1 hour of application). Understanding the limitations of the tubescreen, and particularly its tendency to roll laterally in response to heavily embedded substrates, also helped to inform the design of alternate tools.

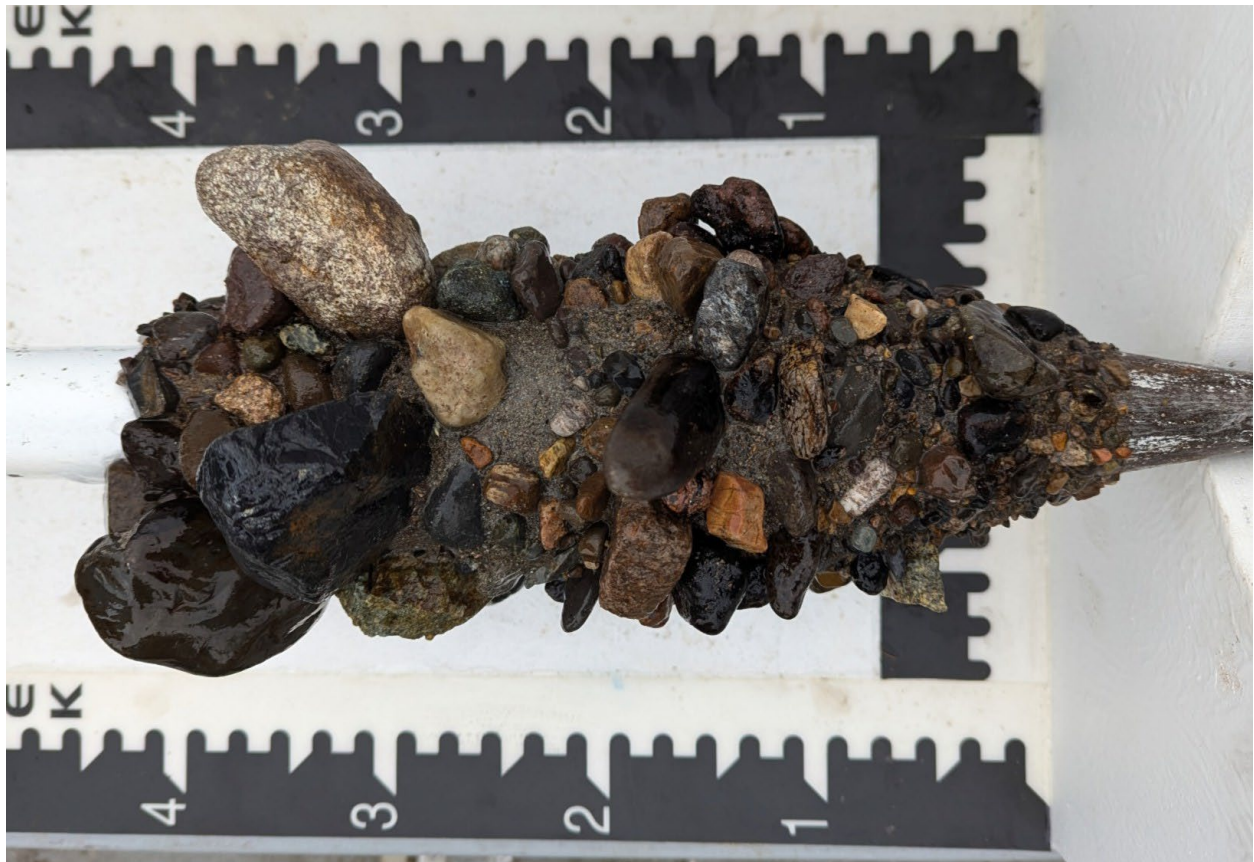
Figure 3. Freeze core sample of the ambient substrate in the Lower Patch restoration site before testing of the tubescreen sediment sorting tool. The large gravel and cobble layer installed in 2011 has persisted (left), but the interstitial spaces are infilled with fine sediment.

Monitoring was conducted under the direction of Northwest Hydraulic Consultants (NHC) using underwater camera monitoring and freeze core sampling. Freeze core sampling is a technique to sample the substrate below the riverbed surface. A hollow pipe is inserted 30 cm into the substrate and liquid nitrogen is poured down the pipe to freeze the surrounding substrate to the pipe. The pipe is then pulled to the surface to observe the substrate layers. Preliminary site surveys indicate that the large material placed at the Lower Patch restoration site in 2011 are still present, but the interstitial spaces are filled with fine sediment (Figure 3). After 1 hour of treatment with the modified tubescreen, the conditions in the top two layers of substrate were improved (Figure 4). The large cobble and gravel were brought to the surface and the sand was deposited below, creating clean habitat for white sturgeon egg and larval rearing. Those results were consistent with the findings from the 2022 pilot study (Sea to Sky 2022).

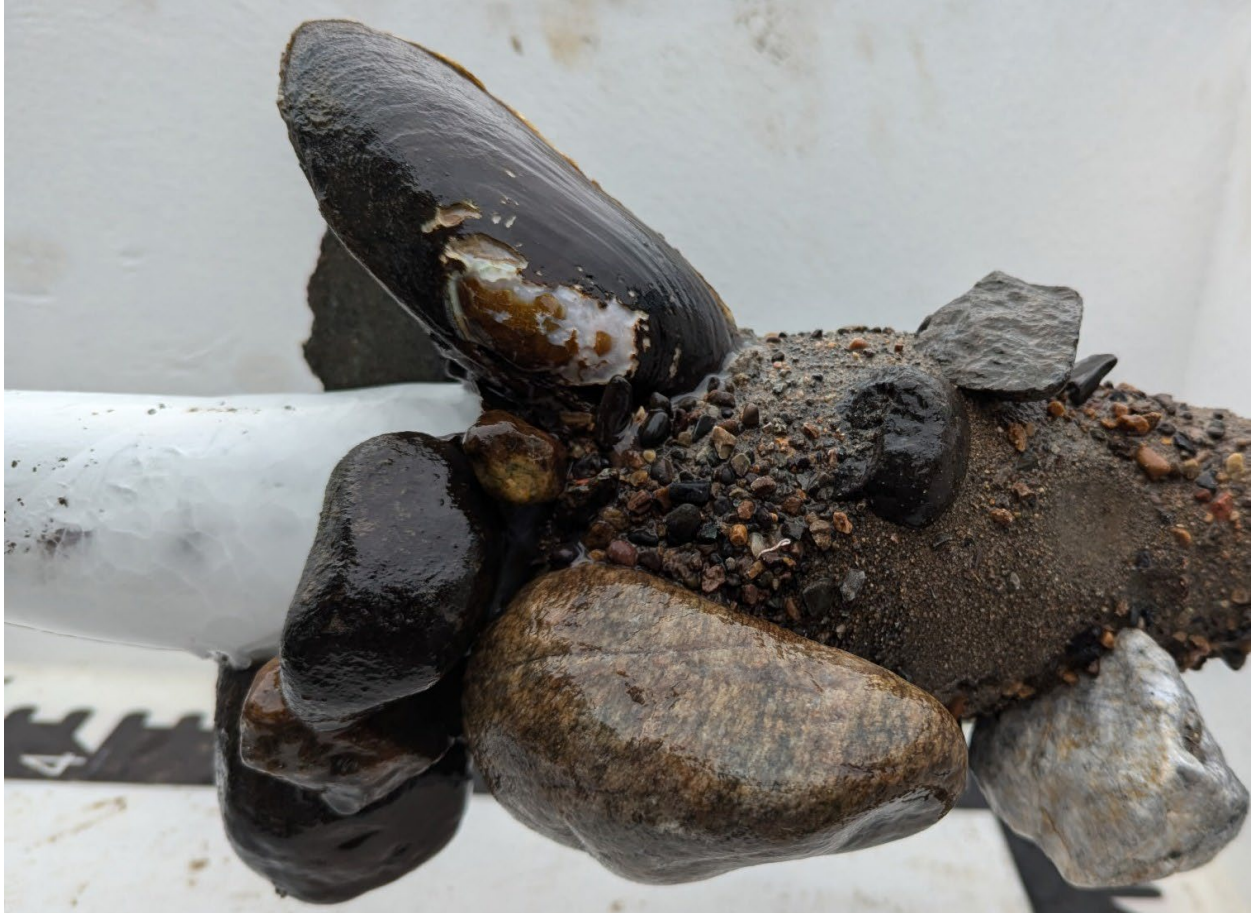
Figure 4. Freeze core sample of the substrate in the Lower Patch restoration site after testing the modified tubescreen sediment sorting tool. The large gravel and cobble have been raised to the bed surface and the fine gravel and sand have been deposited deeper into the bed. The ice frozen to the pipe (left) indicates that large substrate was present at the surface but did not adhere to the pipe.

Two other observations are worth noting regarding tubescreen effectiveness. First, the bed topography affected the ability of the tubescreen to engage with the substrate and the tubescreen was less effective in flat areas. A slightly sloping bed at the top end of the test section allowed the tubescreen to effectively engage its teeth into the substrate, which improved sorting effectiveness. A second observation of these small-scale deployments was that the tubescreen may take a few meters to initiate effective sorting due to the need to 'fill up' with sufficient unconsolidated substrate. Test areas as short as 4 metres may not provide representative results, though notably the 2022 test sections were only slightly longer than 4 m. The main outcome of this testing is that further discussion about tubescreen effectiveness and redesign options were needed prior to implementing larger scale applications.

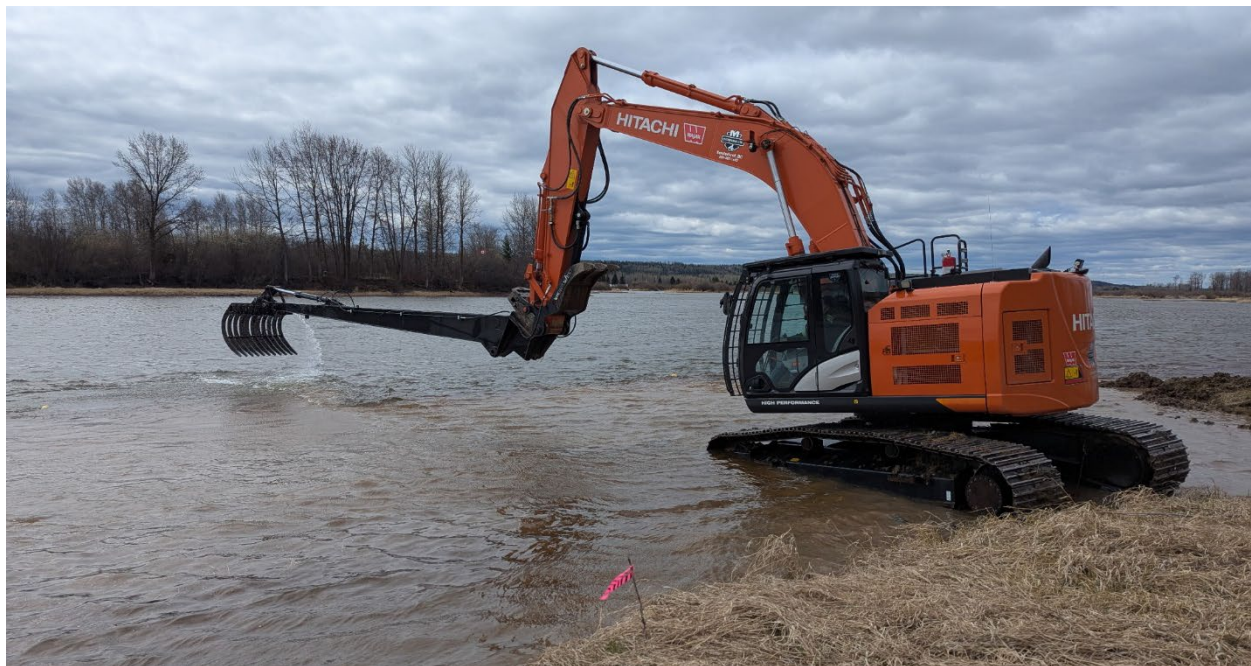
Figure 5. In-river testing of the rake on the Lower Patch, April 2025.

The first option was termed the 'rake' and was designed as a modified bucket for a long reach excavator (Figure 5). The concept of the rake was that the tine spacing (~10 cm) would allow the operator to pick up a load of large substrate (large gravel and cobble) from the bottom of the river and the smaller particles (small gravel and sand) would sift through to remain in place. The separated large substrate would then be deposited back into the river where it was taken from, creating a layer of suitable substrate at the surface. The second restoration tool tested was termed the 'sled' (Figure 6). The sled was designed with a similar concept to the original tubescreen, but was flat rather than round. The sled was designed to be towed in an upstream direction by rotating the outstretched excavator arm. Teeth at the front of the sled would dig into the substrate and cause large gravel and cobble to pass up and over the sled as it was towed. The tine spacing would allow particles <10 cm through and layer the larger rock on top. The flat design was intended to combat the rolling effect observed in the tubescreen trial. Both the rake and the sled were tested on land within the M4 Enterprises works yard to demonstrate that they could effectively sort a substrate mixture containing gravel, cobble, and sand.

Pilot testing of the rake and sled were conducted on April 29th and 30th to test and refine those tools for larger scale applications conducted just prior to the May spawning window. In-river testing showed that the rake was ineffective at sorting the substrate of the Lower Patch. The first challenge was penetrating the substrate surface when reaching out long

distances with the long arm excavator. The substrate is sufficiently compacted with sand and digging into the substrate requires significant downward force. Sufficient force could be applied when working close to the excavator. However, when the excavator arm was extended to work further into the river channel the substrate's resistance, combined with the increased leverage, caused the excavator to lift (i.e. rather than the rake to dig in). A key part of that limitation was the spacing of the tines on the rake. Tines that are of appropriate spacing to engage the target substrate particle size (<10 cm) create lots of resistance. Increasing the tine spacing would reduce resistance but would be too far to achieve the substrate sorting objective. This observation showed that when the substrate is highly compacted two functions are required; disruption of the compacted substrate and sorting to improve surficial habitat quality.

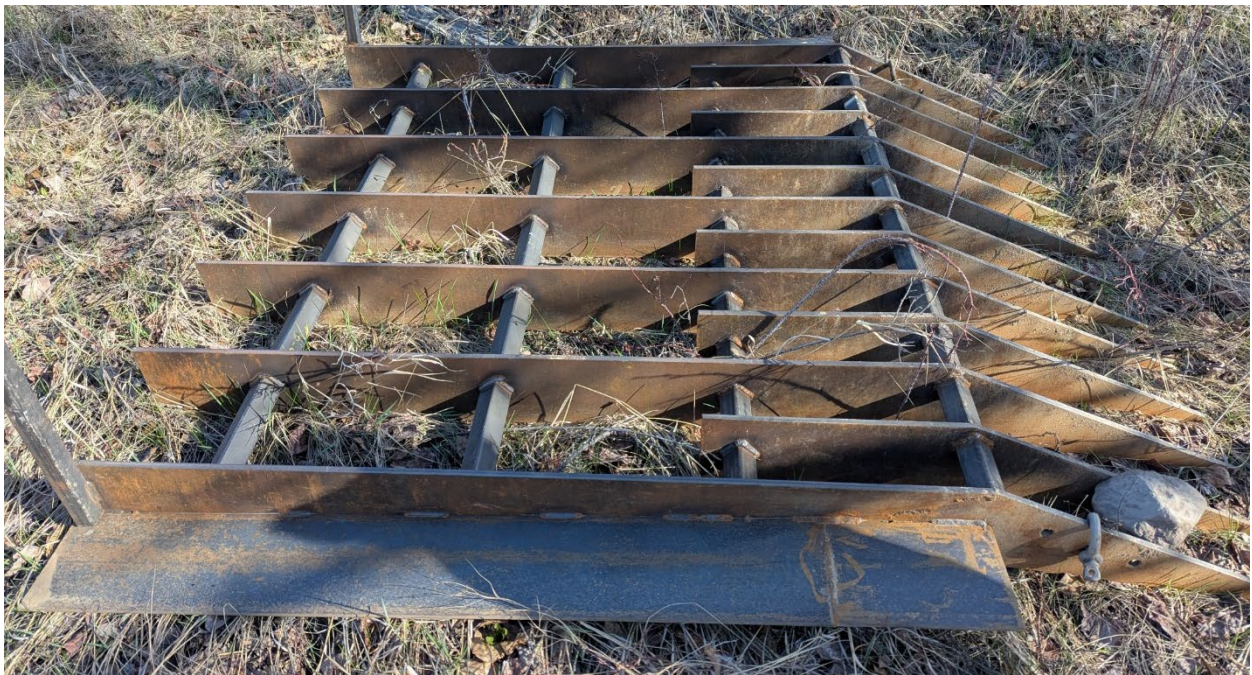
Figure 6. The 'sled' substrate sorting tool on land at the Lower Patch restoration site, April 2025.

The sled was also tested by observing the effect of 1, 3, 5 or 8 passes of the sled over a nearshore area of the restoration site. These areas were located at NHC monitoring sites 6 and 7. After 8 passes of the sled, the substrate condition appeared to have improved (reduced periphyton and sediment visible on the surface of the rocks, lower amounts of subsurface sand). This result was deemed sufficient for full scale testing in May over the Lower Patch site.

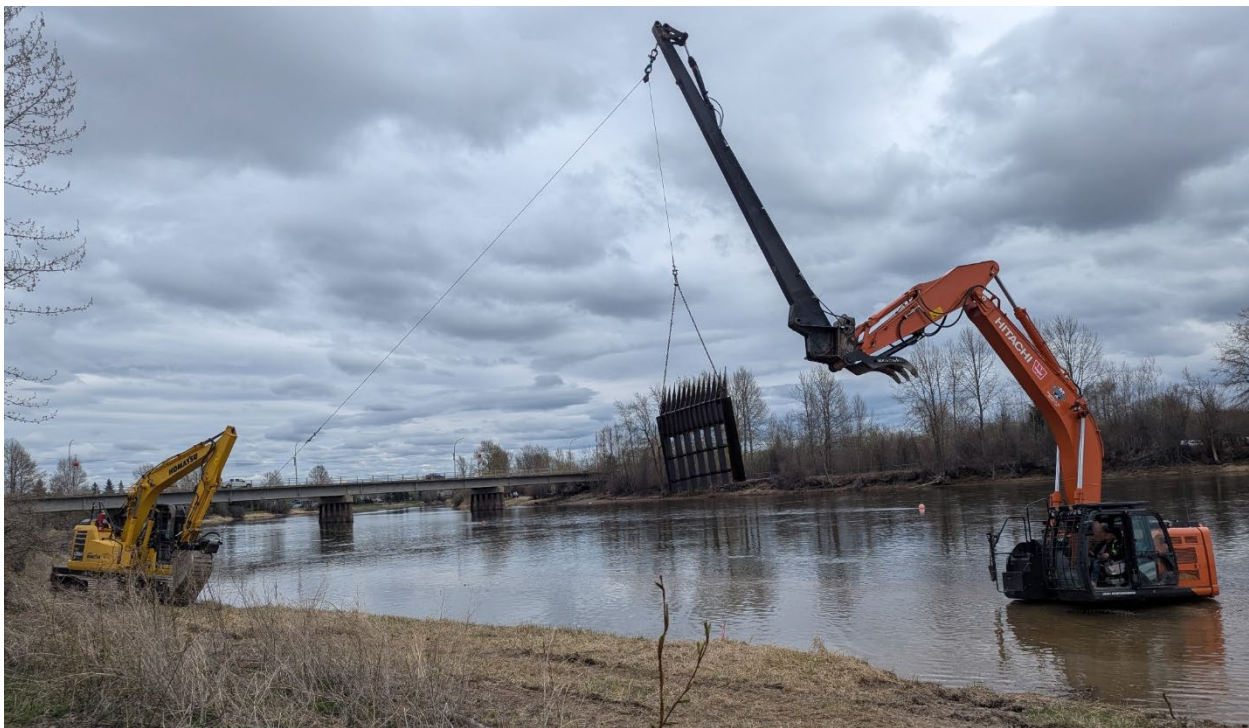
Figure 7. Testing operation of the sled using a winch and pulley system, May 2025.

Methods to access deeper downstream areas were also investigated, including a winch and pulley system and barge-based deployment. A winch, pulley and cable system was tested to assess the feasibility of pulling the sled from a fixed upstream point located on the excavator. This method used a winch located on a shore-based excavator combined with a pulley on the instream excavator (Figure 7). Conceptually, this method would allow the sled to be pulled a distance equivalent to the length of the cable on the winch (possibly followed by adding additional cable to extend the total pull length). However, in practice this method wasn't suitable. The operation was slow and the sled was more prone to snagging on large

substrate or wood debris. The horizontal orientation of the pulling cable in this set up was the main cause of increased snagging, whereas when using the excavator alone (as described above) snagging was remedied by using the excavator to pull the sled up vertically to dislodge it.
