PRELIMINARY ASSESSMENT OF THE MURRAY-CHESLATTA SYSTEM

Submission Date: October 12, 2000

northwest hydraulic consultants
#2 - 40 Gostick Place
North Vancouver, B.C.
V7M 3G2

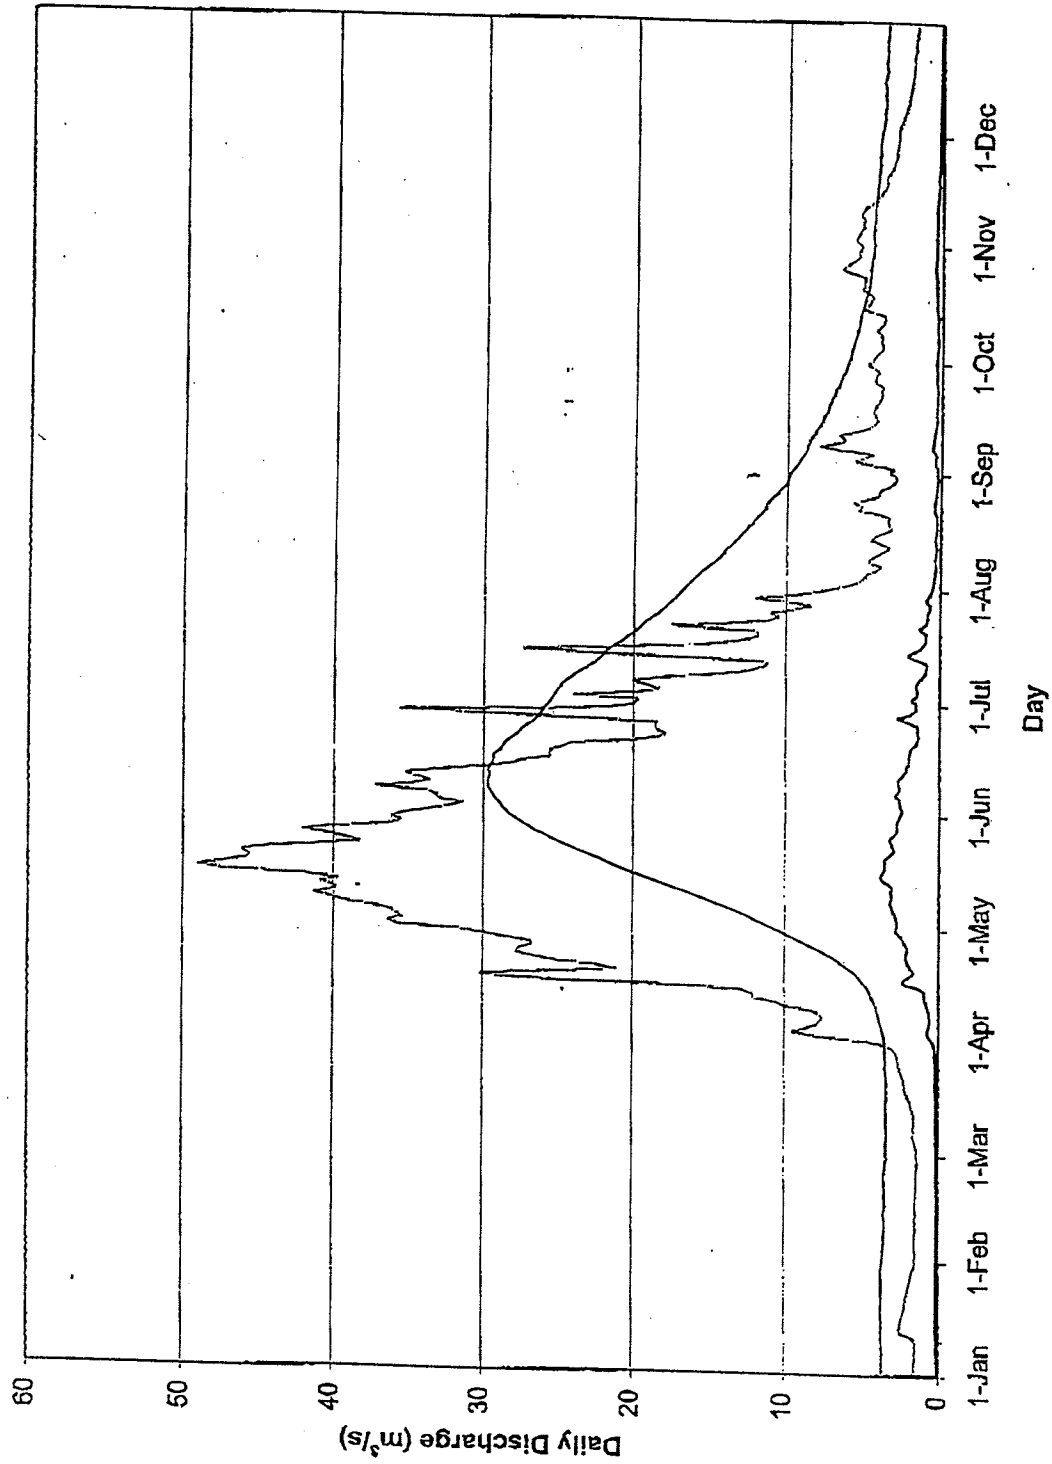
FIGURE 4

As discussed, Van Tine Creek is thought to be similar to the natural flow regime in the Cheslatta River and provides a typical analogue for the releases from the spillway. A hydrograph based on a release of $10 \text{ m}^3/\text{s}$ is shown on Figure 4; Bouillon and Pizio (2000) provide examples for other annual releases.

Upper Cheslatta River Hydrograph for a Release of 10m³/s

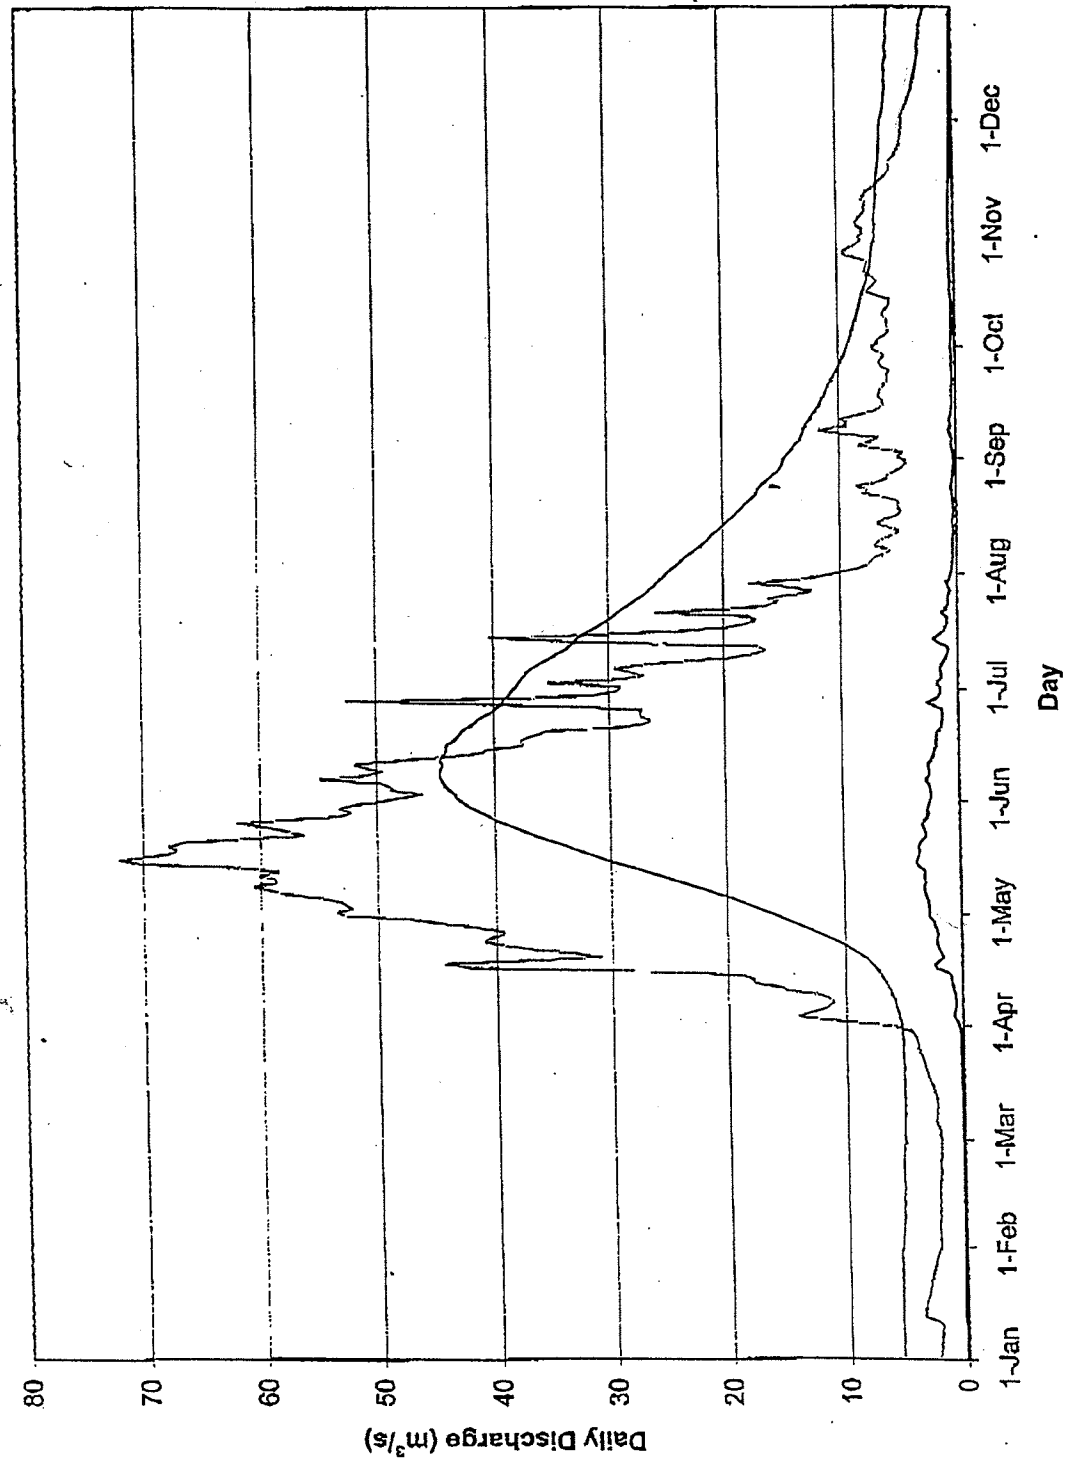
FIGURE 5

Neither of the hydrographs in Figures 4 or 5 provide a sufficiently large flow for flushing or to maintain channel morphology (see Reiser et al 1985). Such as flow might be provided, as required based on habitat observations, by diverting a portion of the pre-spill through the Skins Lake Spillway to coincide with the natural peak in April and May.

Upper Cheslatta River Hydrograph for a Release of 15m³/s
