Annual Report September 1, 2014 to March 31, 2015

Submitted to NEEF

Nechako Environment and Water Stewardship Society – NEWSS

NEEF Project name: Nechako River Sustainability

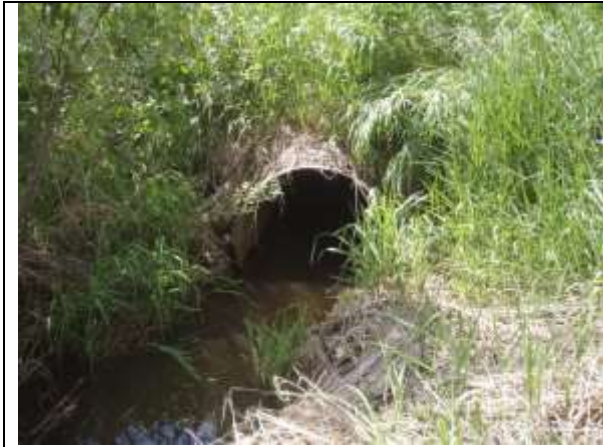
A culvert assessment completed by AMS on June 07, 2011 using the protocol described in B.C. MOE (2011) determined that the three culverts at the Larson Road were found to be a potential fish barrier (**Table 3., Photo 7, Photo 8**). Note, the April 15, 2011 date indicated in the table is an error. DWB re-assessed the Larson Road culverts under low flow conditions on August 15, 2012 and found the two 1200mm diameter overflow culverts perched above the water level (complete fish barriers) and the 1000mm diameter culvert to be a fish barrier with a score of 21 (DWB, 2014) due to a lack of embedment and the culvert being undersized which presumably creates a velocity barrier to upstream fish passage under high flow conditions.

DWB (2014) suggested that the backwatering effect of the undersized culvert may allow some fish passage during moderate to low flows, an effect which is not considered the B.C. MOE (2011) methodology. DWB (2012) concluded that the three culverts were seasonal barriers suggesting that the perched culverts, when fully connected to main stem flows, may allow fish passage during moderate to high flow periods.

Photo 7. Inlet of main culvert at the Larson Rd crossing, June 07, 2011

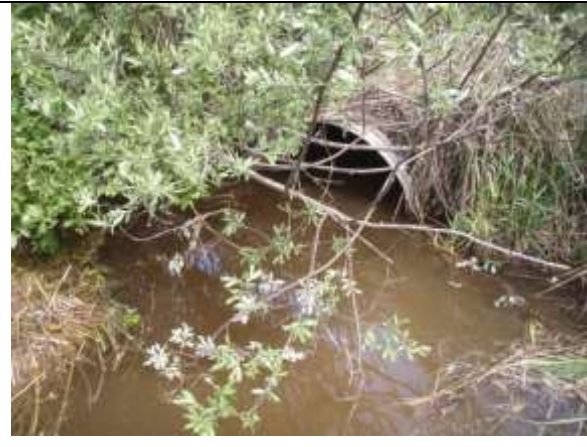
Photo 8. Outlet of main culvert at the Larson Rd Crossing, June 07, 2011.

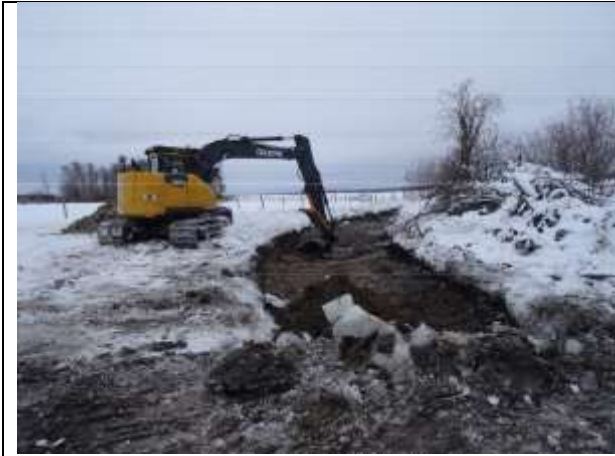
Photo 9. The excavator operating from a protective layer of snow and ice atop frozen ground downstream of the alder grove.

All habitat rehabilitation-related activities followed the guidelines described in the Forest Practices Code (FPC) *Stream Crossing Guidebook* (*e.g.* sediment control, drainage, precautions for deleterious materials) (MOF, 2002). As all activities were completed in the dry, no isolation procedures were required. The excavator and dump truck were operated from January 26, 2015 to February 25, 2015 either on frozen ground covered by a protective cover of ice and snow (**Photo 9**) or within the historic channel footprint (**Photo 10**).

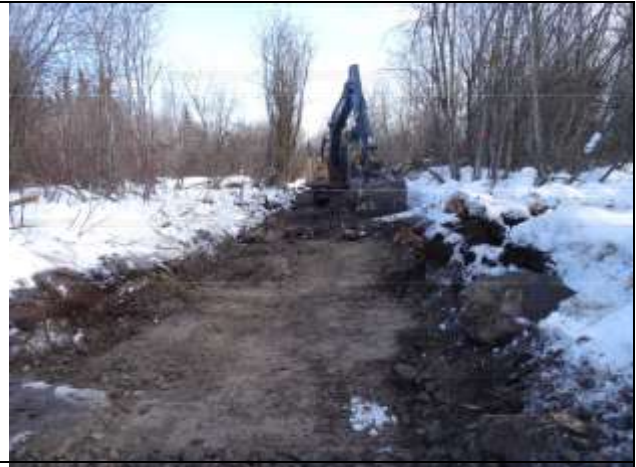
Photo 10. Reconstructing the historic channel within the alder grove.

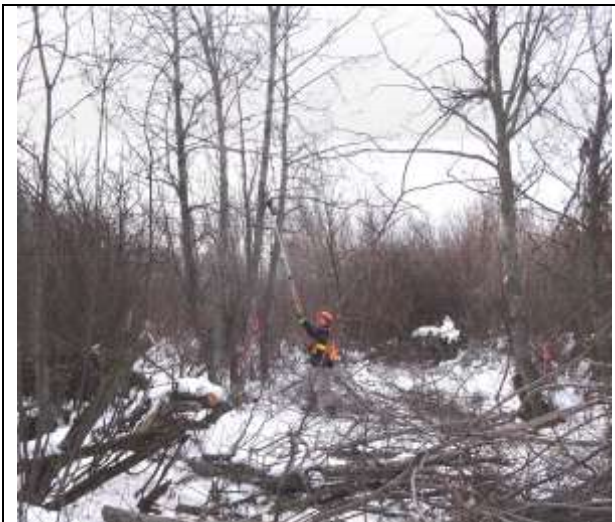
Photo 11. Alder branches overhanging the historic channel carefully being removed to create a path for the excavator.

Two routes through the dense alder stand used to access the Murray Creek historic channel footprint enabled the excavator and dump truck operate along the historic without requiring the falling of trees and shrubs growing along the stream banks or within the flood plain. Branches of standing trees hovering over the historic channel path were removed to prevent significant damage to both the trees and the excavator (**Photo 11, Photo 12**).

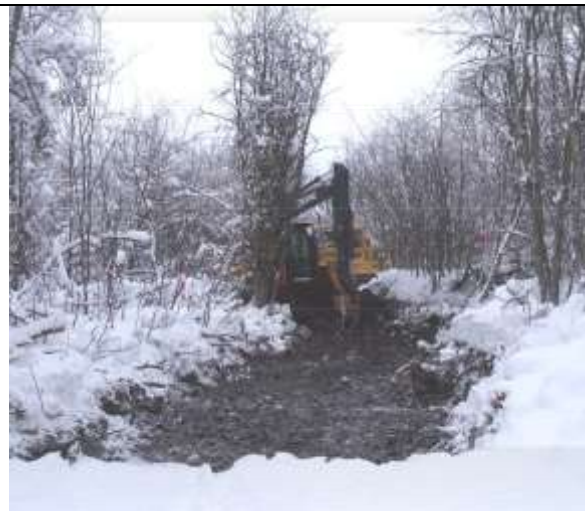
Photo 12. The excavator removing snow and topsoil from the historic channel.

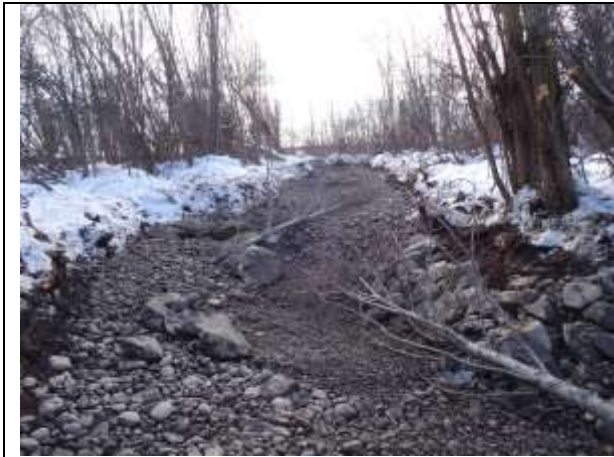
Photo 13. Felled alder trees anchored into stream channel to provide coarse woody debris habitat.

Alder that were removed from the middle of the historic stream channel were later used to build coarse woody debris structures (**Photo 13**). Nearly all of the Alder trees growing along the banks of the historic channel were left in place. In a few cases where alder trees growing along the historic channel route had to be removed to create room for the excavator, as much of the stump and root mass was left as was possible to provide bank stability and fish habitat (**Photo 14**). It is anticipated that the retained stumps and root masses of the cut alder trees will produce

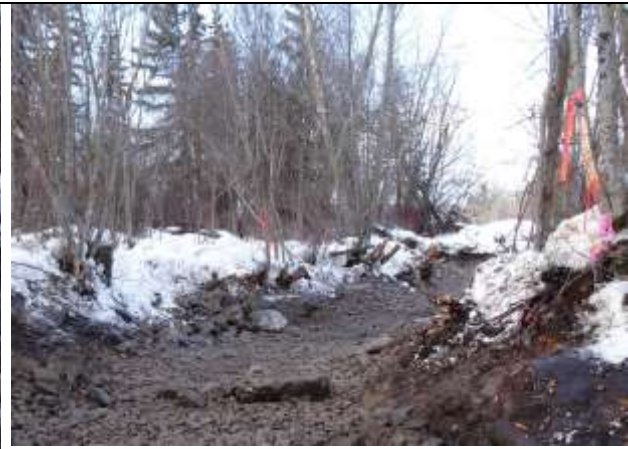
Photo 14. Alder tree stumps and roots left to provide bank stability, create undercut bank refugia and sprout new shoots.

new shoots through vegetative reproduction (suckering) and allow for the formation of undercut banks which provides excellent cover for all life stages of salmonids.

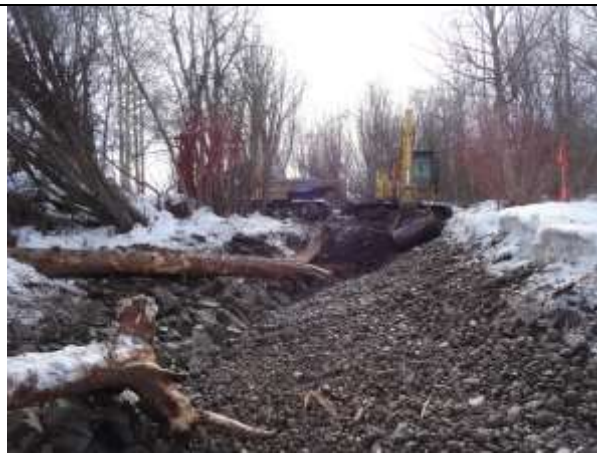
Photo 15. Sloping channel bed to simulate natural stream morphology. Note the dump truck in the background transporting soil removed from the historic channel.

The bed was sloped such that depth gradually increased towards the bank at outside bends with shallow water habitats along the inside bends as typically occurs under natural conditions (**Photo 15**). Stream bank at the outside bends and other locations vulnerable to erosion were armoured with boulders and cobbles. A 15 to 20cm layer of cobbles and gravels were placed over nearly the entire channel bed to maximize macroinvertebrate production and provide cover for juvenile salmonids and small fish species (*e.g.* **Photo 16**). Gravels with an intermediate diameter of 1.5 - 6.0cm, considered optimum for resident rainbow trout spawning success (Raleigh *et al.*, 1984), were placed at typical rainbow trout spawning locations such as pool tail-outs, behind boulders, behind and in front of weirs, amongst coarse woody debris structures and in riffle habitats (*e.g.* **Photo 13, Photo 16**). Stream gradient from the Larson Road crossing to the end of the restored channel ranged from <1 to 2%. The restored historic channel should contain all moderate to low flows thereby improving fish passage.

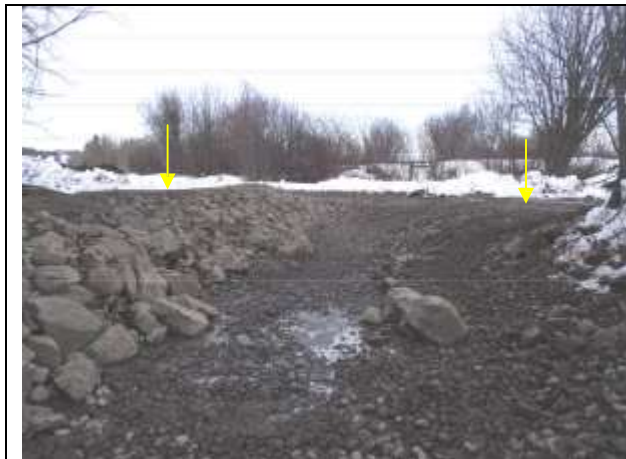
Photo 23. Top of the north (left) and south banks (end of tractor route on right) seeded with Vanderhoof Roadside Mix[®] (arrows). Larson Road is in the background.

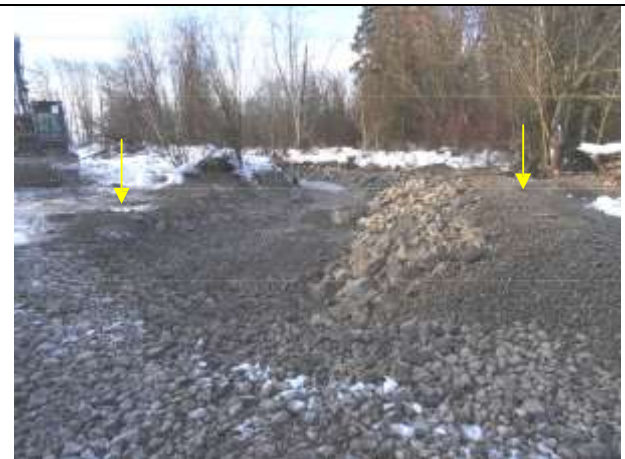
Photo 24. Top of the north bank and transportation route seeded with Vanderhoof Roadside Mix[®] looking downstream.

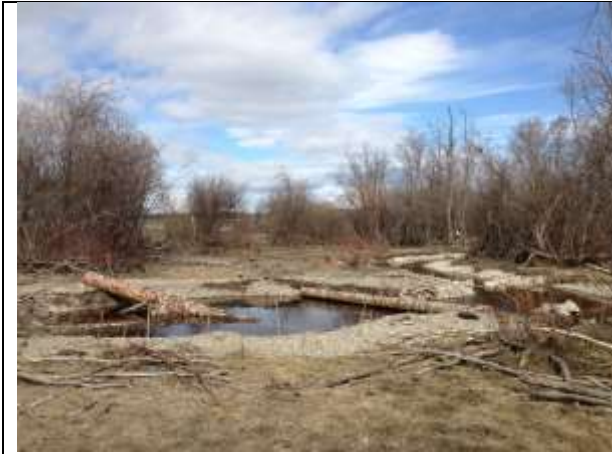
Photo 25. Willow cuttings planted on March 26, March 30 and March 31, 2015 along the banks of overwintering pool 3.

Additional willow cuttings were planted along any remaining gaps along the bank of overwintering pool 3 on March 30 and March 31, 2015. Willow cuttings were also planted along exposed banks within the 180m of channel between the alder stand and the end of the project (**Photo 26**)

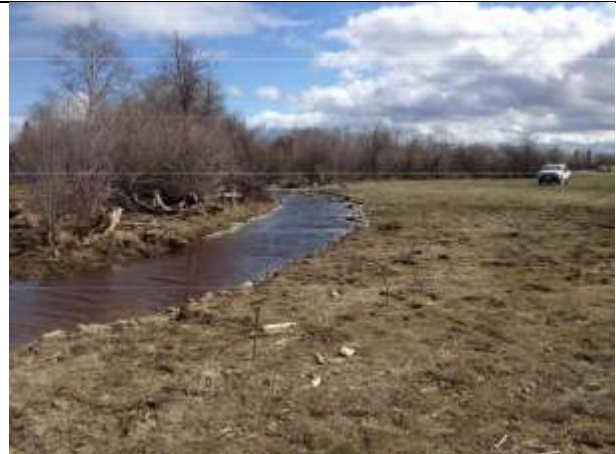
Photo 26. Exposed South bank devoid of riparian vegetation planted with willow cuttings on March 31, 2015

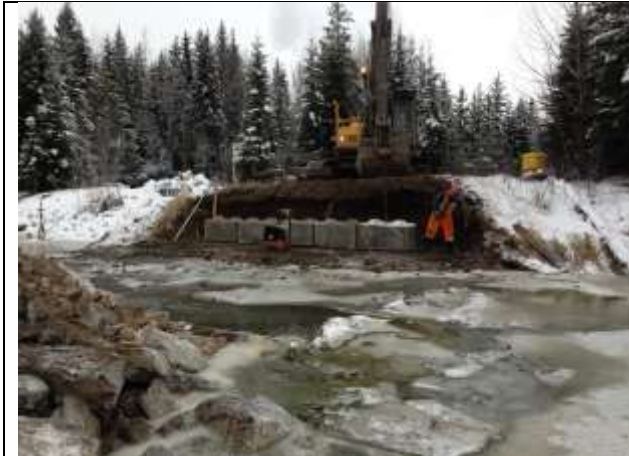
Photo 7. Post culvert removal and early stage of beam bridge installation.

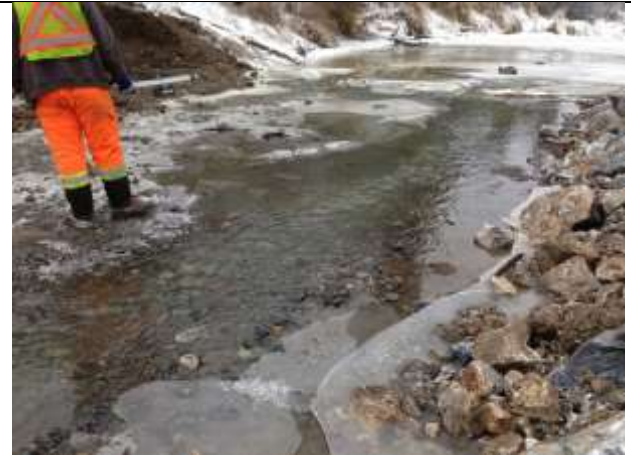
Photo 8. Stoney Creek discharge following culvert removal.

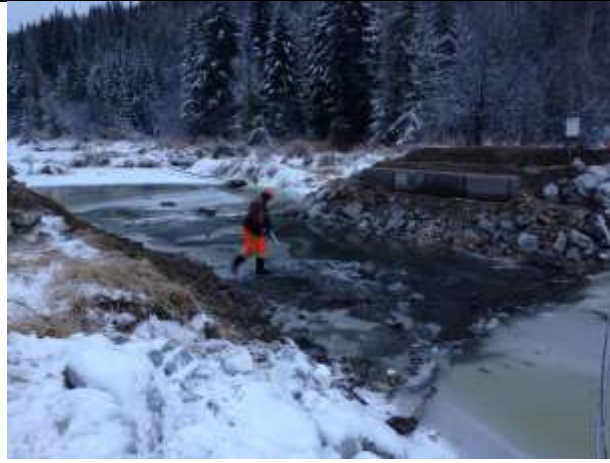
Photo 9. West beam bridge abutment.

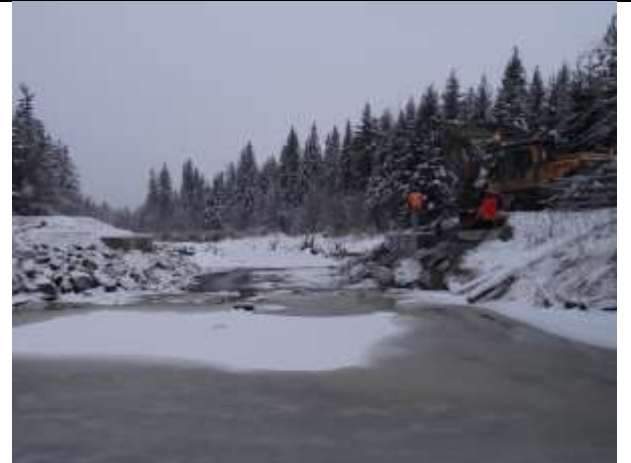
Photo 10. Beam Bridge abutments installed.

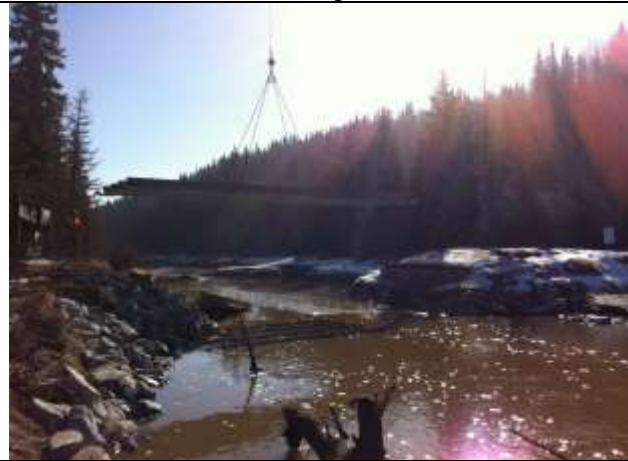
Photo 11. Beam bridge being installed on March 24, 2015 looking downstream.

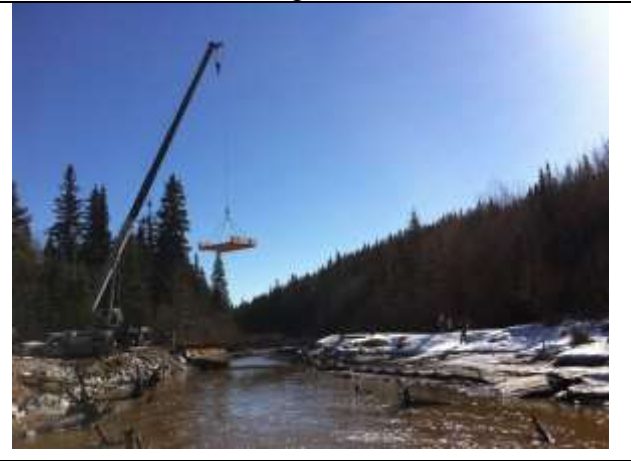
Photo 12. Latter stage of the beam bridge installation process, March 24, 2015, looking downstream.

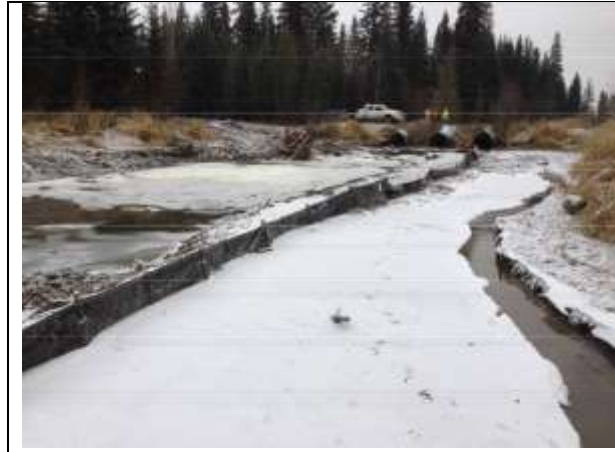
Photo 14. Isolation of area to be dredged and enhanced with fish habitat structures. Note the diversion channel to the right of the photo.

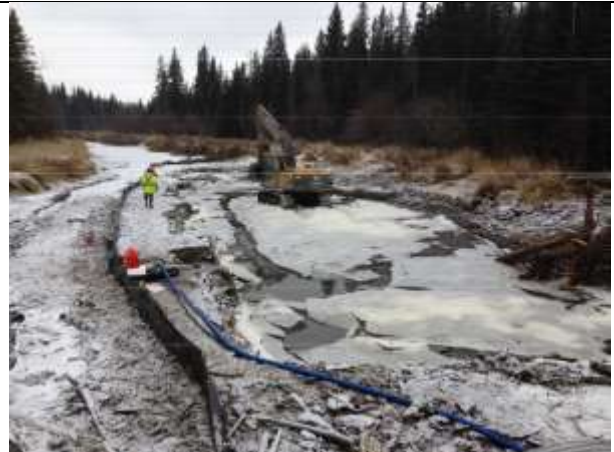
Photo 15. Beginning of dredging along the North bank with area fully isolated with flow diverted along the South bank

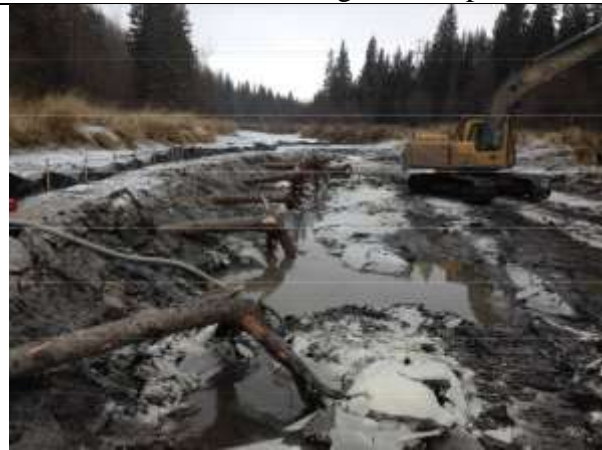
Photo 16. Installation of root wads (LWD) that will provide cover, create scour to maintain pool depth, and capture debris.

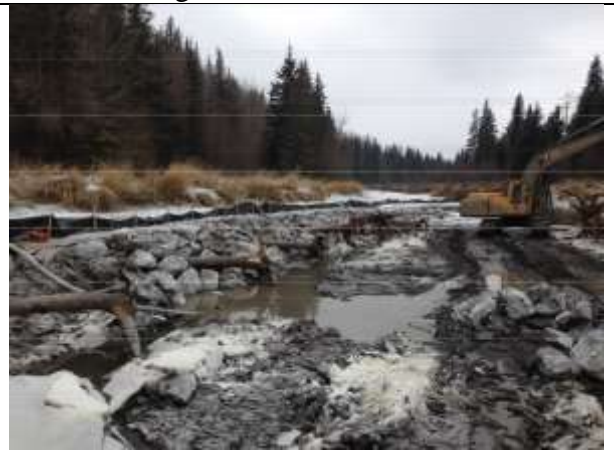
Photo 17. Armouring of the channel. All root wads were anchored to boulders with 1/4 inch cable.

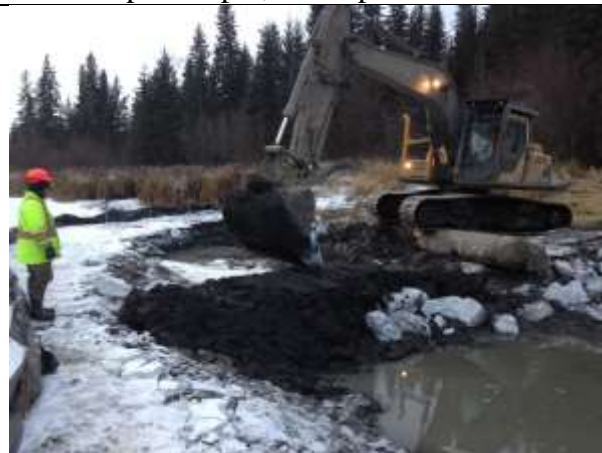
Photo 18. Installation of the V weir and channel armouring.

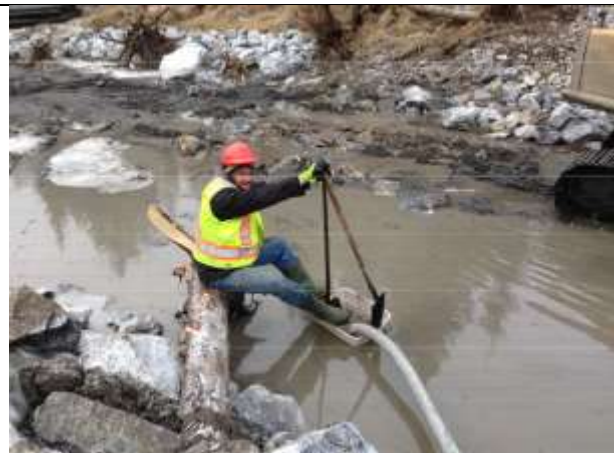
Photo 19. Pumping of turbid water into the riparian habitat with a fish-friendly intake.

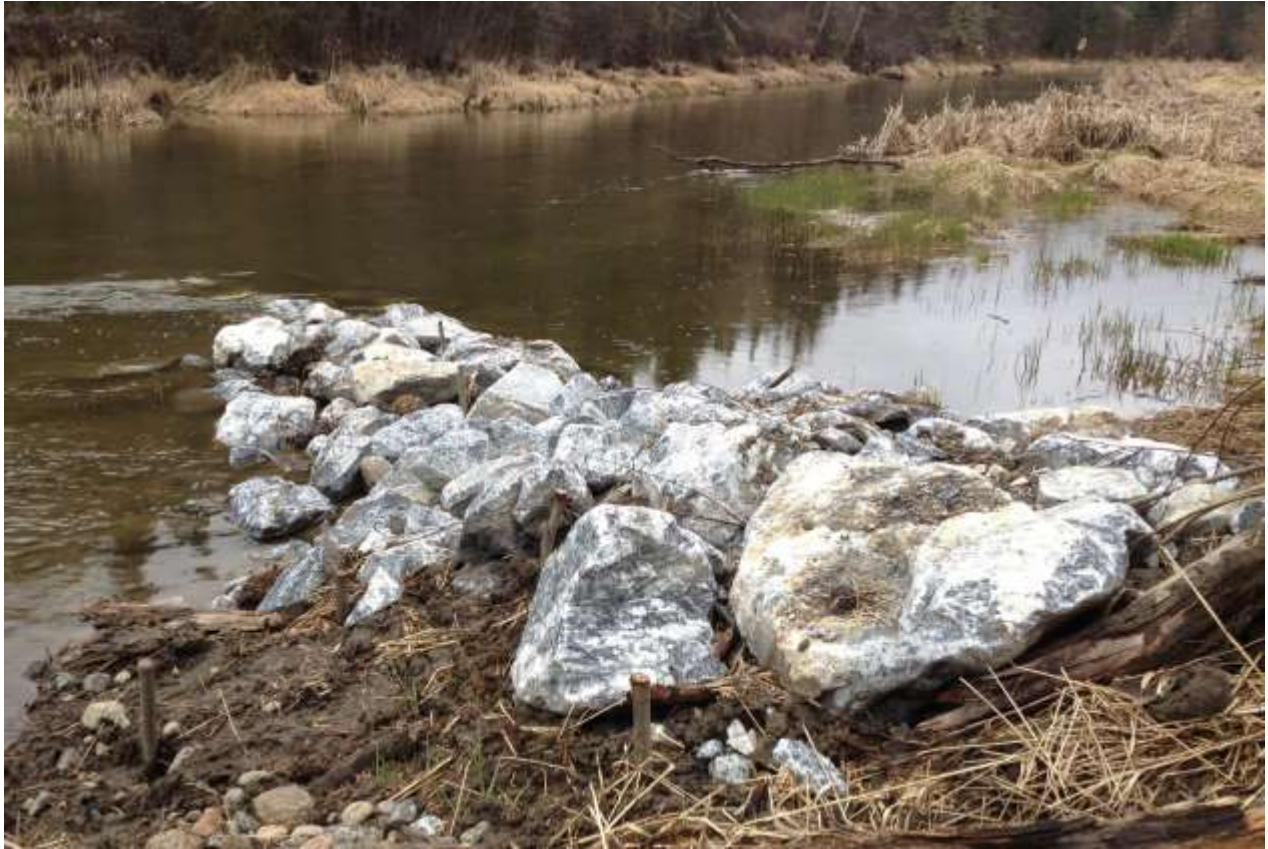
Photo 28. Willow cuttings planted within and adjacent to the V-weir upstream of the L&M Bridge, March 30, 2015. Note the extensive reed canarygrass and cattails (*Typha* spp.) growing along the flood-prone channel banks - a condition characteristic of the riparian vegetation throughout lower Stoney Creek.

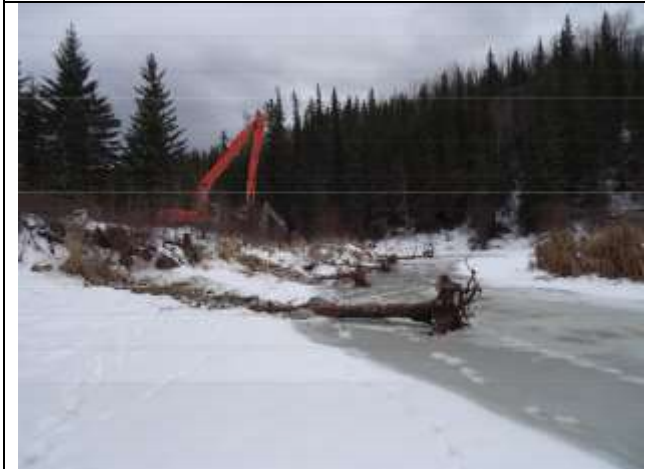
Photo 41. Root wads and boulder clusters being installed on the North bank looking upstream to the West.

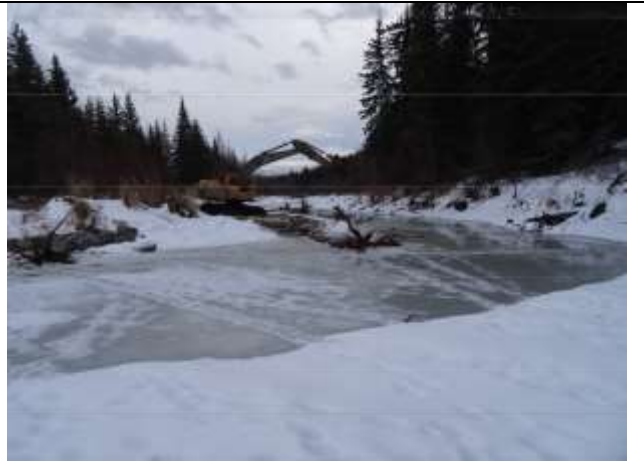
Photo 42. Root wads and boulder clusters being installed on the North bank looking upstream to the North.

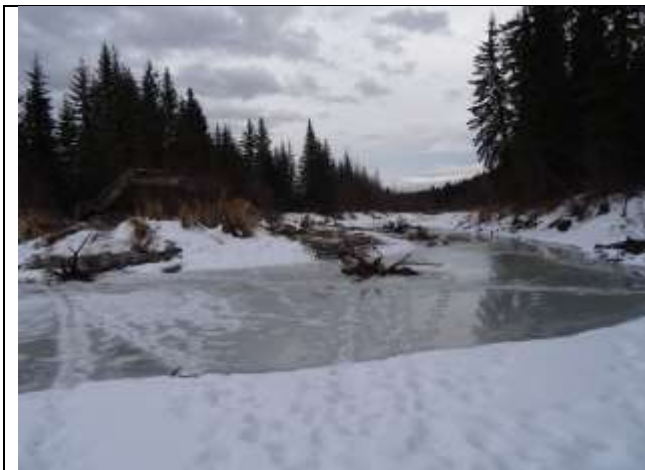
Photo 43. Boulder clusters and root wads installed on the North bank looking downstream

<p>to the East.</p>

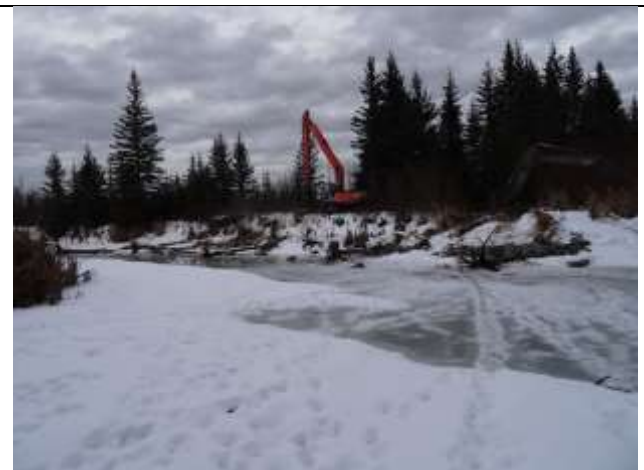
Photo 44. Boulder Clusters and root wads being placed from atop of the North bank.

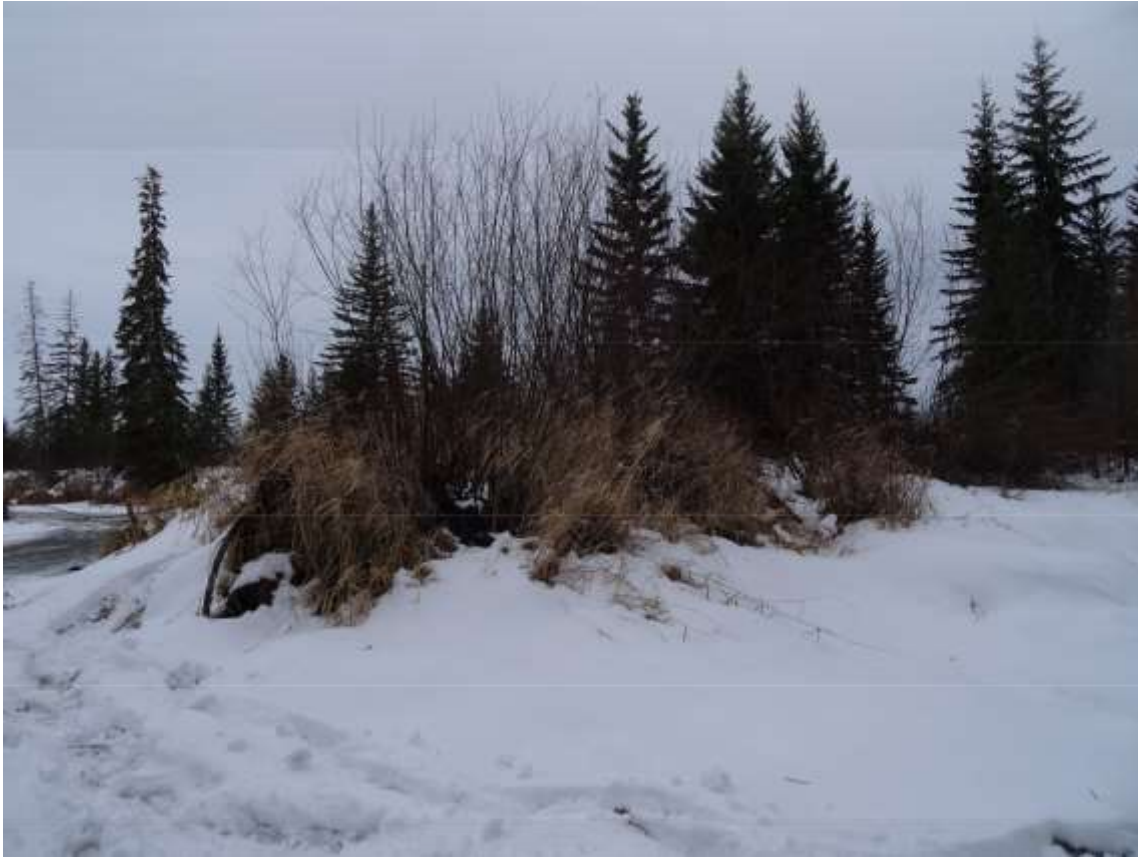
The noted lack of overstory vegetation identified during the preliminary assessment likely referred specifically to the area of channel within bankfull which is frequently flooded and possibly unsuitable for woody riparian shrubs and trees which roots are intolerant of the hypoxic to anoxic conditions that occur in continually saturated soils. As is the case for all four sites and throughout most of lower Stoney Creek, reed canary grass (*Phalaris arundinacea*), a wetland plant capable of achieving heights of up to 2.7m (9ft) and tolerant of anoxic wetland sediments, has established dense stands within the continuously to frequently flooded sections of channel. Although reed canary grass may offer some erosion protection and nutrient removal services (Stannard and Crowder, 2003) it is likely reducing biological diversity by inhibiting the establishment of other herbaceous species such as sedges and rushes and possibly willows. The planting of willow cuttings, conducted on March 30, 2015, was mainly restricted to the few areas slightly below bank full elevation that lacked naturally occurring willow. Willow occurred in a near continuous belt slightly below and above bank full height at all sites below which a dense, near continuous belt of reed canarygrass had established. Cuttings were also placed at intermediate elevations to determine whether willow can establish in the wetter substrates and possibly outcompete reed canary grass. The planting of willow stakes was shown to be experimentally effective in controlling reed canary grass under some conditions by Kim *et al.* (2006).

Photo 47. Representative vegetation observed on the North and South banks of Stoney Creek at KP2+175, early winter, 2014.

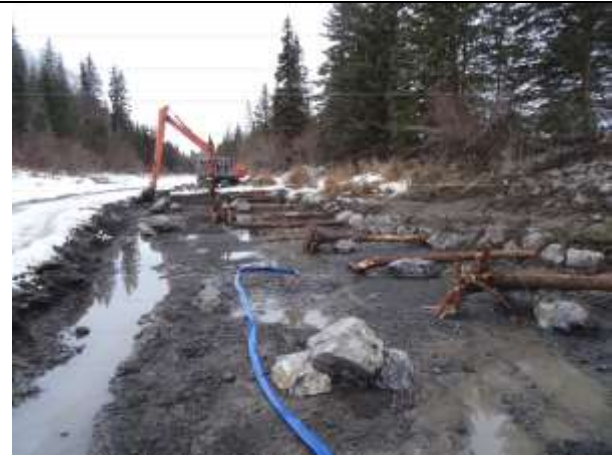
Photo 49. Root wad (LWD) and boulder clusters being added to provide fish habitat.

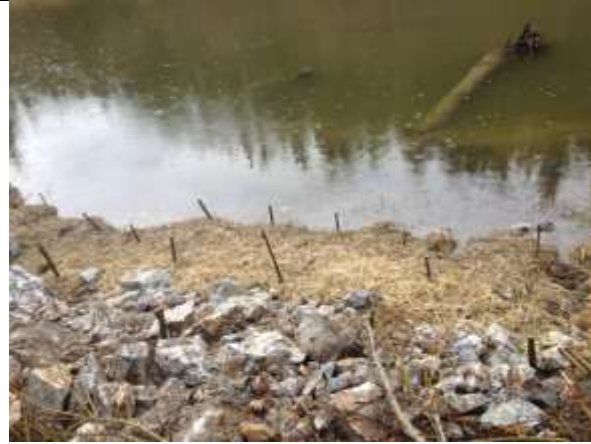
Photo 52. Willow cuttings planted below and between boulders within soft sediment at KP2+450.

Willow cuttings were planted on March 30, 2015. Planting was limited to below and within the one section of bank that was armoured with boulders (**Photo 52, Photo 53**), visible to the right in **Photo 50**, as the existing riparian vegetation at this site, including willows and conifers of mixed ages, was so extensive that some vegetation had to be cut back to provide access to the site. Cuttings were inserted into any available soft, wet substrate at the foot of and within the boulders to a depth of approximately 0.5m.

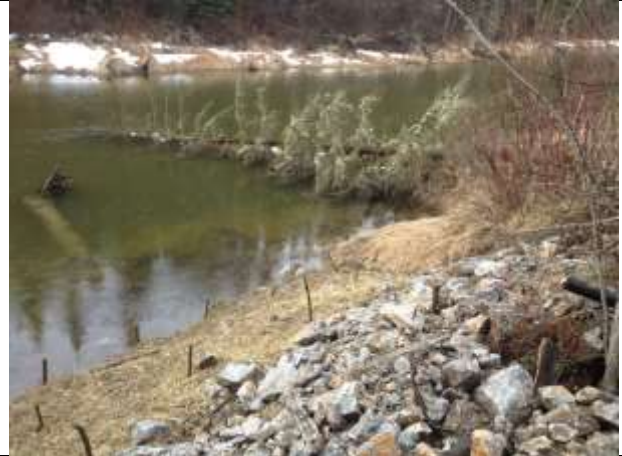
Photo 53. Willow cuttings planted at KP2+450. Note the recently fallen conifer tree.
