# 2024-2025 Nechako River Substrate Monitoring

## Final Report

**Northwest Hydraulic Consultants Ltd.**

November 20, 2025  
Final Report, Rev. 1

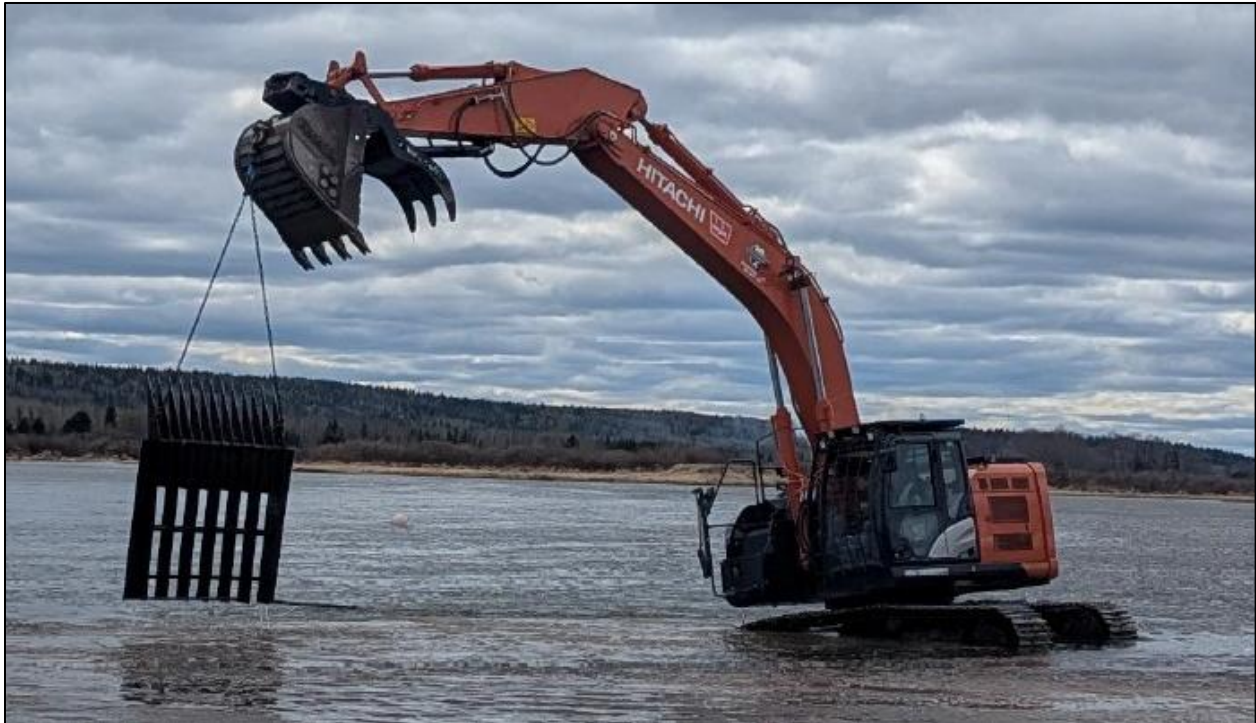
Subsequent testing of the tube screen on the Lower Patch spawning pad on October 29-30, 2024, revealed that the device did not have the weight nor stability to effectively restore the substrate of the spawning pad, leading to a redesigned tool termed a *sled* (Photo 1.2). This sled was the primary tool used for the larger-scale restoration of the Lower Patch on May 5-10, 2025, which was operated using an excavator with a boom extension.

**Photo 1.2 Sled used during the larger-scale restoration of the Lower Patch on May 5-10, 2025; a boom extension was also used for greater reach (not shown).**

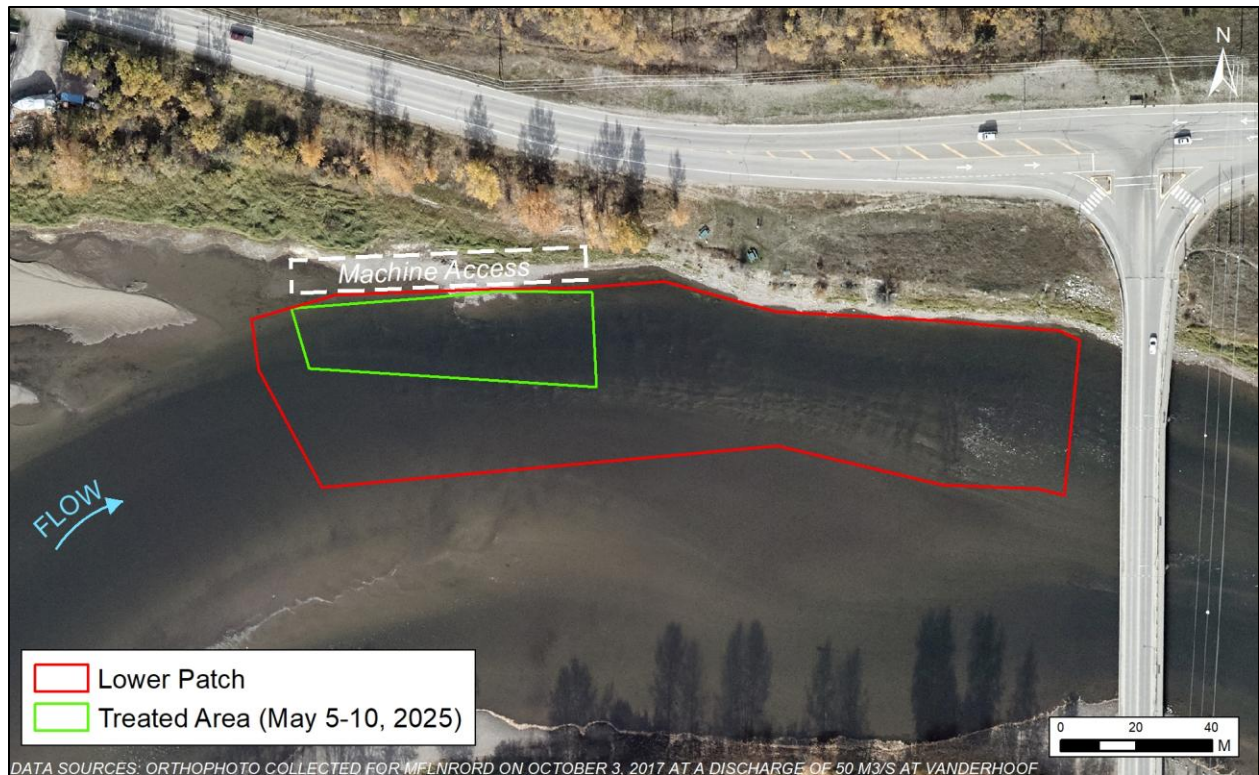
The substrate cleaning was intended to cover the entire area of the Lower Patch. However, the water depth at the time of the restoration prevented the excavator from accessing much of the wetted area; thus, the machine was limited to working along the bank with a boom extension. Overall, an estimated 18% (1,655 m<sup>2</sup>) of the total Lower Patch area (9,325 m<sup>2</sup>) was treated as part of the restoration effort. The treated area is shown below in Figure 3.1.

**Figure 3.1** An estimated 18% (1,655 m<sup>2</sup>) of the total Lower Patch area (9,325 m<sup>2</sup>) was treated during the restoration on May 5-10, 2025.

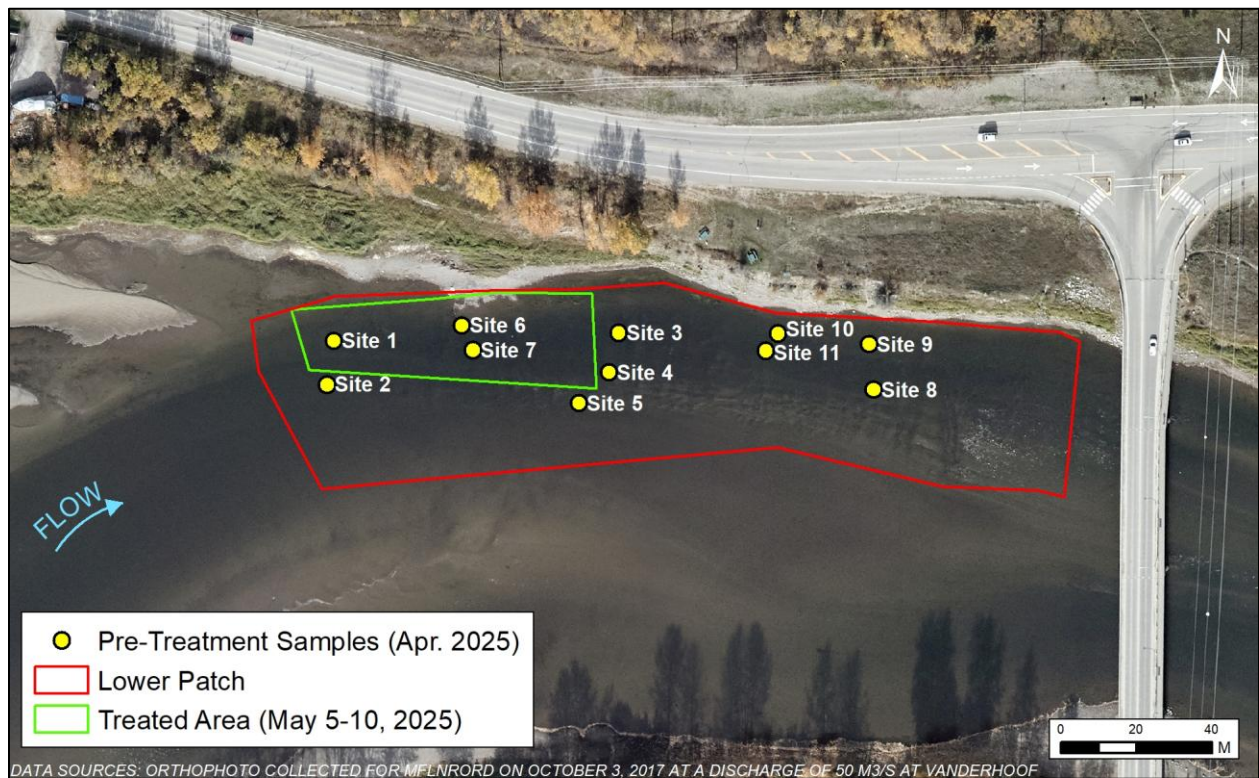
A total of 11 sites were sampled on April 23-25, 2025, using paired underwater photos and freeze coring. The samples were distributed across the Lower Patch spawning pad (Figure 3.2) because the specific area where the restoration was to take place had not yet been determined at the time of the sampling. Site-specific descriptions of the pre-treatment substrate characteristics and conditions are provided in Table 3.2, while Figure 3.3 presents a visual classification of the substrate conditions. All sampling results are shown visually in Appendix A.

**Figure 3.2** Locations of pre-treatment sampling sites (April 23-25, 2025) shown in relation to where the restoration treatment was performed in May 2025.

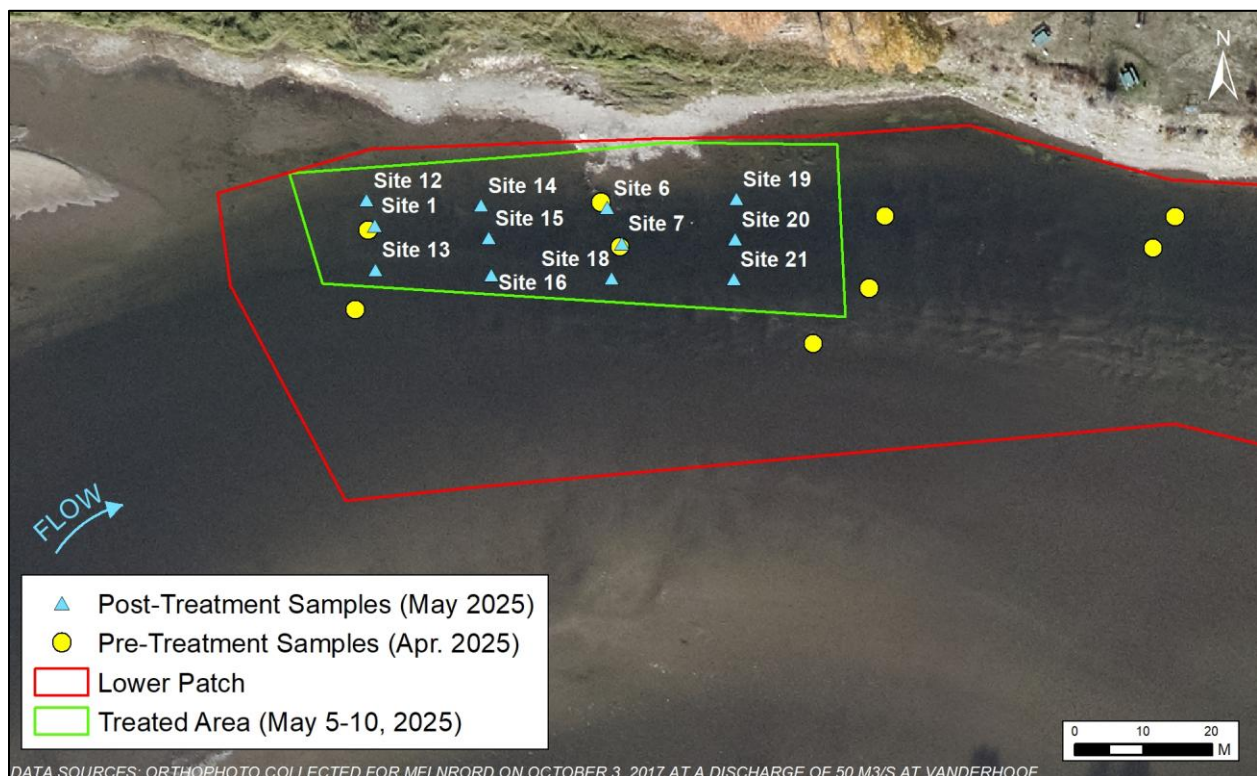
A total of 12 sites were sampled on May 12-13, 2025. The samples were distributed across the portion of the Lower Patch where restoration took place between May 5-10, 2025, immediately preceding the sampling event. As seen on Figure 3.4, only three of the pre-treatment sampling locations (Site 1, Site 6, Site 7) were within the restored area because, as previously stated, the specific area where the restoration was to take place had not yet been determined at the time of the pre-treatment sampling.

**Figure 3.4 Spatial comparison of pre-treatment (April 23-25, 2025) and post-treatment (May 12-13, 2025) sampling locations; only three sites overlap (Site 1, Site 6, Site 7) because the specific area where the restoration was to take place had not yet been determined at the time of the pre-treatment sampling.**

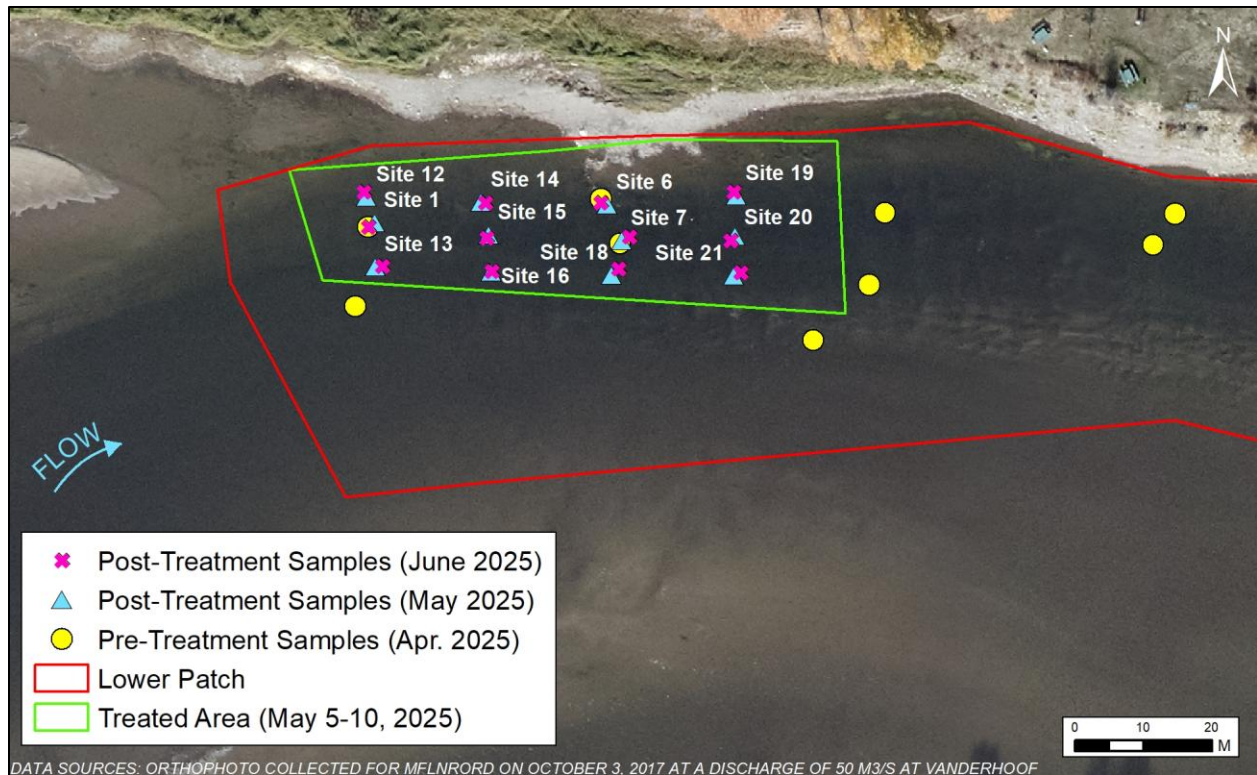
The 12 post-treatment sites initially sampled on May 12-13, 2025, were resampled on June 18-20, 2025, to monitor changes in substrate conditions (Figure 3.6). No notable changes in substrate conditions were found to have occurred between the May 2025 and June 2025 sampling events; refer to Appendix B for a visual comparison of the substrate conditions observed during each sampling event.

**Figure 3.6 Spatial comparison of pre-treatment (April 23-25, 2025) and post-treatment (May 12-13, 2025; June 18-20, 2025) sampling locations; post-treatment samples collected in May and June spatially correspond for repeated site monitoring.**

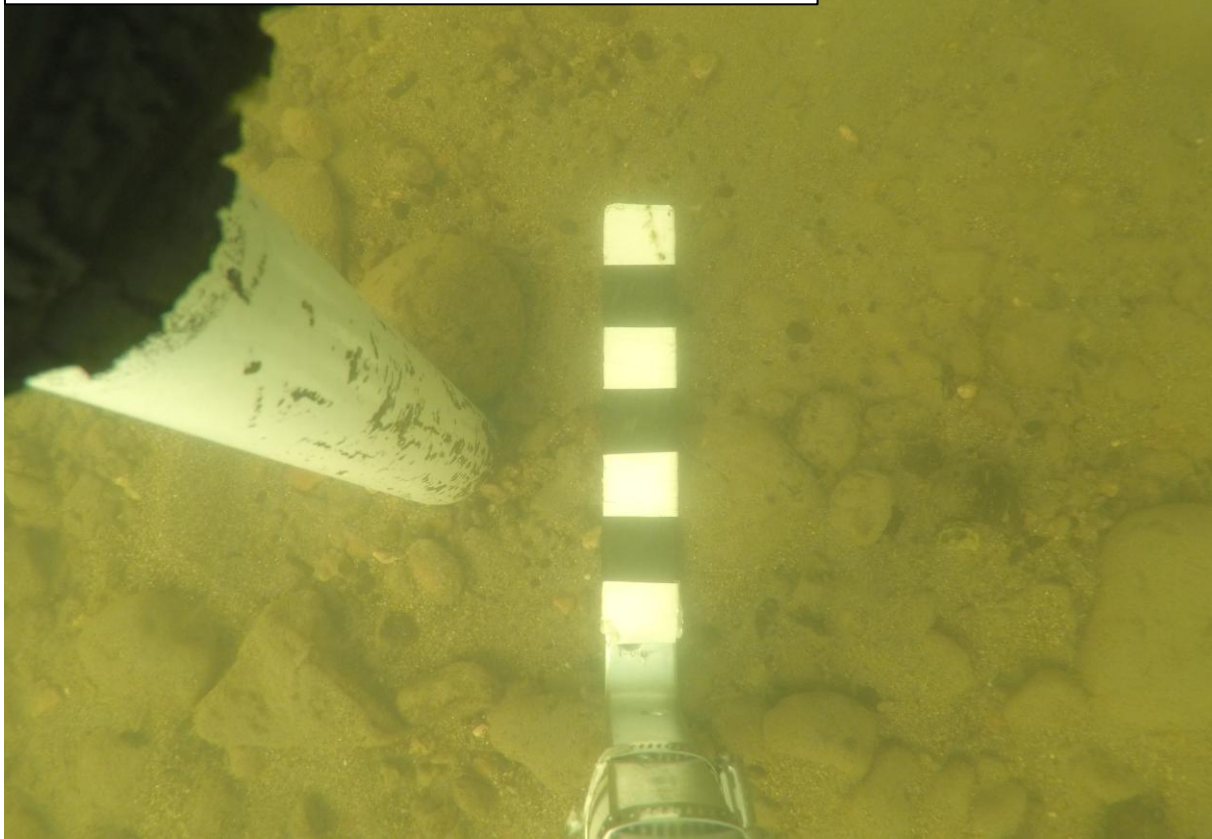
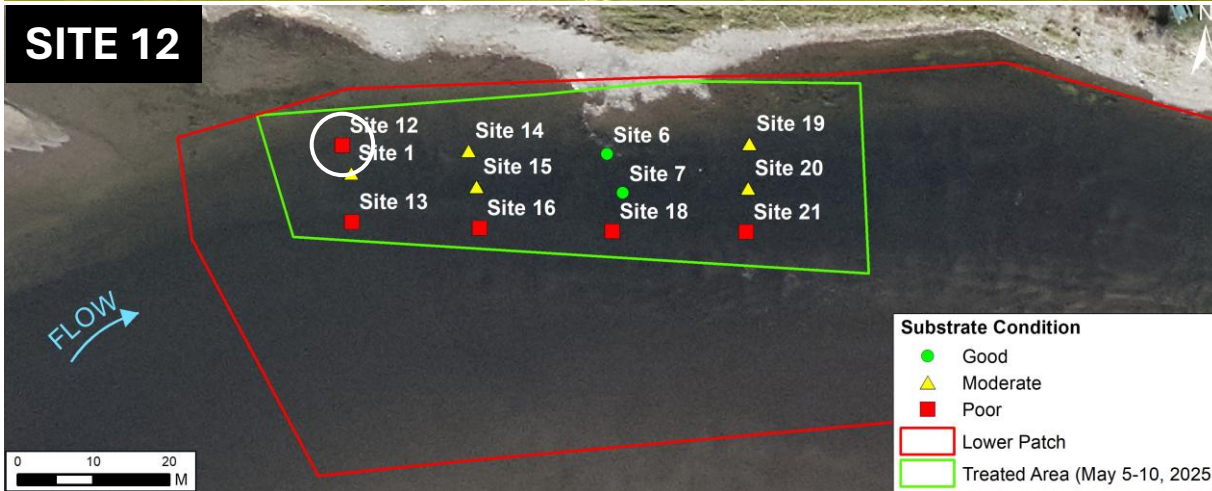
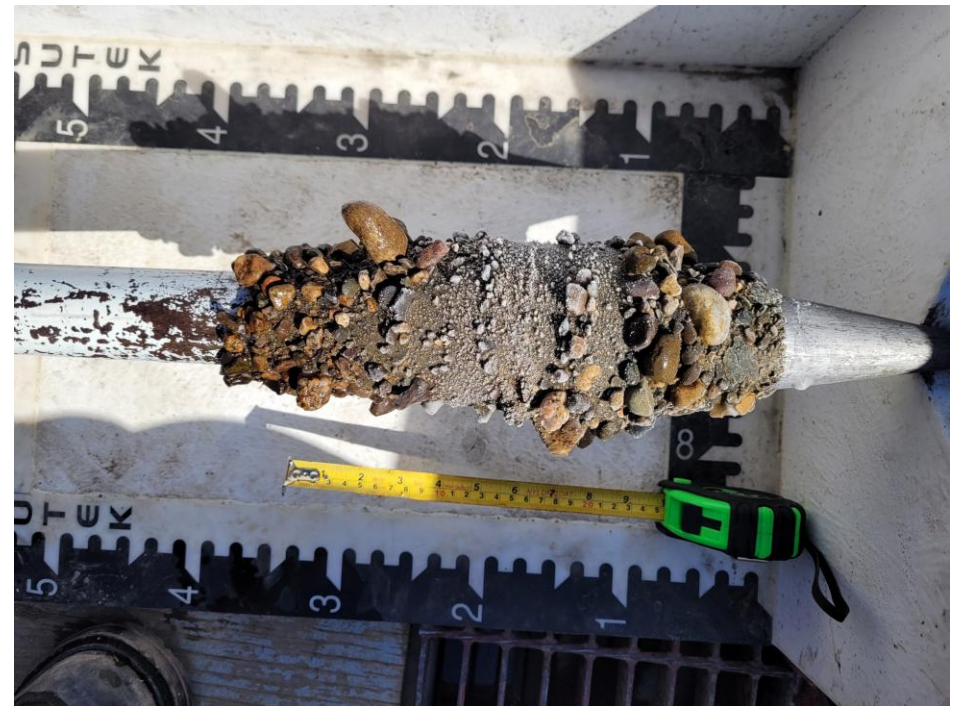
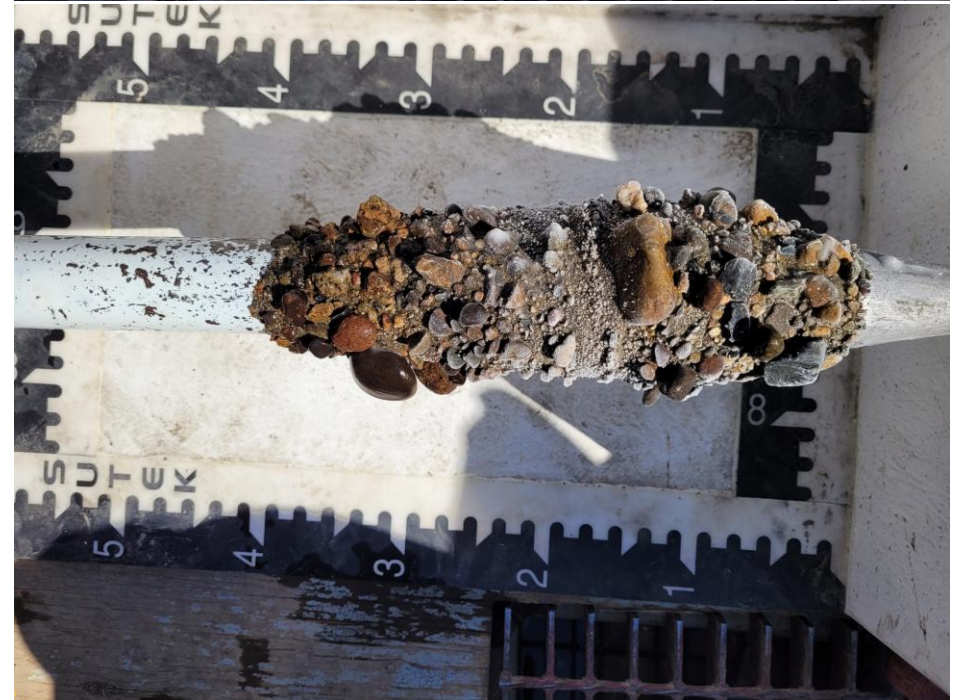
## SITE 12

# POST-TREATMENT (20250512-13)

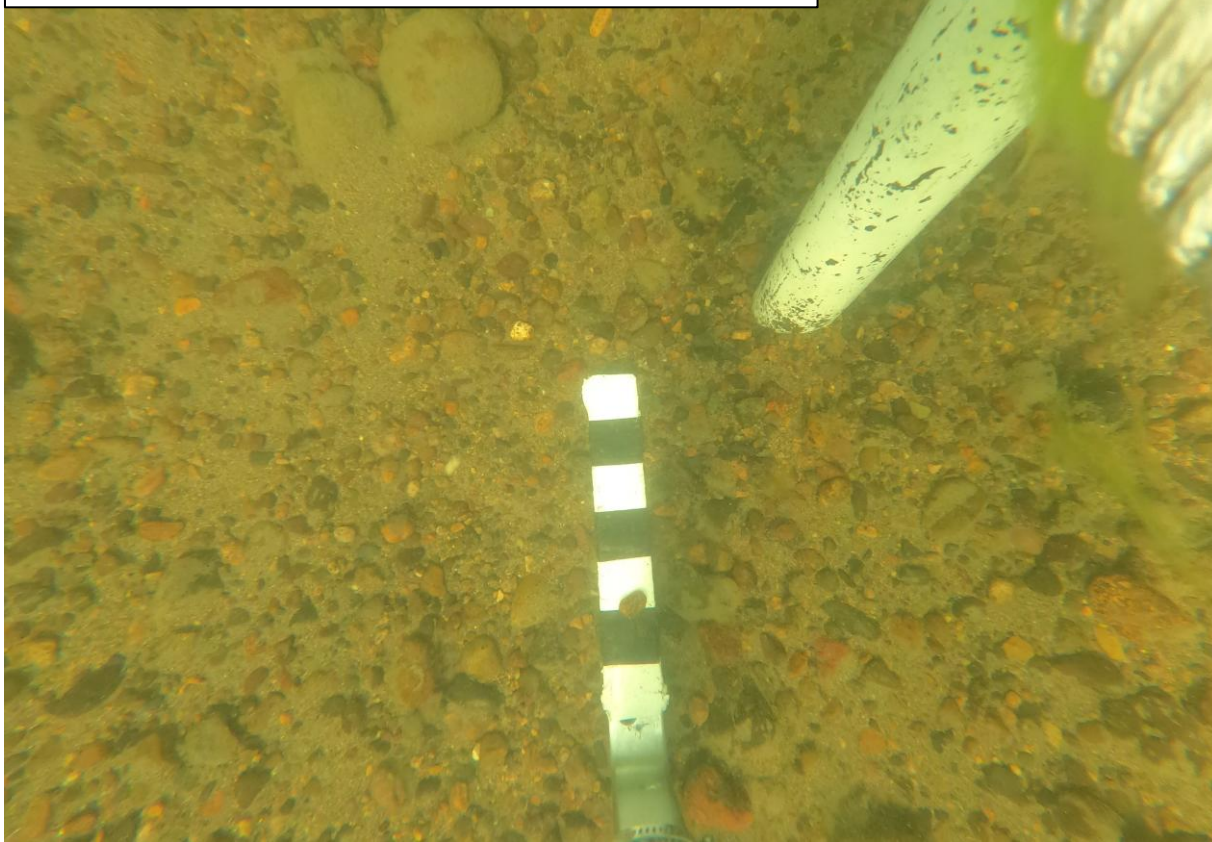
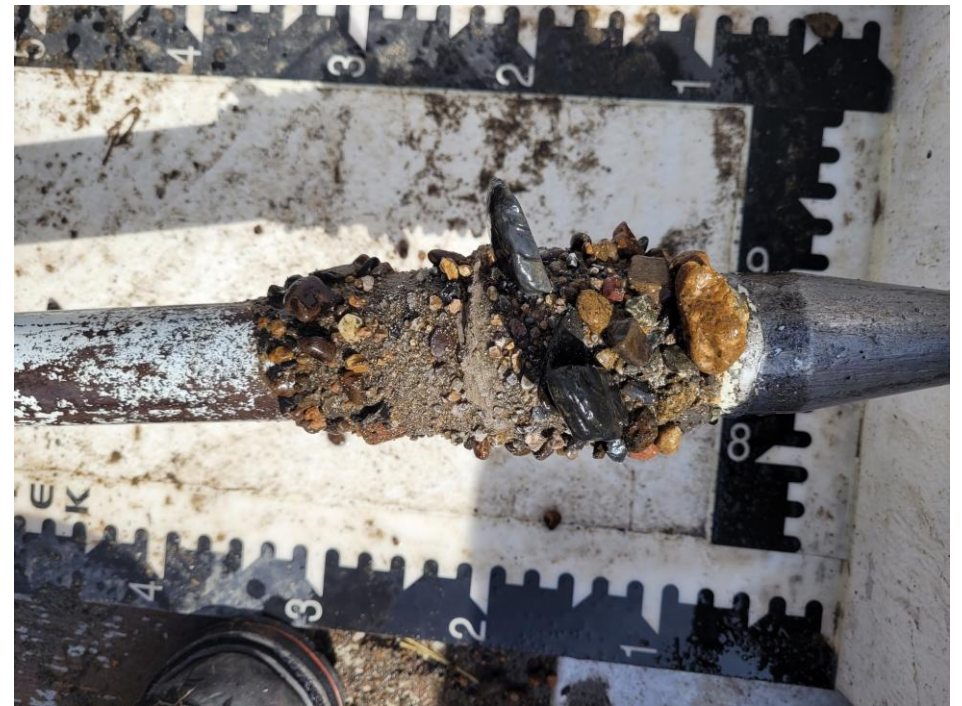
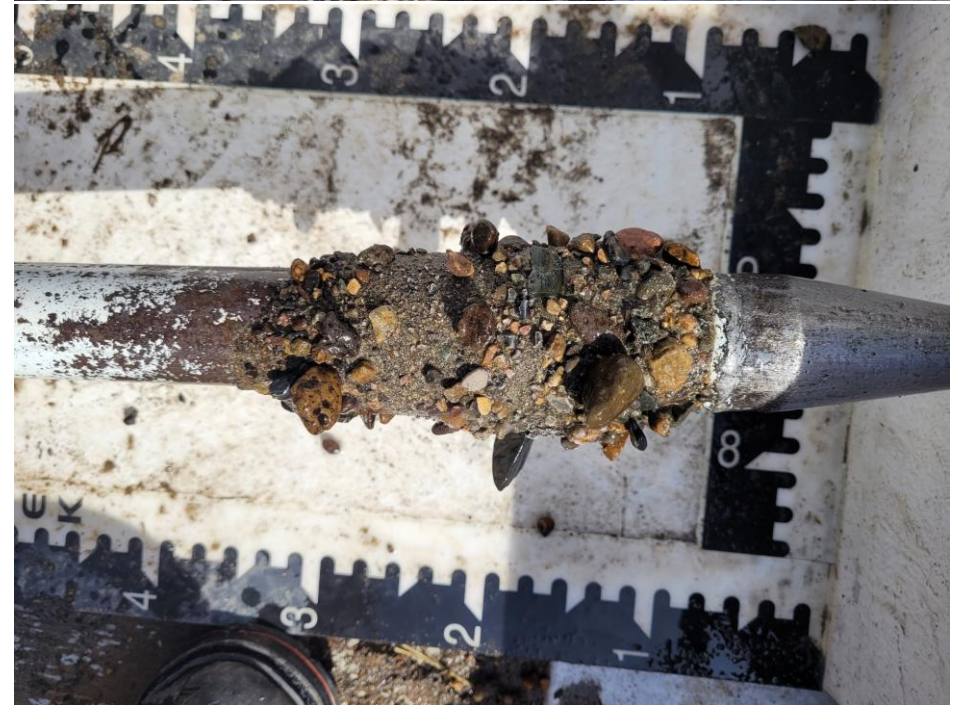
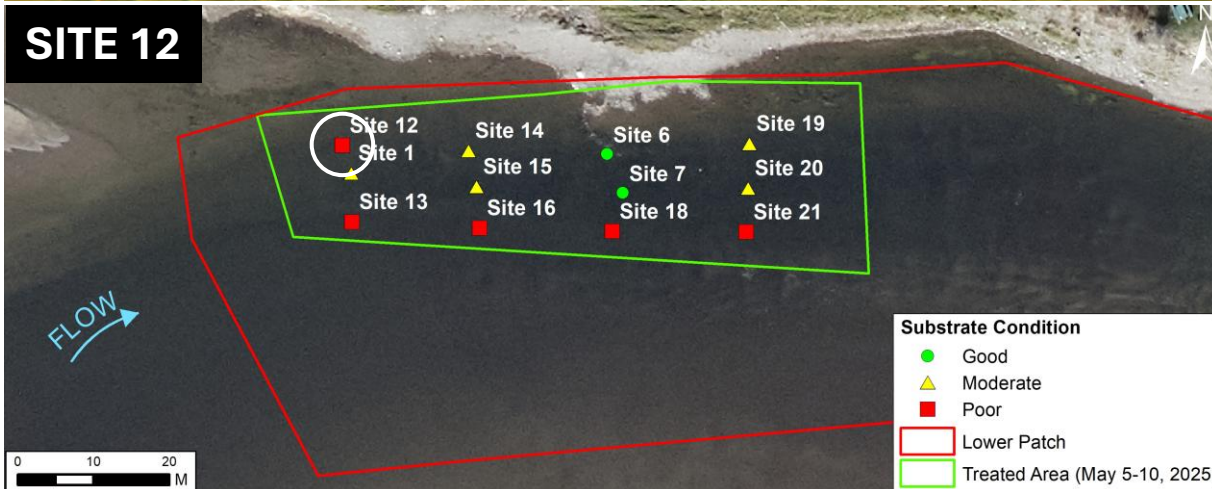
## SITE 12

# POST-TREATMENT (20250619-20)

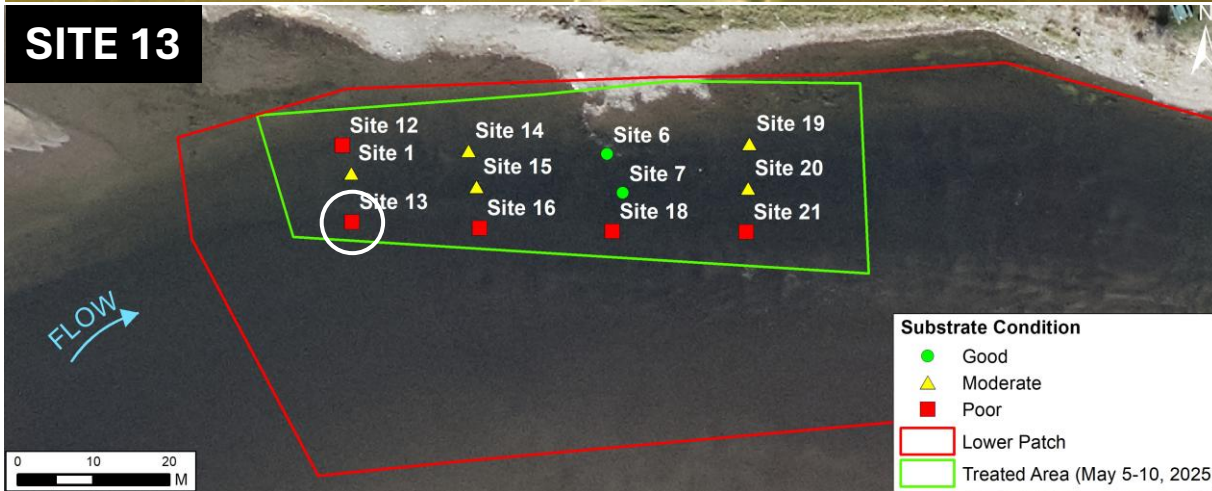
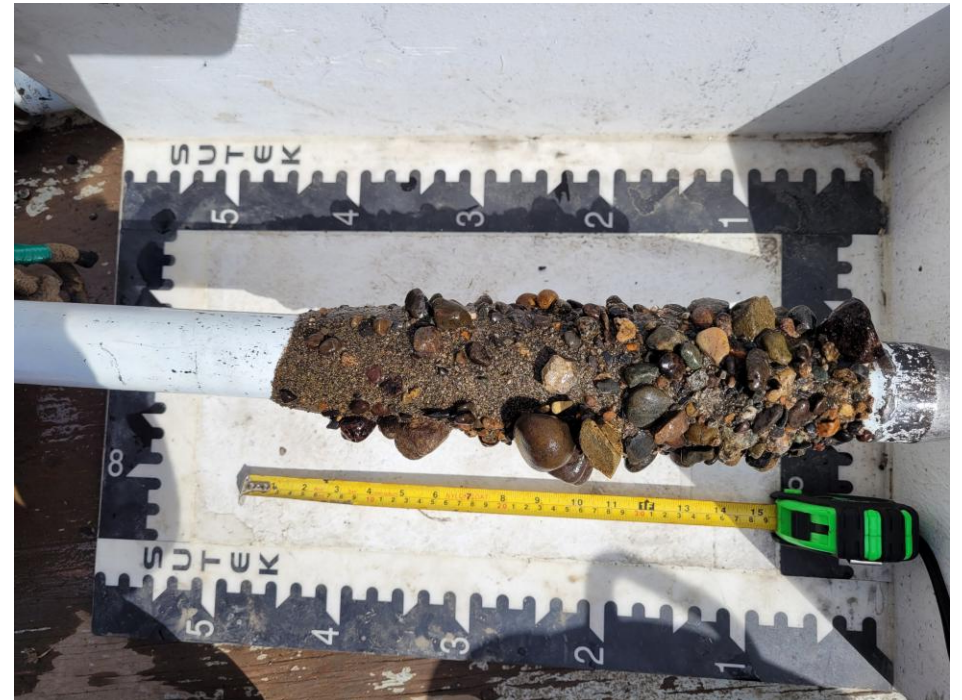
## SITE 13

The lack of large gravels and cobbles is particularly evident along the upstream, southern portion of the Lower Patch spawning pad (see Sites 13 and 16 in Appendix B). These locations were found to contain only a very limited number of cobbles, presumed to have been placed during construction of the spawning pad in 2011. It is uncertain whether the lack of cobbles in these areas reflects: inconsistent/non-uniform material placement in 2011; inaccurate mapping of the spawning pad extents; burial by finer sand and gravel; or downstream transport of the placed cobbles. Of the potential explanations listed above, it is most likely that the lack of coarse substrate in these areas reflects inconsistent placement and/or inaccurate mapping; no survey of the thickness nor extent of the placed substrate was done following construction, which complicates the analysis and is recommended for future gravel placement work. Burial of the placed cobbles by finer sand and gravel is also possible; however, the cores showed no evidence of a buried cobble layer to depths of 40 cm at Sites 13 or 16 (Appendix B). In contrast, Sites 18 and 21, located further downstream on the spawning pad, showed greater evidence of placed cobbles both on the surface and at-depth (Appendix B). The varying proportion of coarse gravels and cobbles in the pre-existing substrate has direct implications for the potential effectiveness of different restoration treatments; for example, insufficient gravels and cobbles would limit the effectiveness of dredging or mechanical raking, as digging through sandy gravel will likely still result in a sandy gravel substrate. Further recommendations regarding potential restoration treatments and their effectiveness are provided in Section 5.

# POST-TREATMENT (20250512-13)

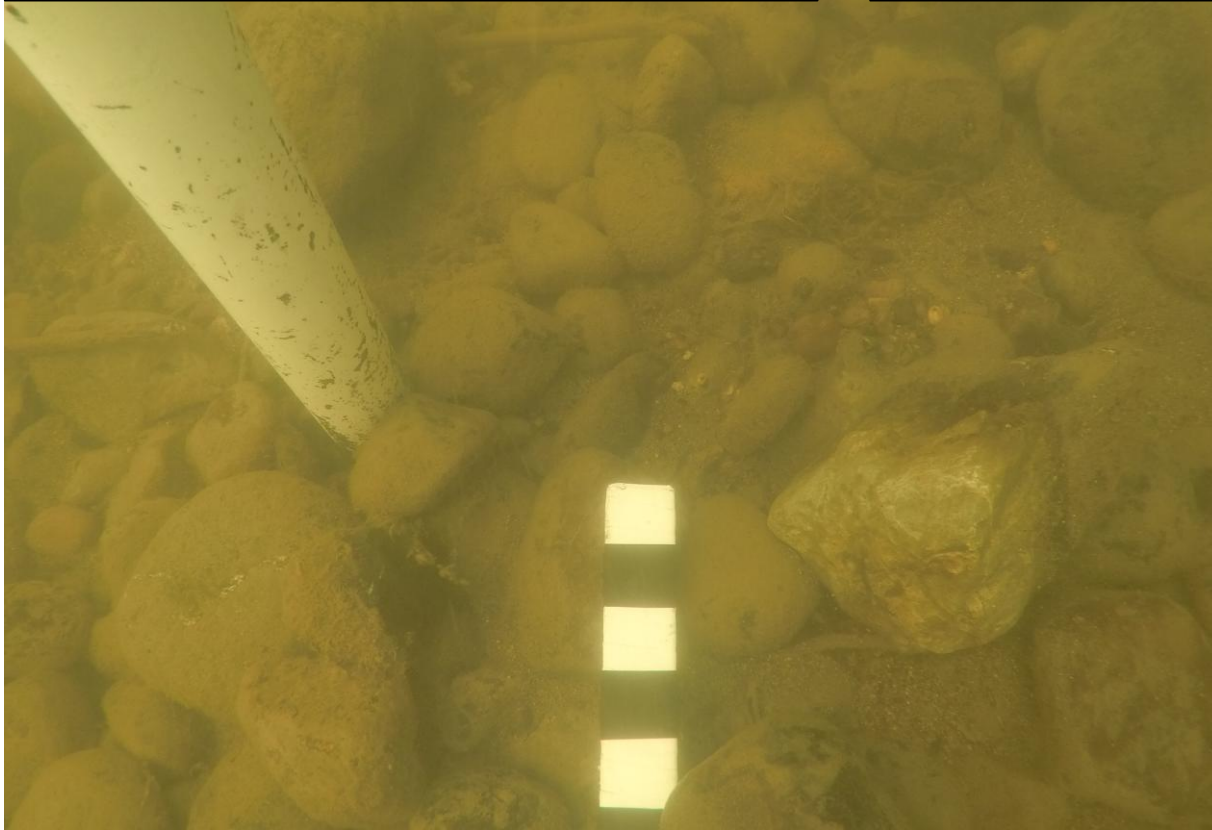
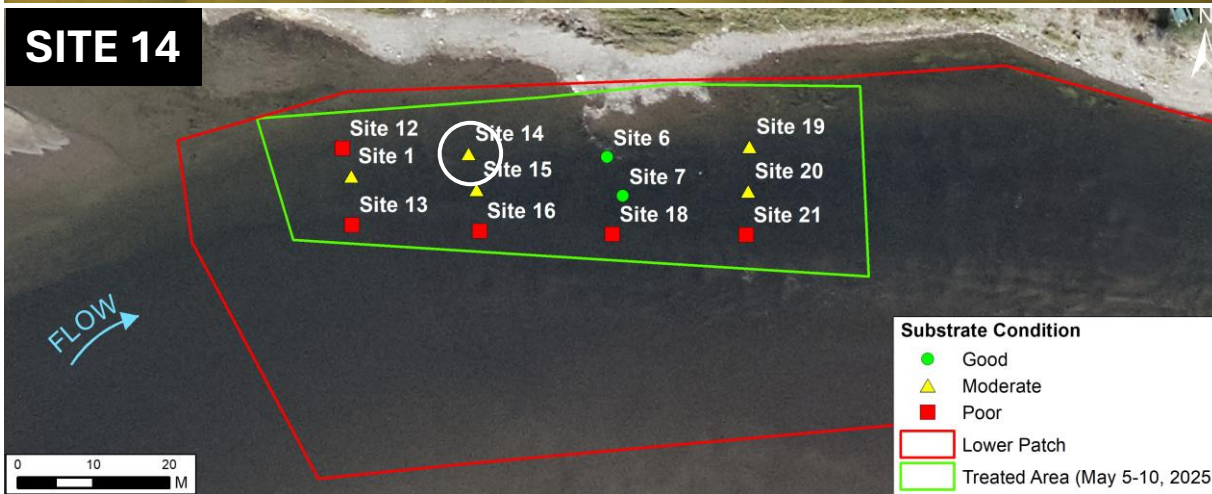
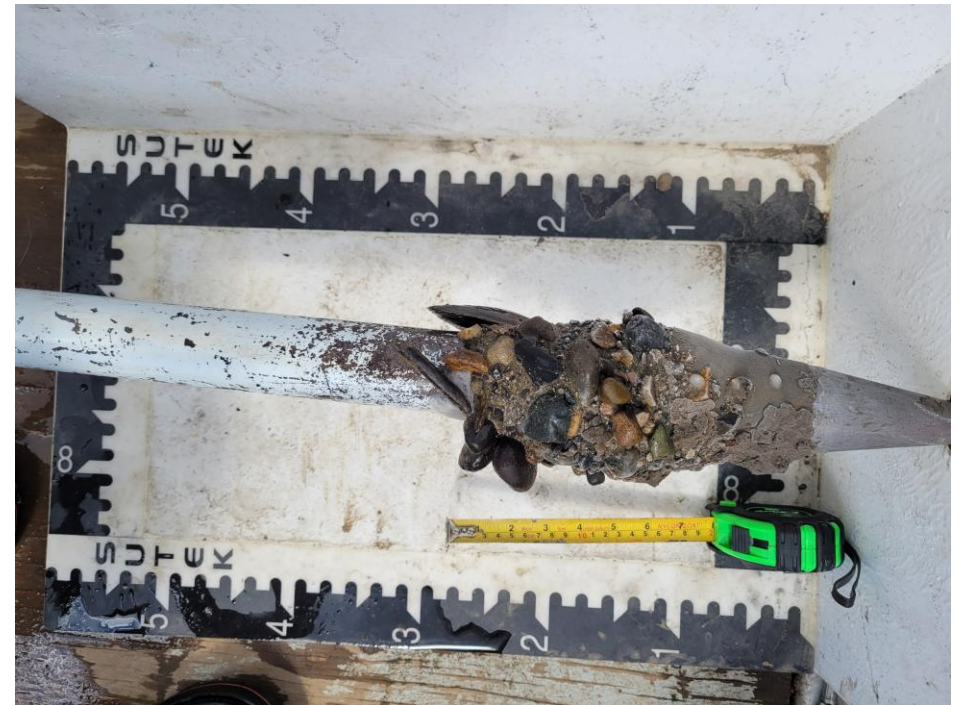
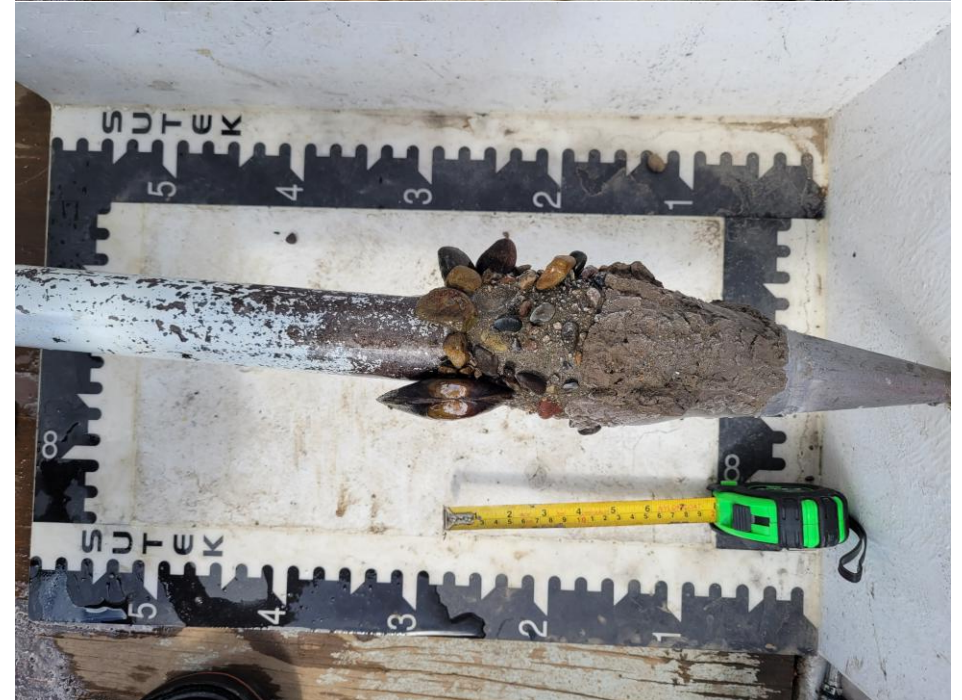
SITE 14

POST-TREATMENT (20250512-13)

Sample 1 of 2

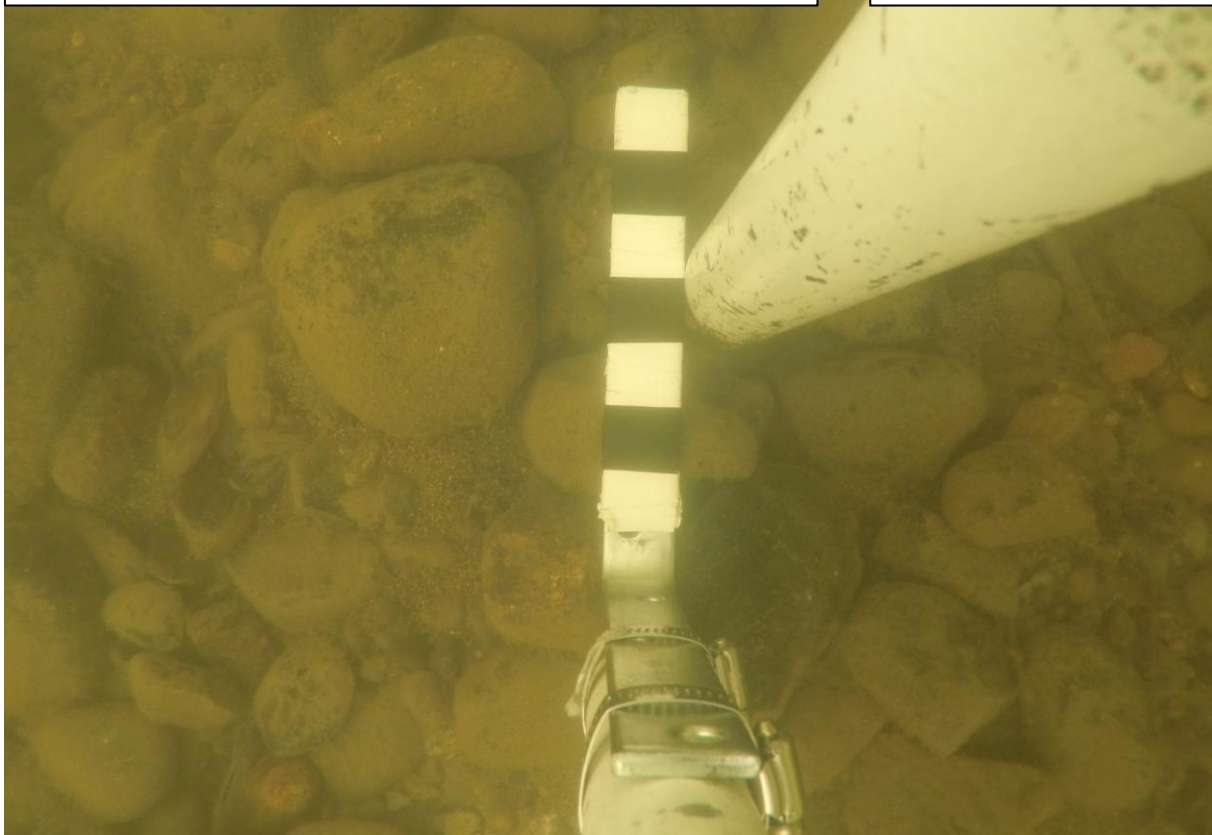
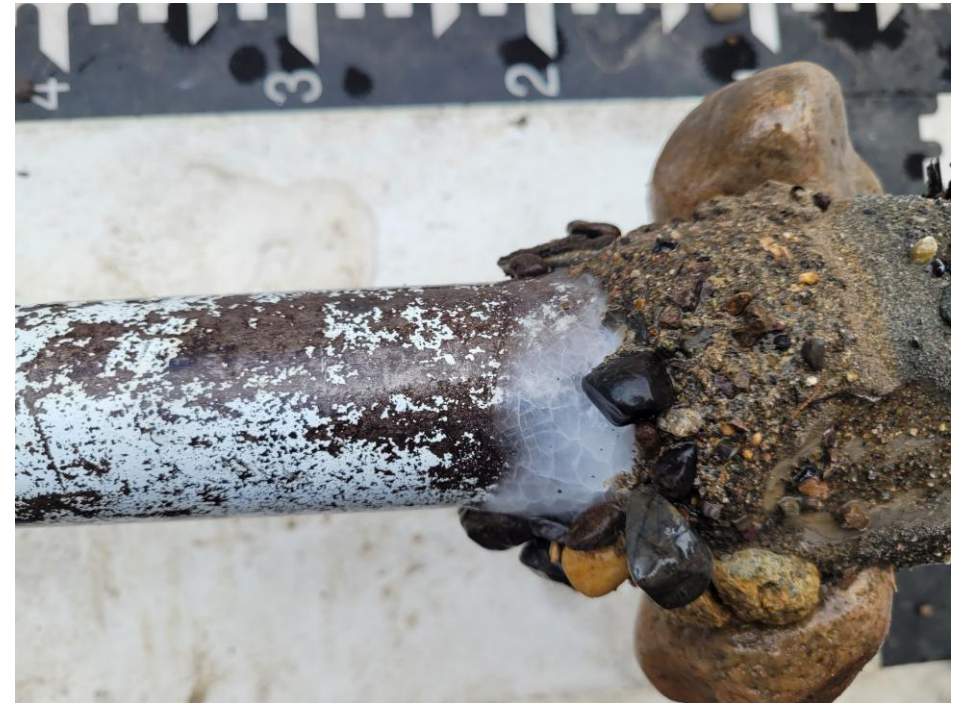
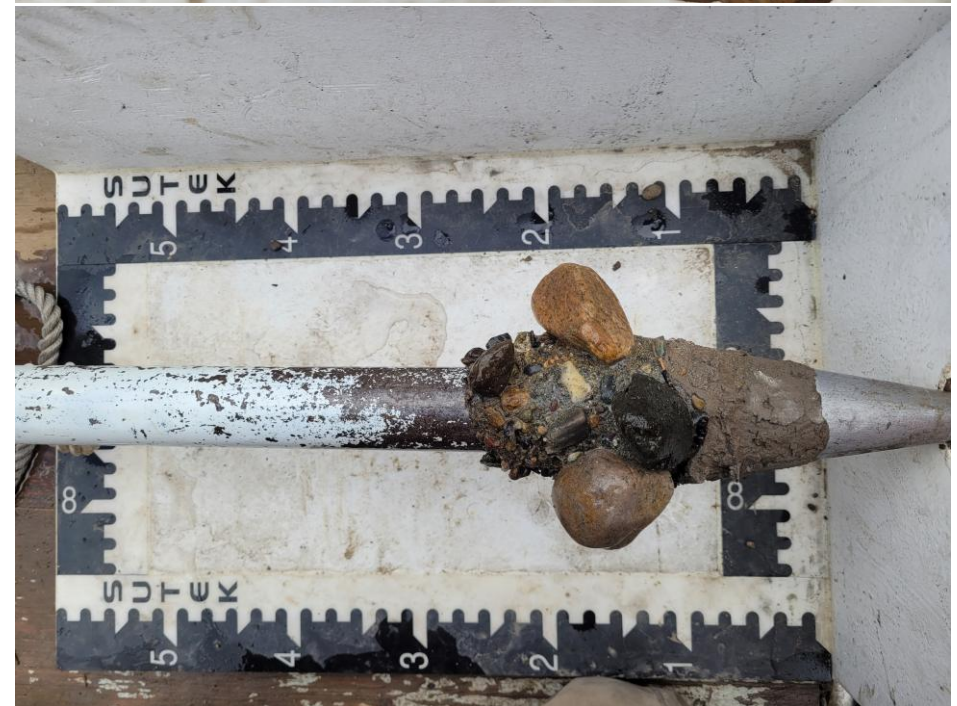
SITE 14

POST-TREATMENT (20250512-13)

Sample 2 of 2
