# 2024-2025 Nechako River Substrate Monitoring

## Final Report

**Northwest Hydraulic Consultants Ltd.**

November 20, 2025  
Final Report, Rev. 1

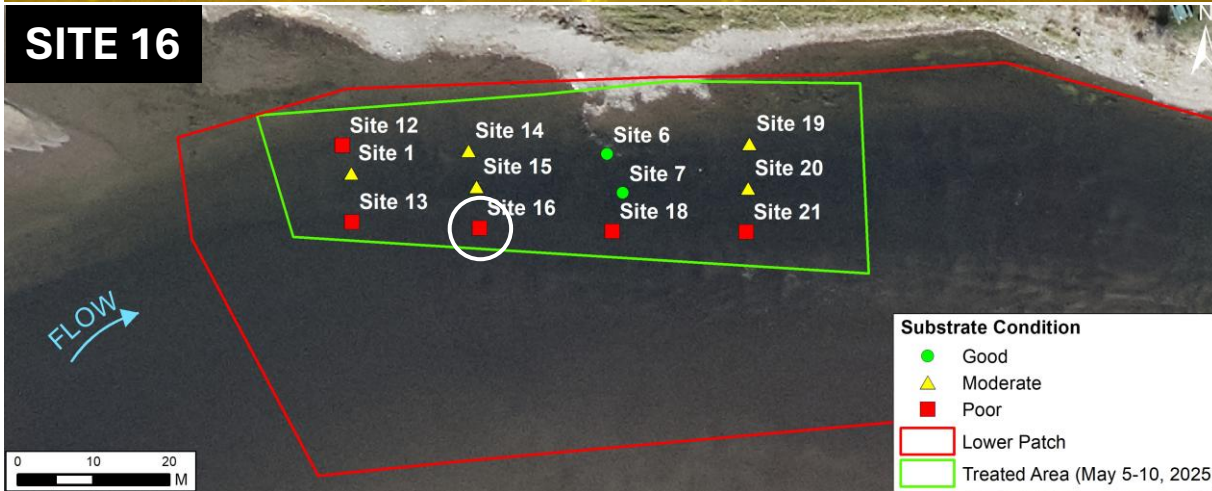
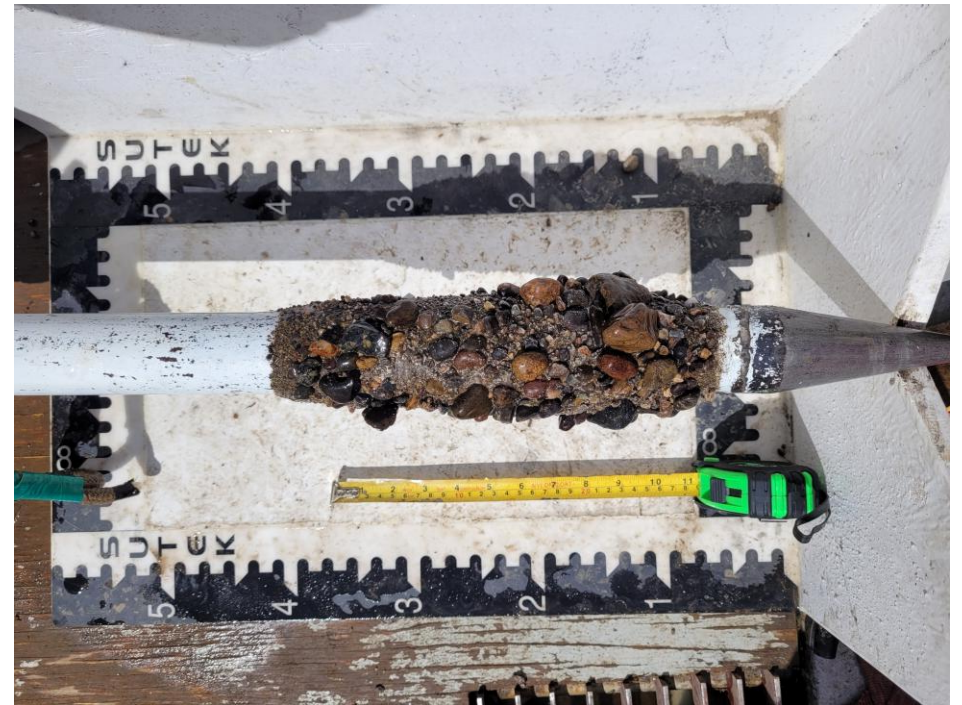
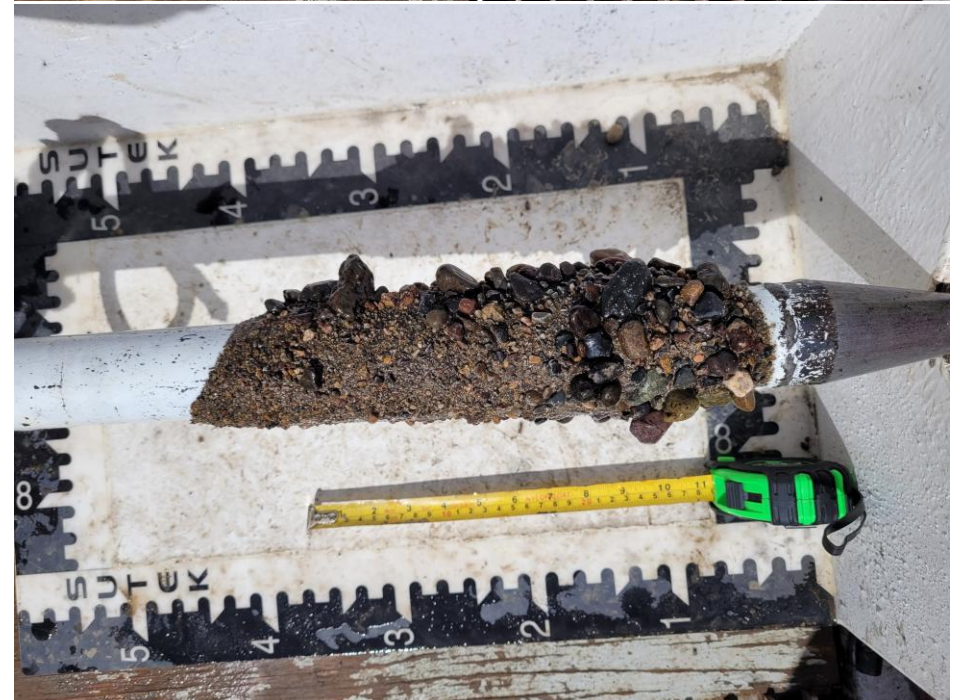
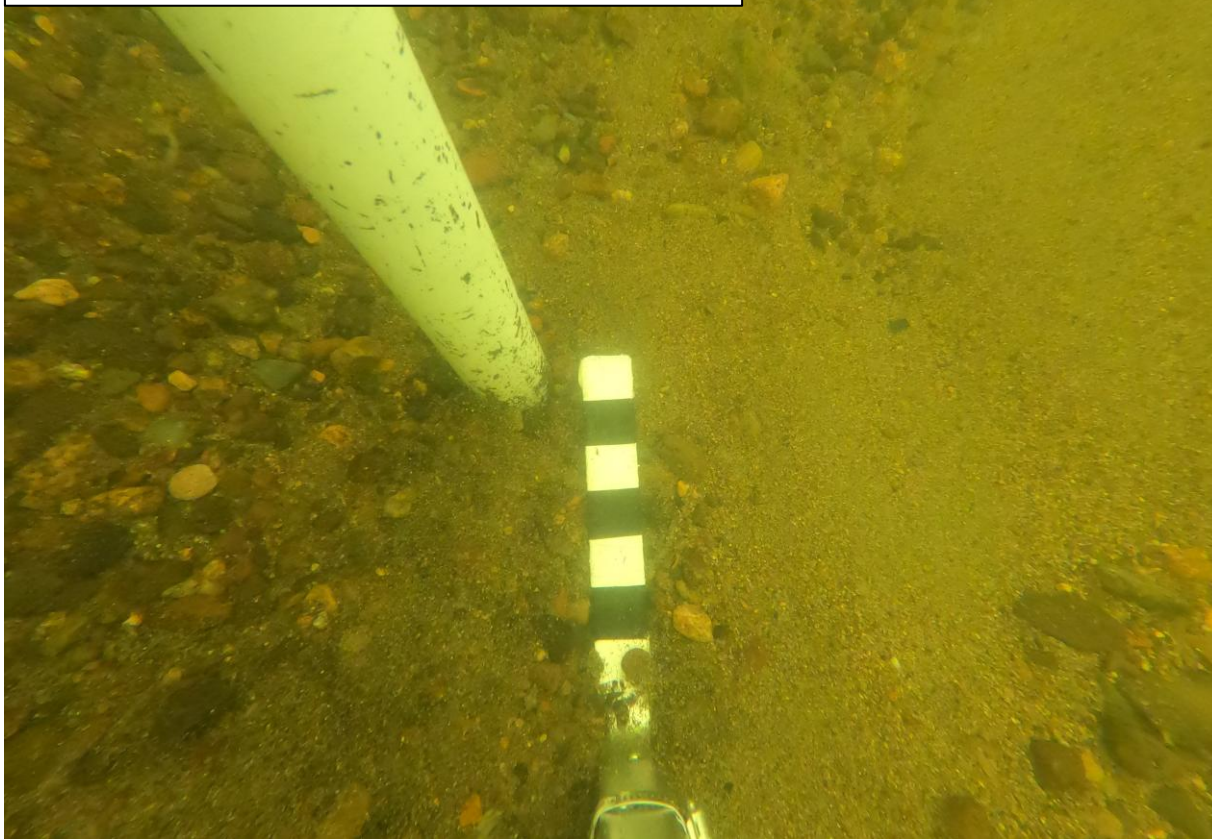
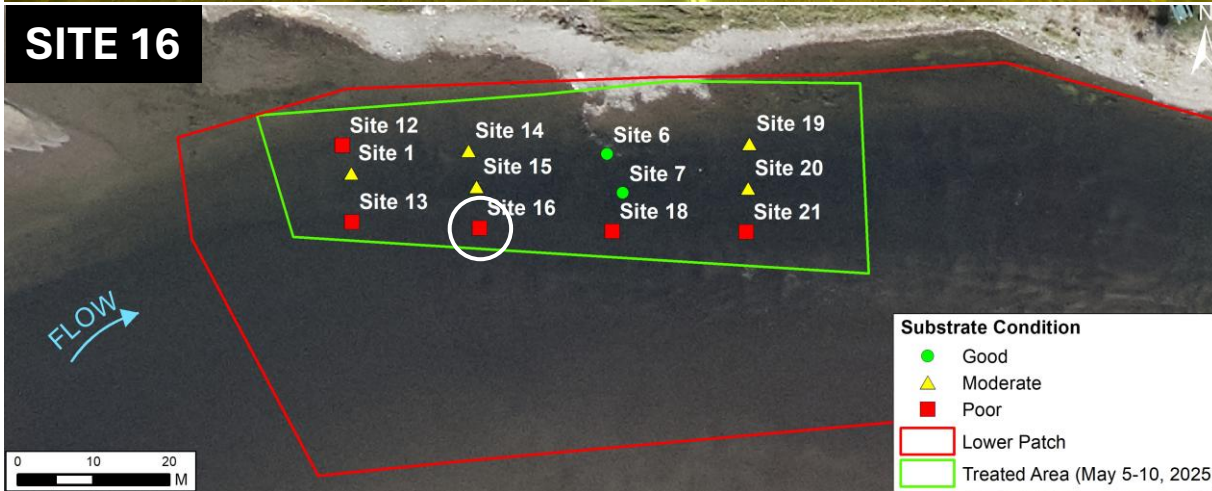
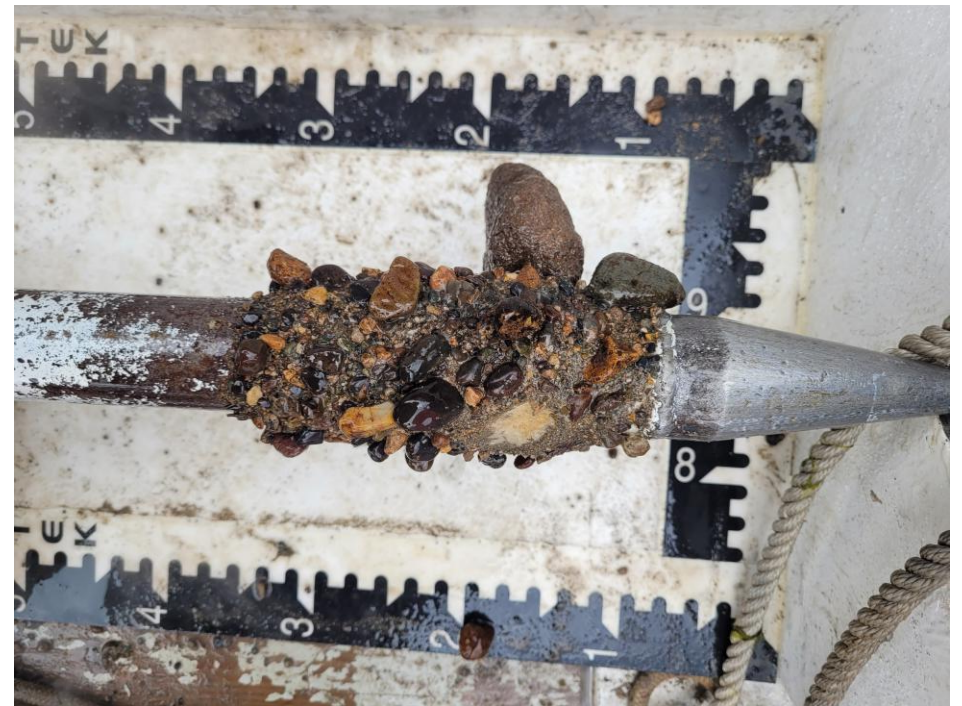
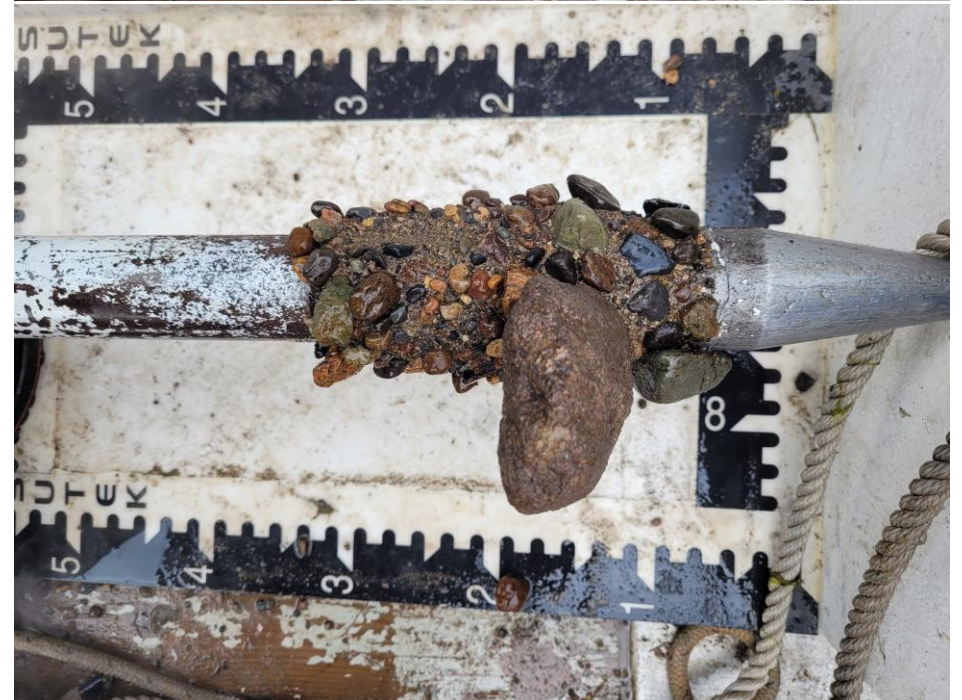
## SITE 16

The lack of large gravels and cobbles is particularly evident along the upstream, southern portion of the Lower Patch spawning pad (see Sites 13 and 16 in Appendix B). These locations were found to contain only a very limited number of cobbles, presumed to have been placed during construction of the spawning pad in 2011. It is uncertain whether the lack of cobbles in these areas reflects: inconsistent/non-uniform material placement in 2011; inaccurate mapping of the spawning pad extents; burial by finer sand and gravel; or downstream transport of the placed cobbles. Of the potential explanations listed above, it is most likely that the lack of coarse substrate in these areas reflects inconsistent placement and/or inaccurate mapping; no survey of the thickness nor extent of the placed substrate was done following construction, which complicates the analysis and is recommended for future gravel placement work. Burial of the placed cobbles by finer sand and gravel is also possible; however, the cores showed no evidence of a buried cobble layer to depths of 40 cm at Sites 13 or 16 (Appendix B). In contrast, Sites 18 and 21, located further downstream on the spawning pad, showed greater evidence of placed cobbles both on the surface and at-depth (Appendix B). The varying proportion of coarse gravels and cobbles in the pre-existing substrate has direct implications for the potential effectiveness of different restoration treatments; for example, insufficient gravels and cobbles would limit the effectiveness of dredging or mechanical raking, as digging through sandy gravel will likely still result in a sandy gravel substrate. Further recommendations regarding potential restoration treatments and their effectiveness are provided in Section 5.

- The effectiveness of mechanical remediation of existing substrate on the Lower Patch (using the tools to date) appears to be limited due to the insufficient proportion of coarse gravels and cobbles and high sand content contained within the bed sediment mixture. Two recommendations stem from this finding:

- Should remediation of existing substrate remain the NWSRI's preferred approach, it is recommended that additional remediation techniques be investigated that can effectively remove and displace the sand contained within the sediment mixture (e.g., specialized dredge).
- A more effective approach may be to shift the focus from remediation or cleaning of existing substrate to placement of additional spawning substrate to effectively coarsen the composition of the surficial sediment mixture. Should this approach be selected, NHC recommends further study be conducted prior to implementation, including: sediment transport and substrate monitoring at candidate sites; sediment tracer studies to assess gravel mobility; and numerical modelling to assess potential increases in flood risk associated with the substrate placement.

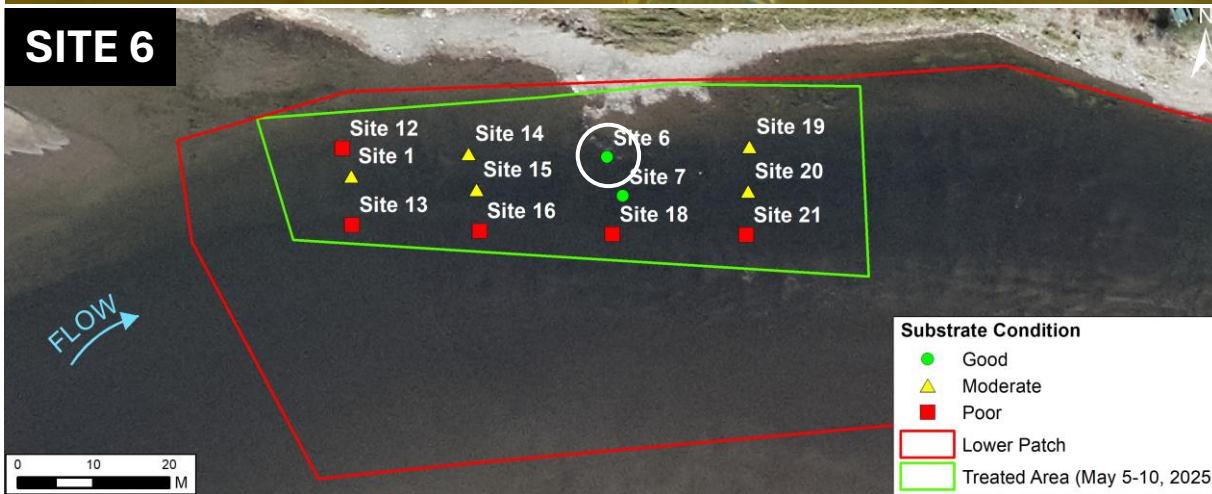
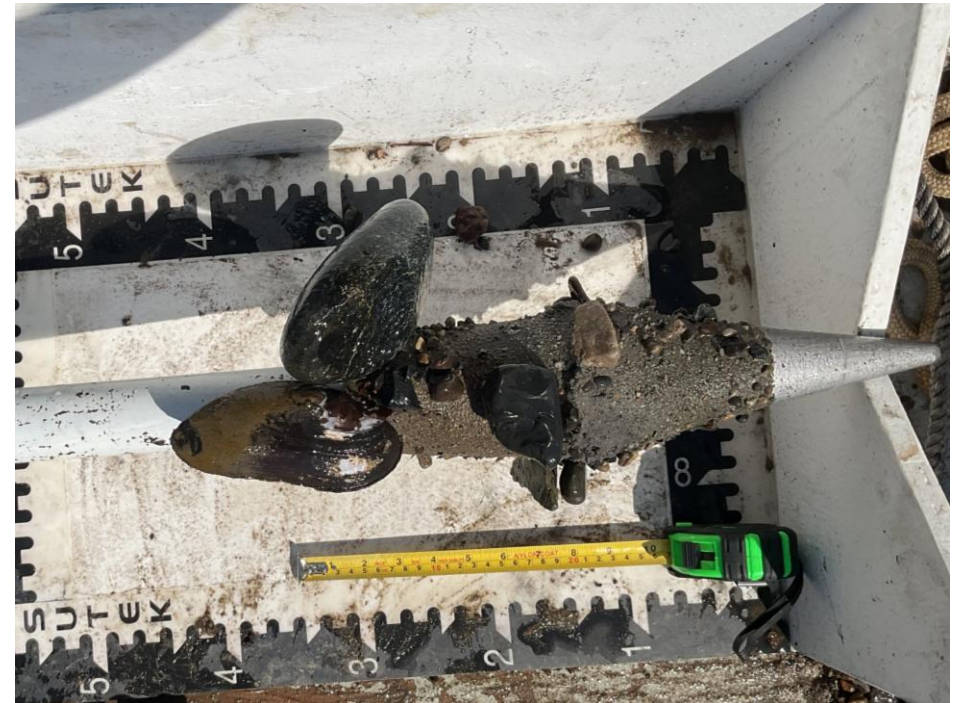
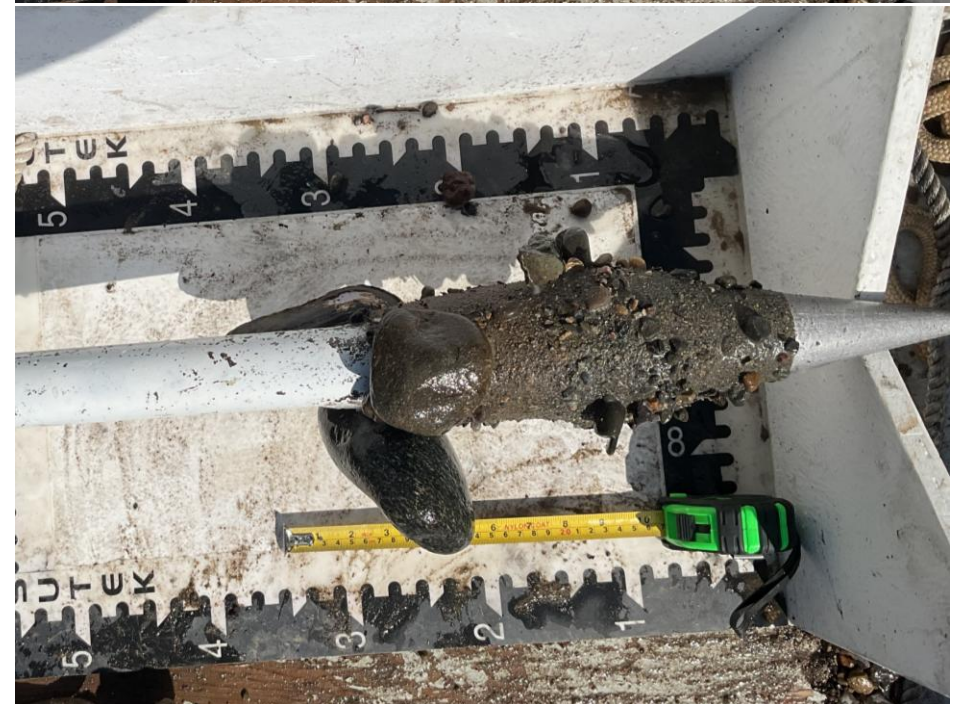
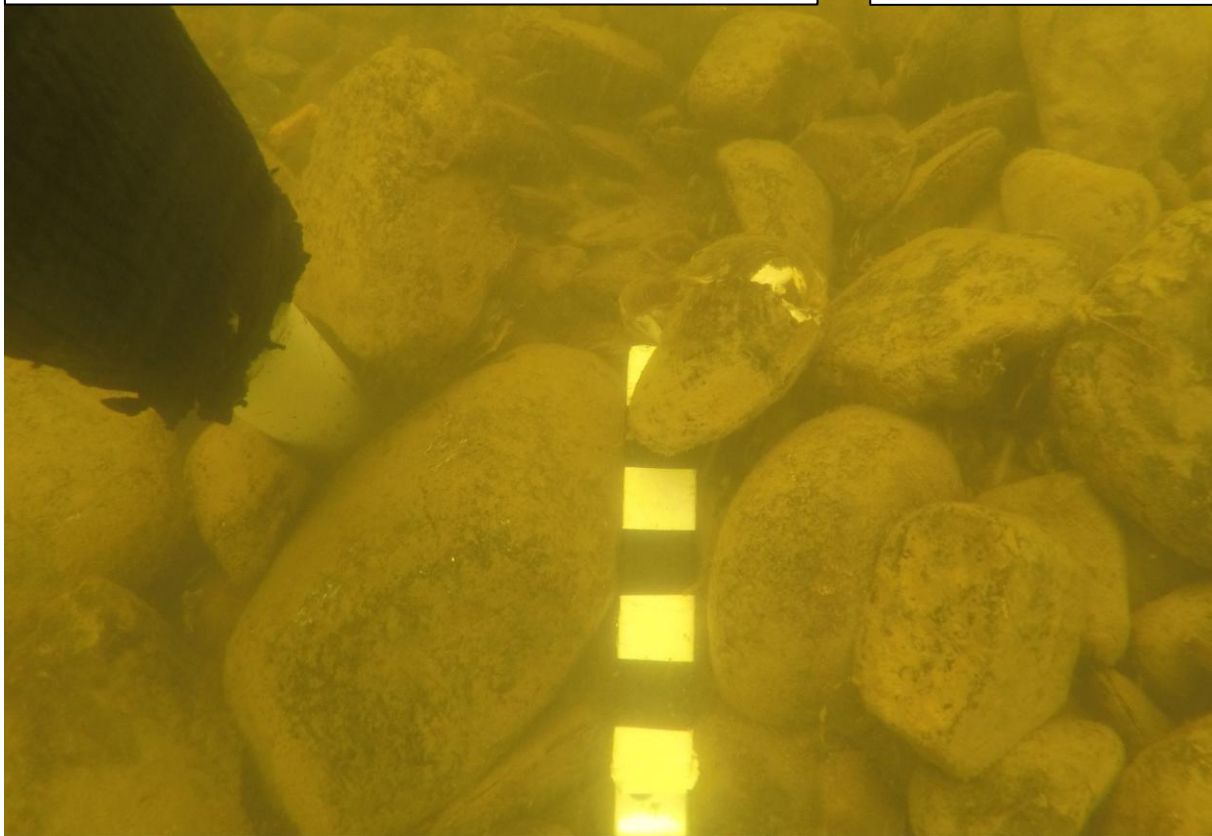
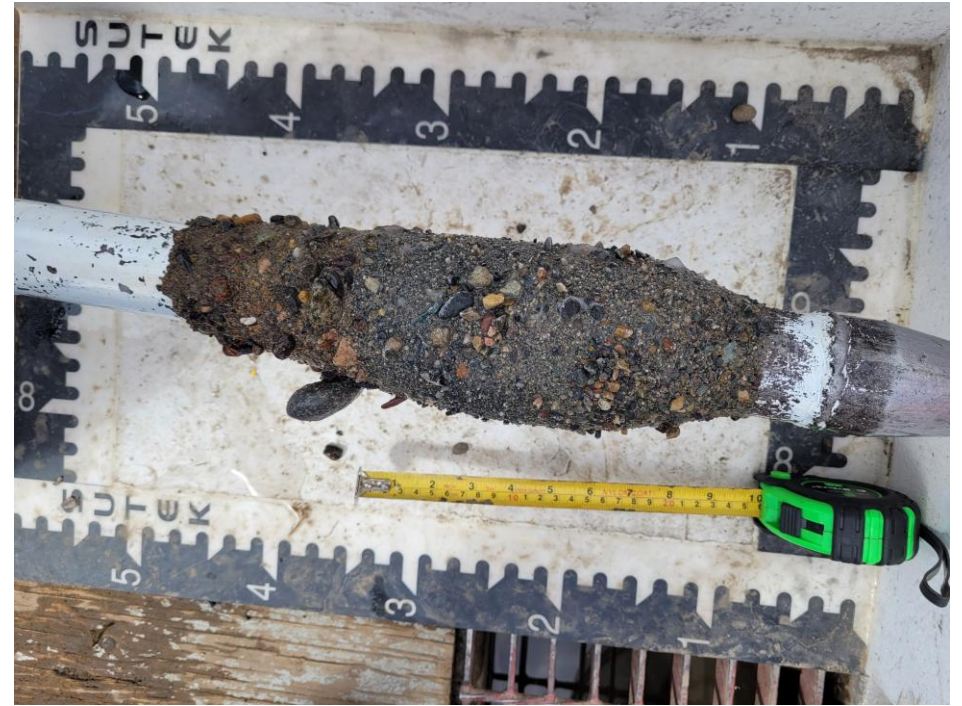
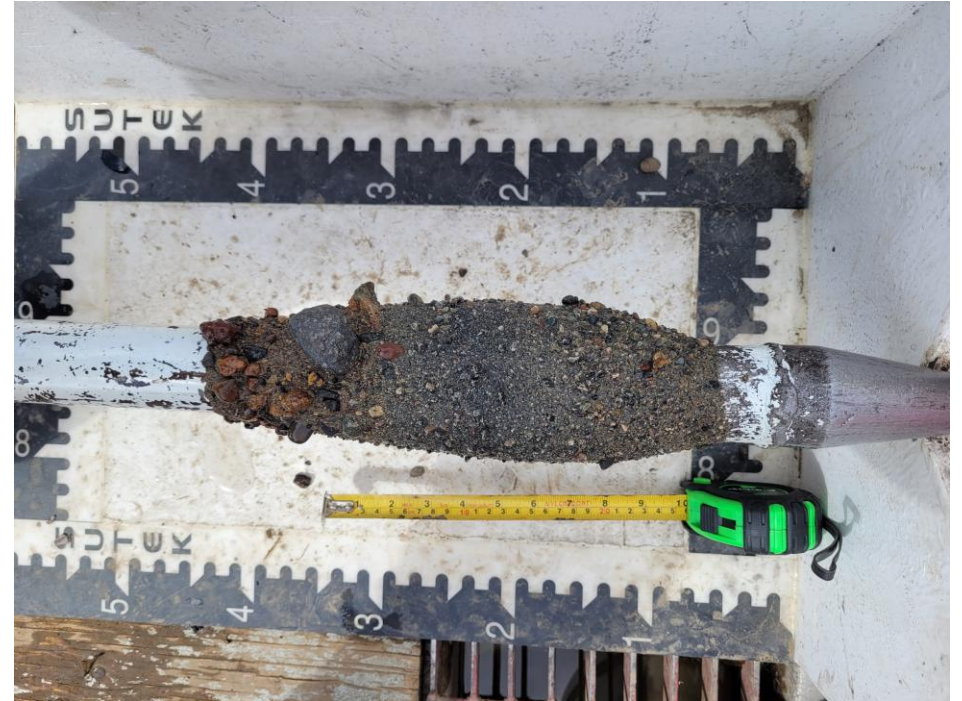
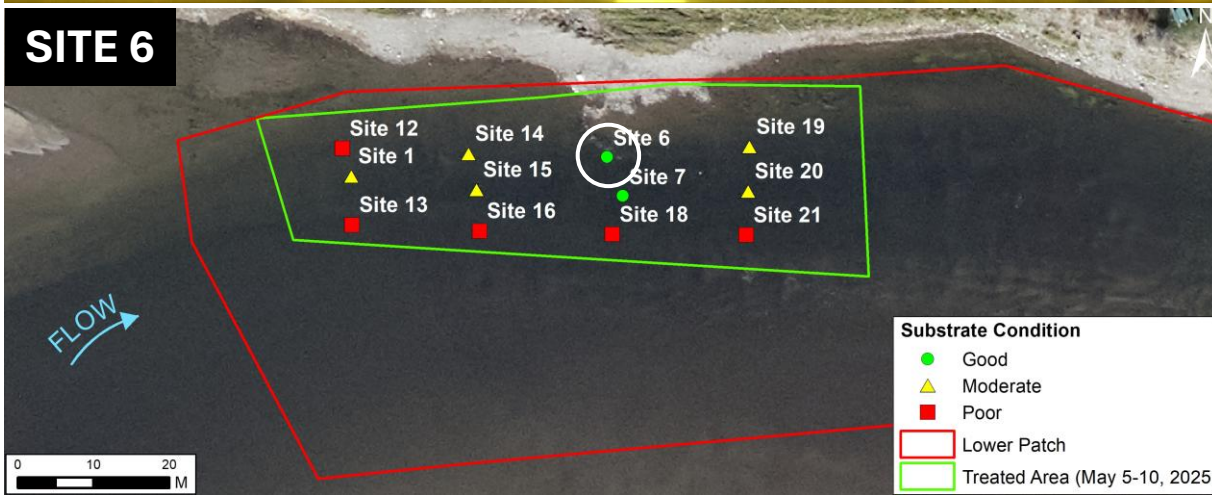
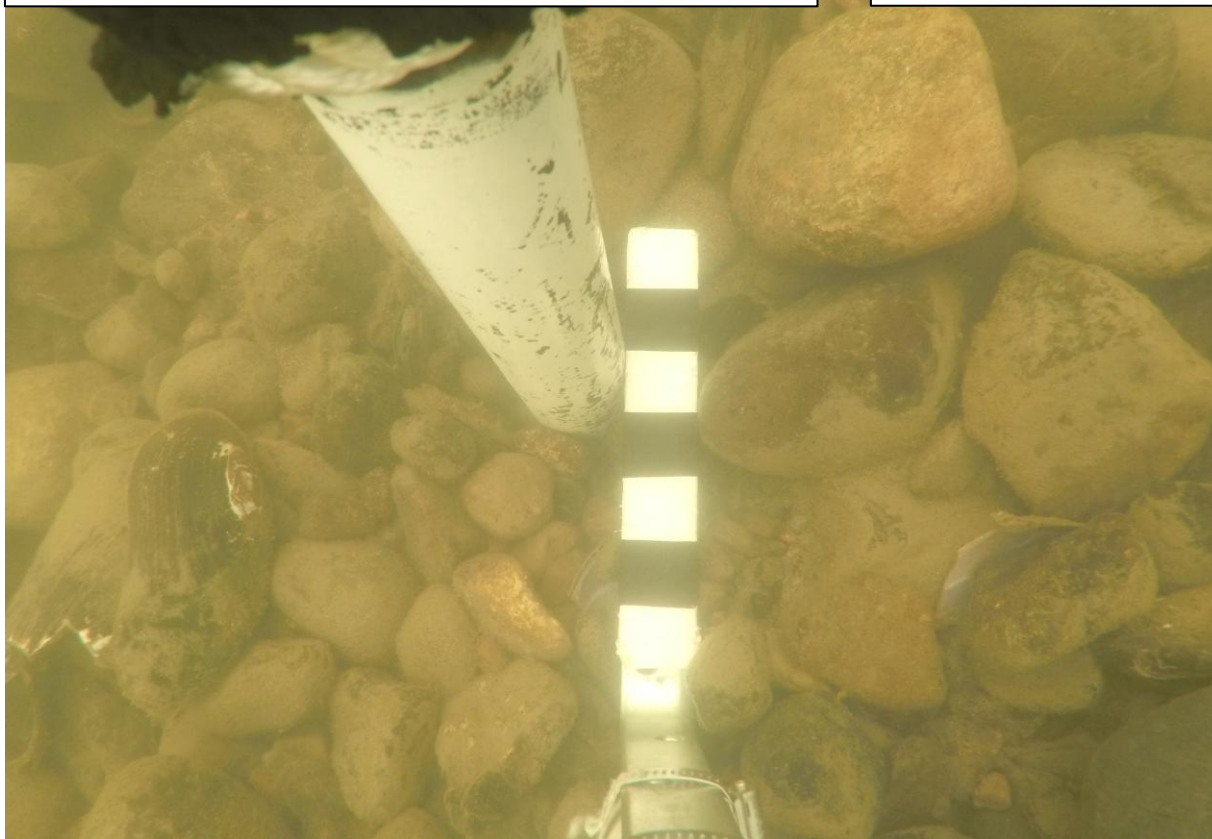
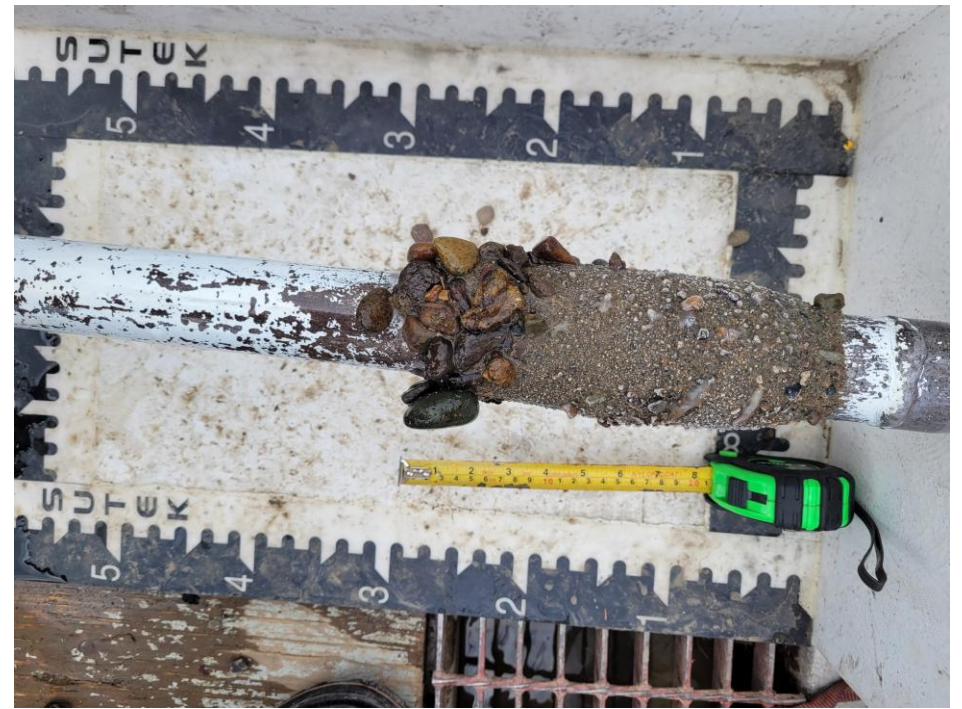
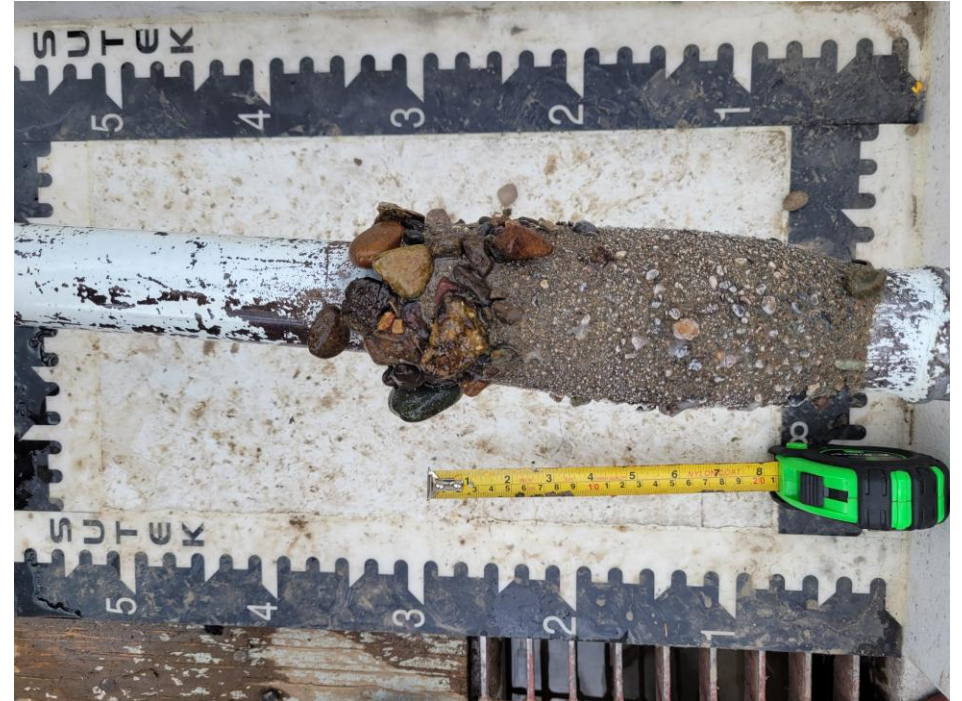
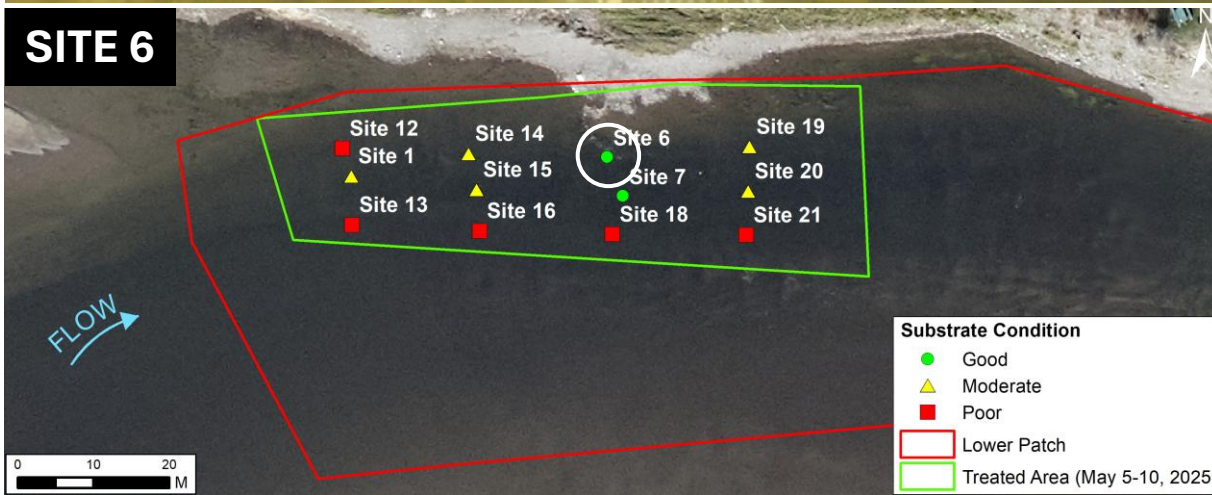
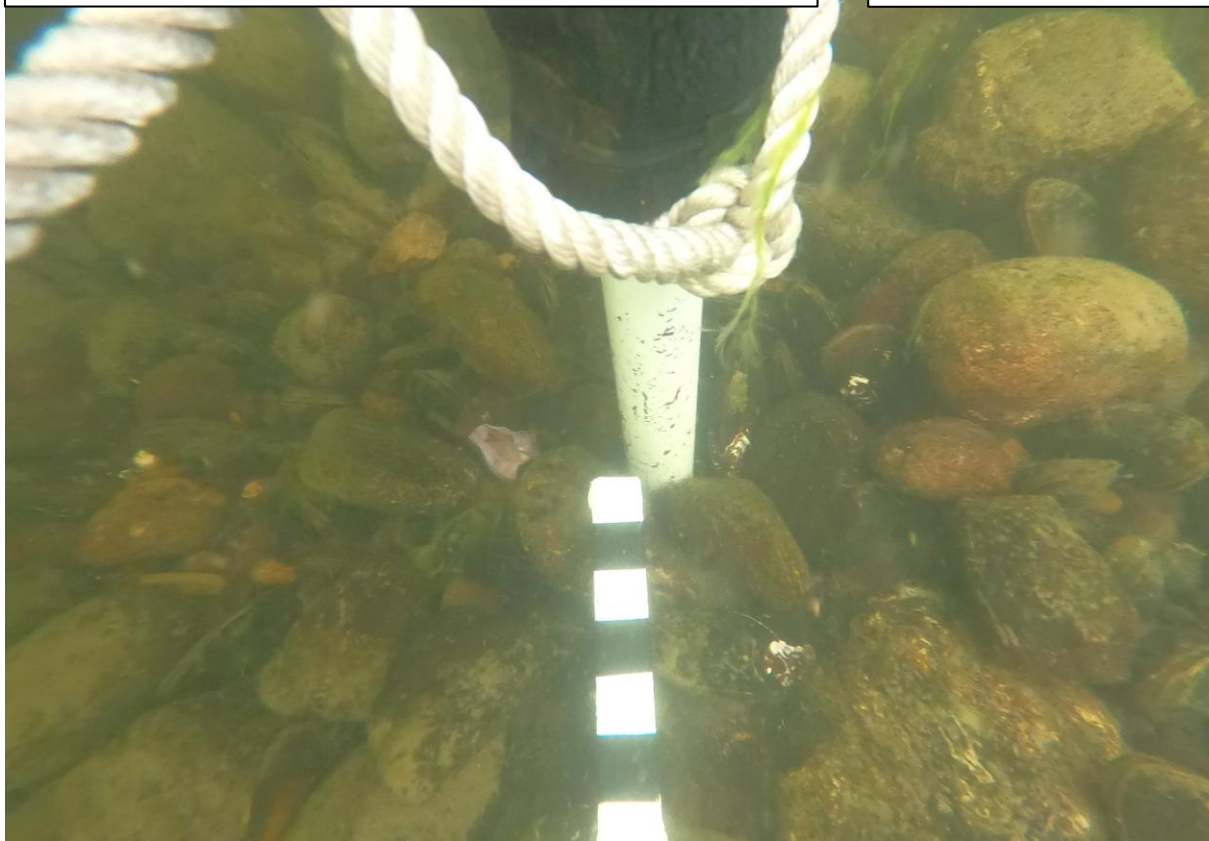
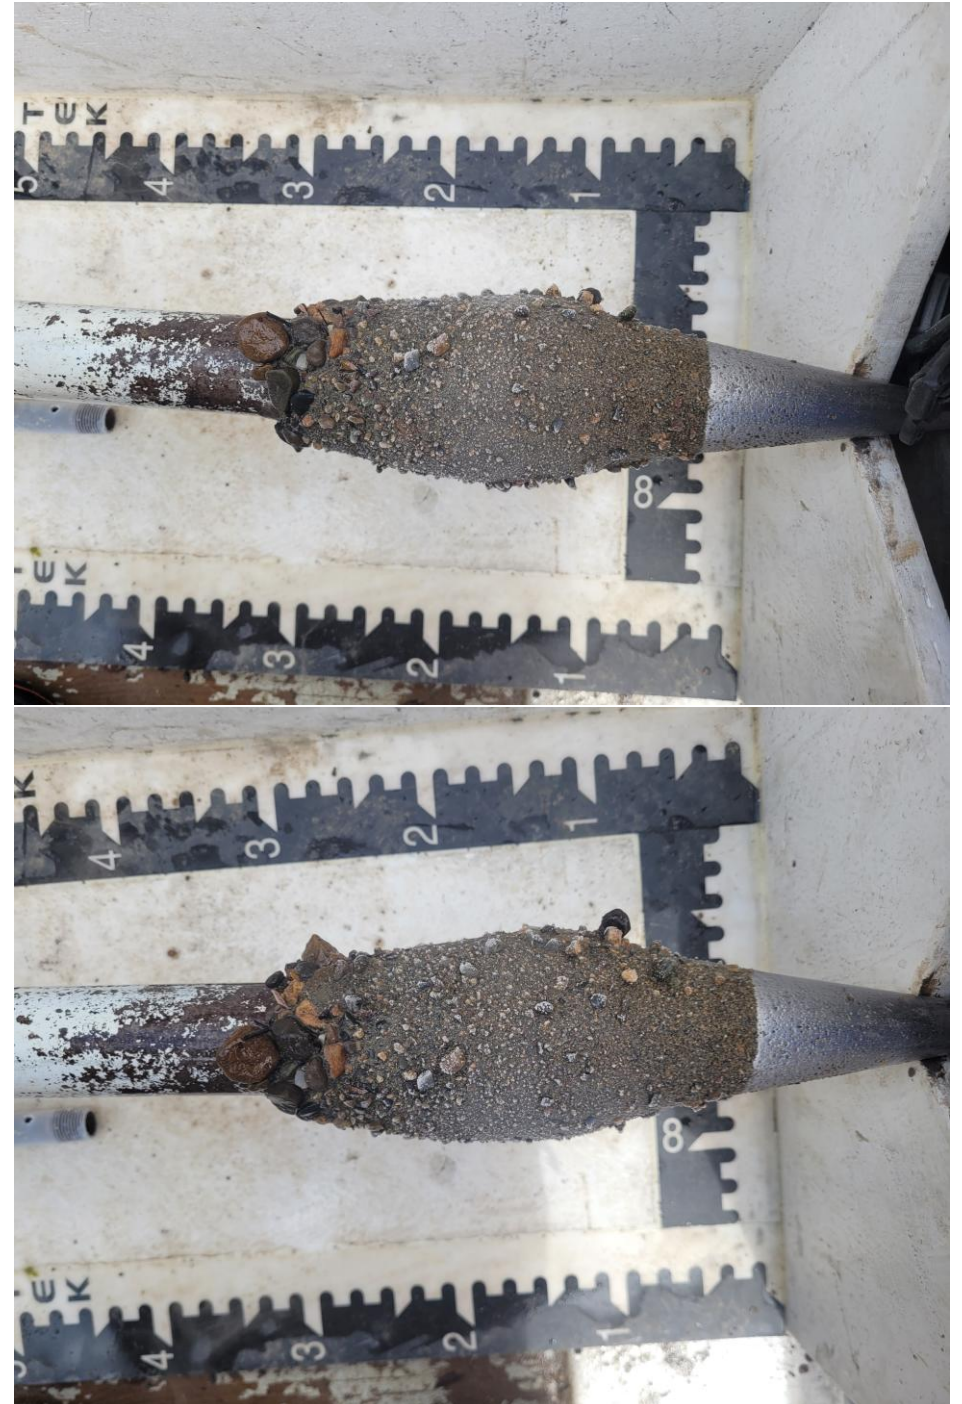
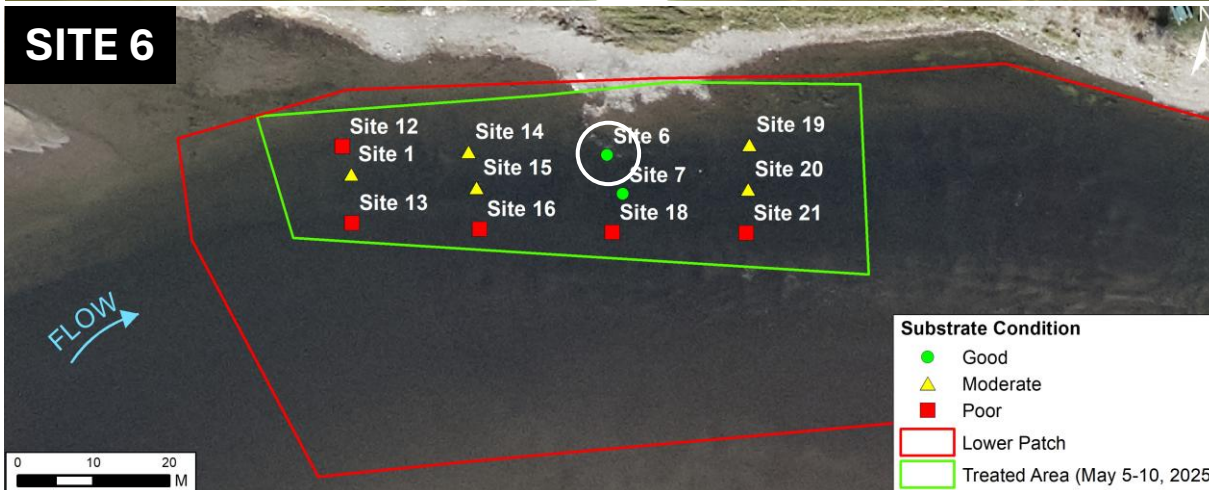
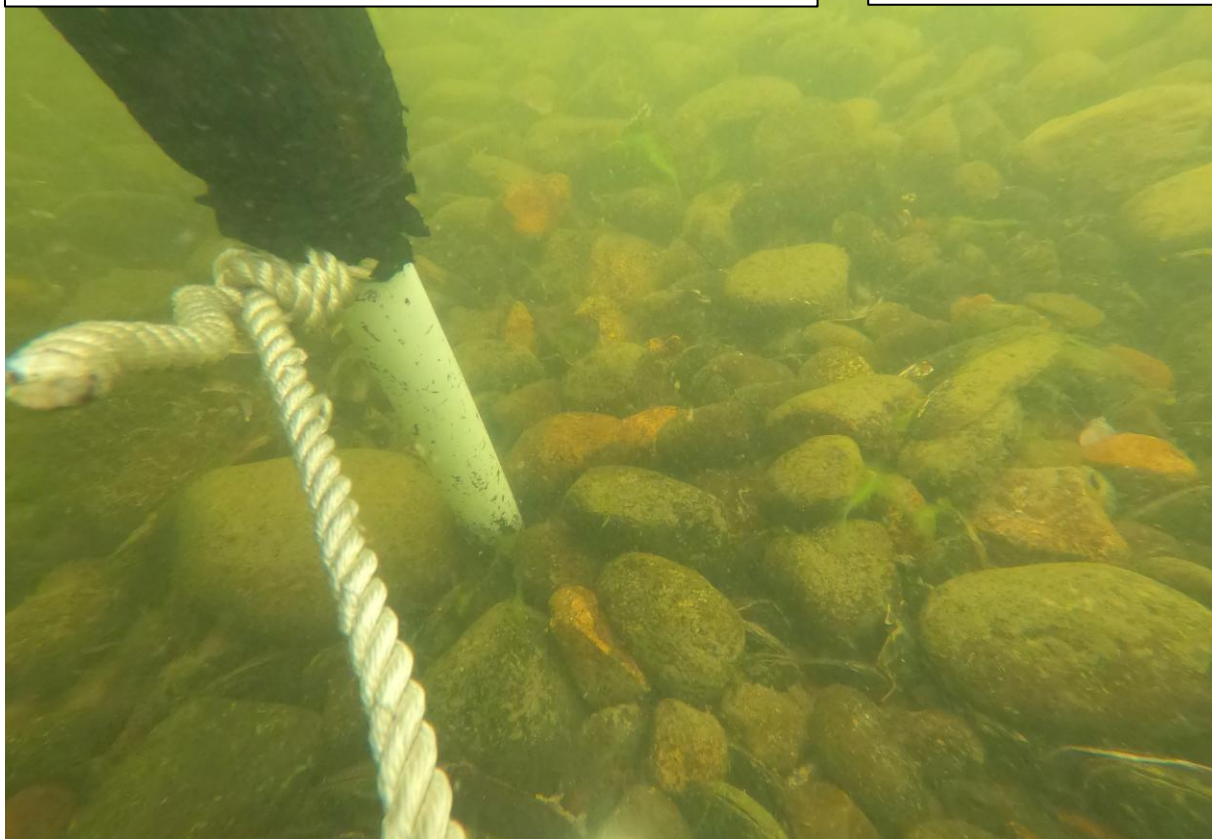
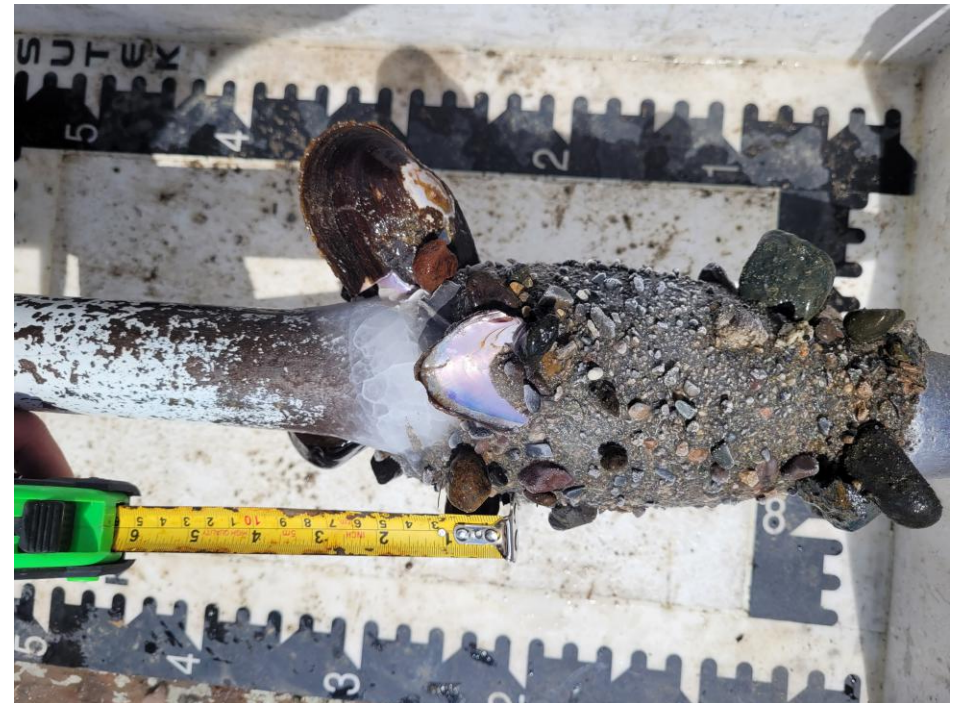
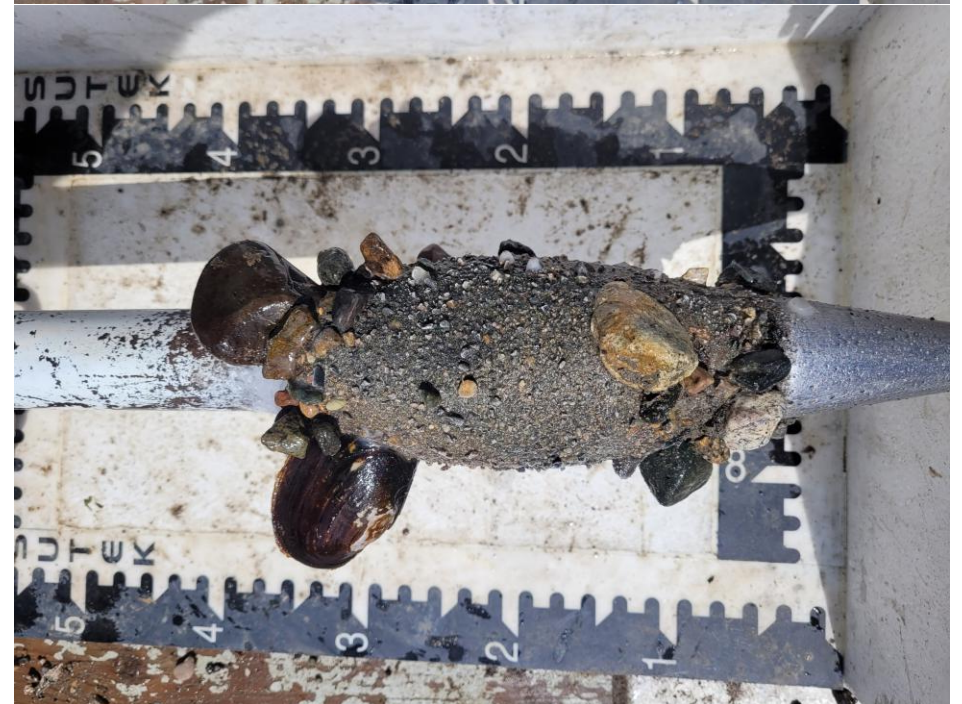
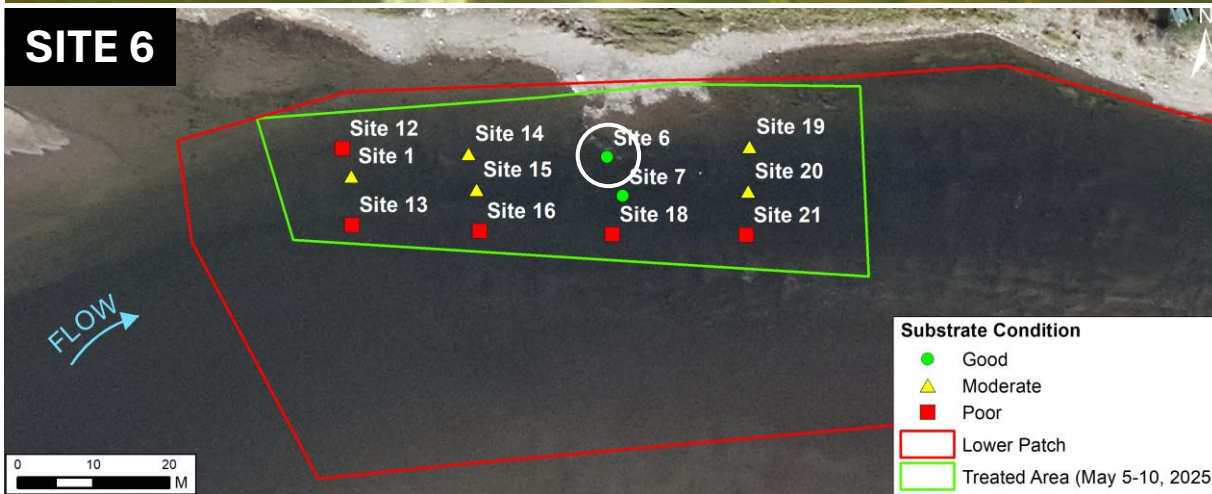
## SITE 6

In comparison to the sites discussed above, the treatment did produce very good results at Site 6 and Site 7 (Figure 3.5). The pre-existing substrate at these sites contained a high proportion of gravels and cobbles and relatively low proportion of surficial sand (Table 3.2; Figure 3.3). The restoration methods used in May 2025 may therefore be effective at restoring moderately degraded habitat, such as a veneer of sand otop of gravels and cobbles, but less effective in highly degraded habitats with high sand content. This finding has important implications for the planning of future restoration efforts within the spawning reach, where the focus may shift from remediation or cleaning of existing substrate to placement of additional spawning substrate to effectively coarsen the composition of the surficial sediment mixture (see Section 5).

**Figure 4.1 Comparison of substrate conditions at Site 6 during each sampling event.**
