Annual Report September 1, 2014 to March 31, 2015

Submitted to NEEF

Nechako Environment and Water Stewardship Society – NEWSS

NEEF Project name: Nechako River Sustainability

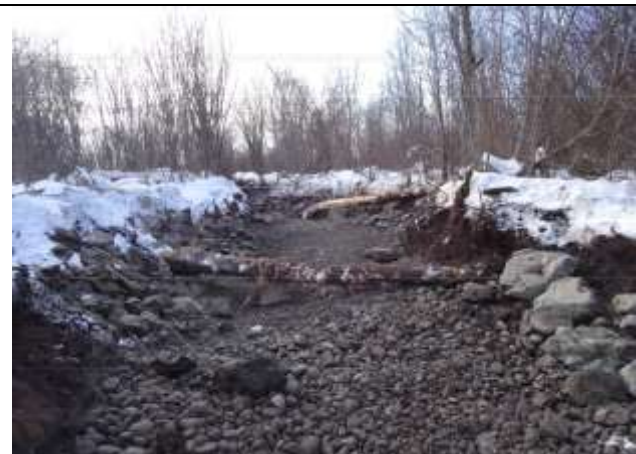
Photo 16. Spawning gravel, cobble and boulder substrate with armoured banks.

The bed was sloped such that depth gradually increased towards the bank at outside bends with shallow water habitats along the inside bends as typically occurs under natural conditions (**Photo 15**). Stream bank at the outside bends and other locations vulnerable to erosion were armoured with boulders and cobbles. A 15 to 20cm layer of cobbles and gravels were placed over nearly the entire channel bed to maximize macroinvertebrate production and provide cover for juvenile salmonids and small fish species (*e.g.* **Photo 16**). Gravels with an intermediate diameter of 1.5 - 6.0cm, considered optimum for resident rainbow trout spawning success (Raleigh *et al.*, 1984), were placed at typical rainbow trout spawning locations such as pool tail-outs, behind boulders, behind and in front of weirs, amongst coarse woody debris structures and in riffle habitats (*e.g.* **Photo 13, Photo 16**). Stream gradient from the Larson Road crossing to the end of the restored channel ranged from <1 to 2%. The restored historic channel should contain all moderate to low flows thereby improving fish passage.

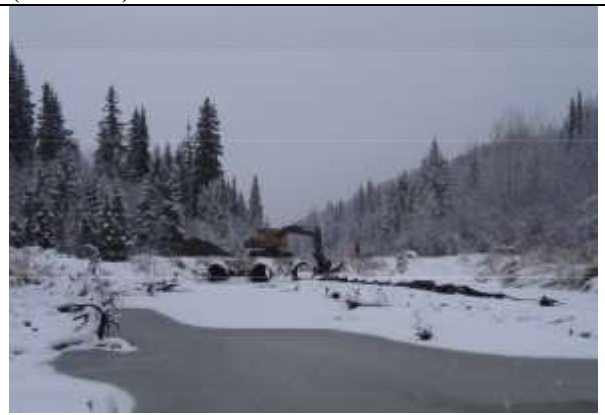
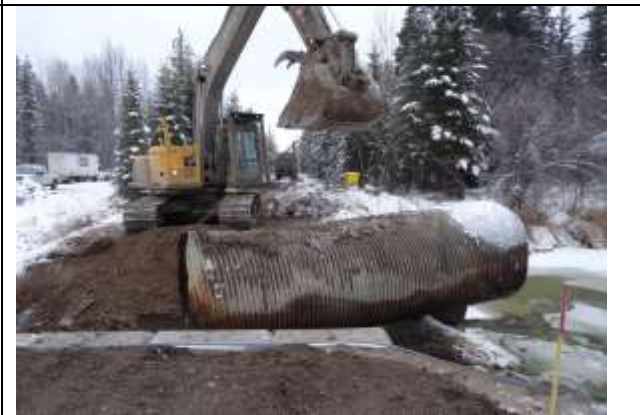
<p>Photo 5. Excavation of the east bridge abutment site, November 24, 2014 after the installation of the habitat enhancement structures.</p>	<p>Photo 6. Removal of the first culvert following the installation of the east bank bridge abutment.</p>

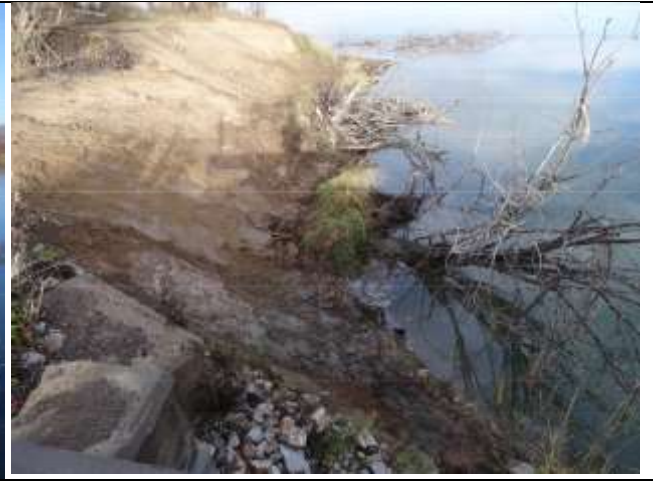
Photo 32. Re-sloped west bank of Stoney Creek prior to bank armouring and root wad placement.

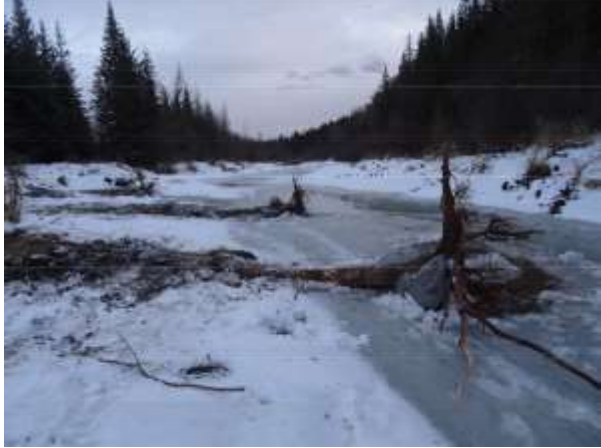
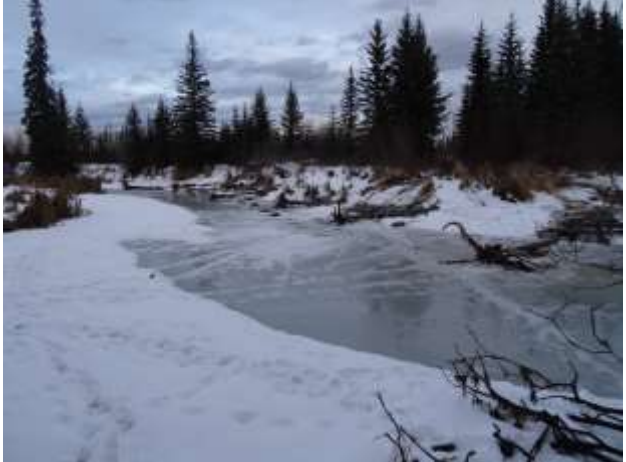
<p>Photo 45. Installed boulder clusters to which the root wads were anchored with cable.</p>	<p>Photo 46. KP2+175 at project completion.</p>

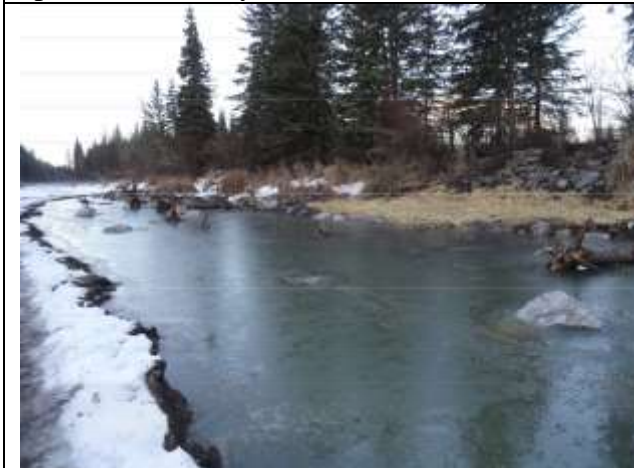
Photo 50. Completed habitat restoration upstream of the non-active beaver dam looking upstream.

Willow cuttings were planted on March 30, 2015. Planting was limited to below and within the one section of bank that was armoured with boulders (**Photo 52, Photo 53**), visible to the right in **Photo 50**, as the existing riparian vegetation at this site, including willows and conifers of mixed ages, was so extensive that some vegetation had to be cut back to provide access to the site. Cuttings were inserted into any available soft, wet substrate at the foot of and within the boulders to a depth of approximately 0.5m.

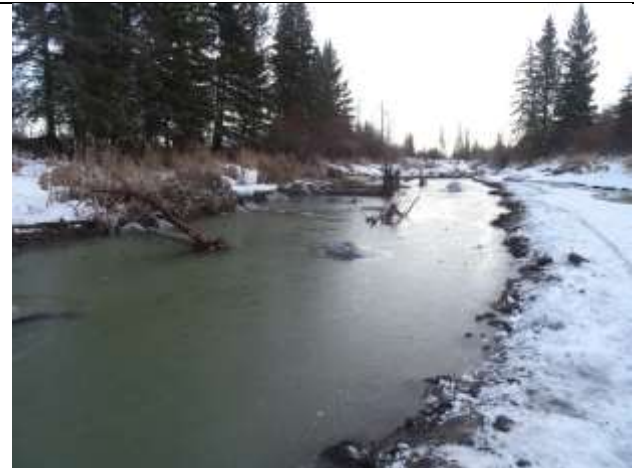
Photo 51. Completed restoration upstream of the non-active beaver dam looking downstream.
